AIC 14-1003

**PAPUA NEW GUINEA
ACCIDENT INVESTIGATION COMMISSION
SHORT SUMMARY REPORT**

P2-RNB

Go-around— collision with terrain

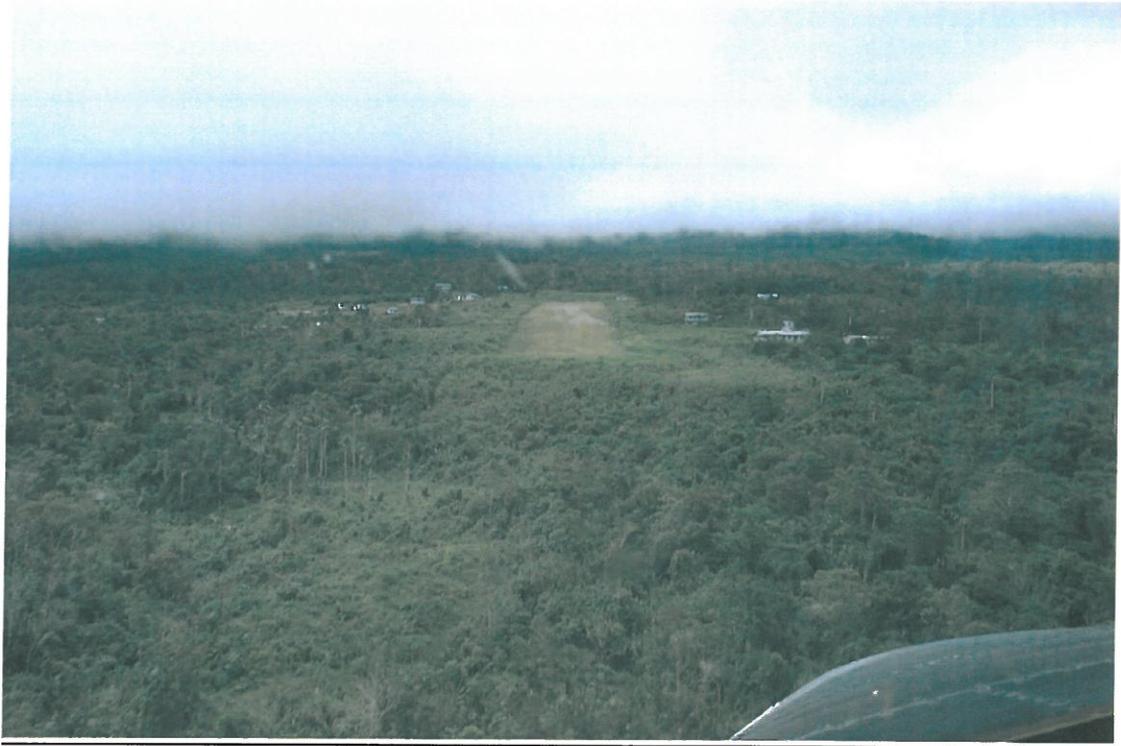
Figure 2: Final approach view on runway 03 at Gulgubip

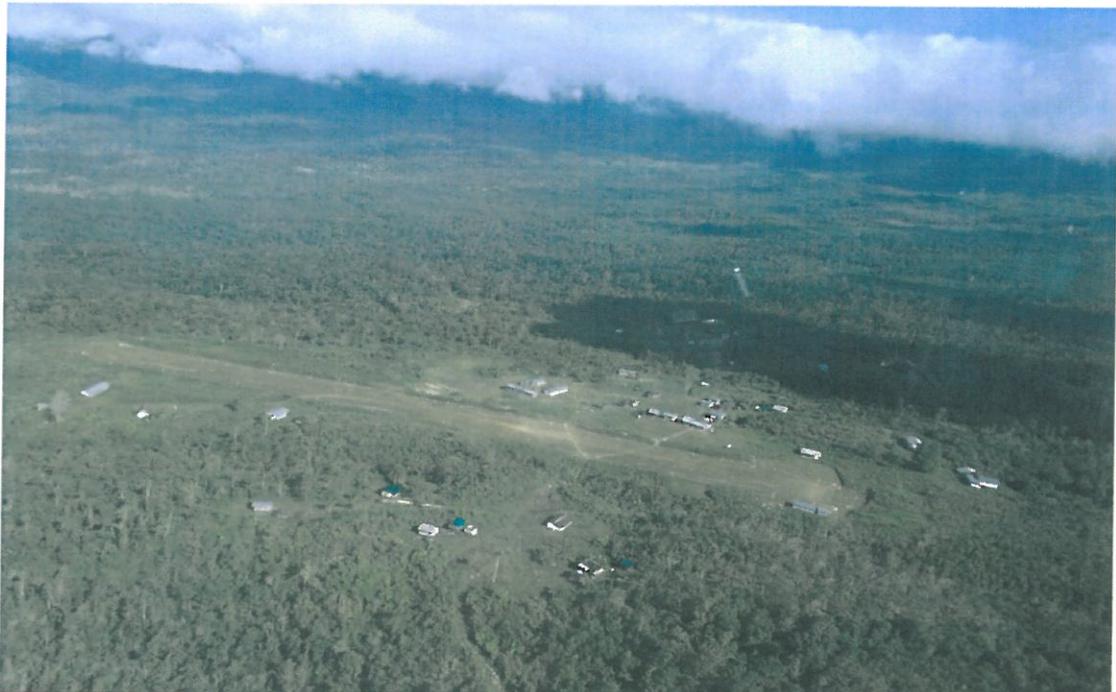
Figure 3: The Gulgubip airstrip with an arrow pointing to the windsock from runway 03

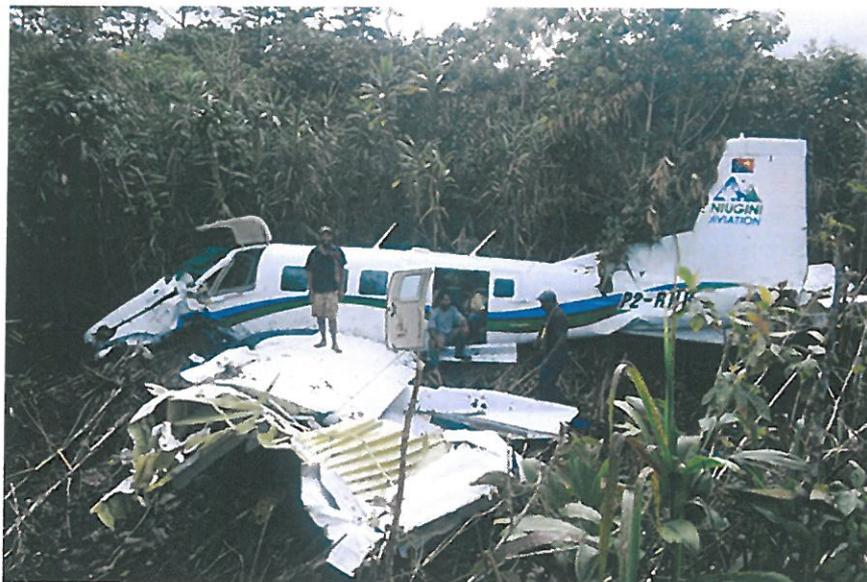
The aircraft was substantially damaged during the impact with vegetation and terrain. (See Fig. 3).

Figure 3: View of damaged aircraft from the left wing
