**PAPUA NEW GUINEA
ACCIDENT INVESTIGATION COMMISSION
FINAL REPORT**

P2-MFV

Cessna Aircraft Company TU206G

Practice rejected takeoff - aircraft overturned

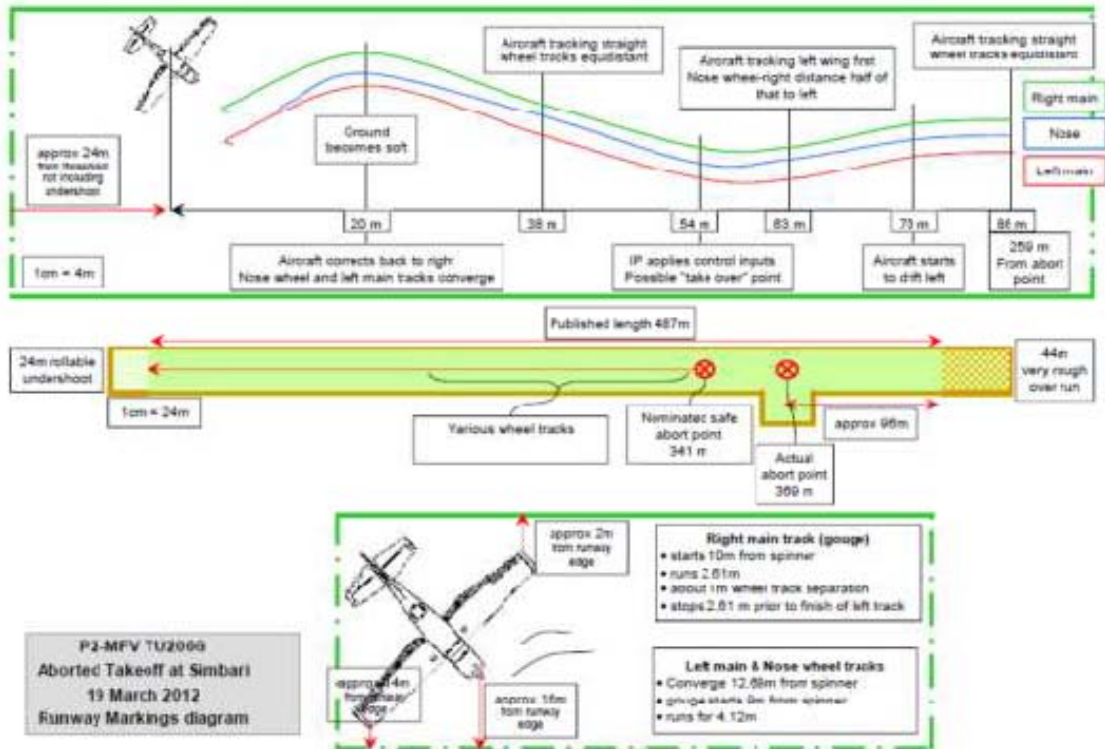
5 Appendix

Airstrip marks show that during the abort process, the airplane turned a little left, then right, then back to the left. At the point where the aircraft was turned towards the left this last time, the tracks indicate that the aircraft rotated around the yaw axis such that the right wing was leading. This is evidenced by the tracks as the nose wheel track converges and then merges with the left main wheel track. At this time, while the aircraft rotated, the resultant aircraft direction of travel did not immediately change.

Only during the last few meters did the aircraft direction of travel begin to change back to the left, towards the centre of the strip. At this point the aircraft encountered a soft spot on the runway. Up until this point the runway had been firm, but slippery. The runway suddenly and noticeably became much softer toward the end of the airstrip. It is difficult to quantify surface strength, but while the spot where the aircraft dug in was soft, it was not to the extent that normal foot prints left substantial marks.

The significant sideways drag – significant because the nose wheel and left main were carving only one track – was sufficient with the aircraft residual momentum to cause the aircraft to over-turn. The quantity of dirt collected by the right side of the nose wheel, compared to the absence of dirt on the left side, confirms the level of drag and angle of travel at the time the aircraft turned over.
