AIC 11-1003

AIRCRAFT ACCIDENT REPORT

P2-PHL

Eurocopter AS350 B2

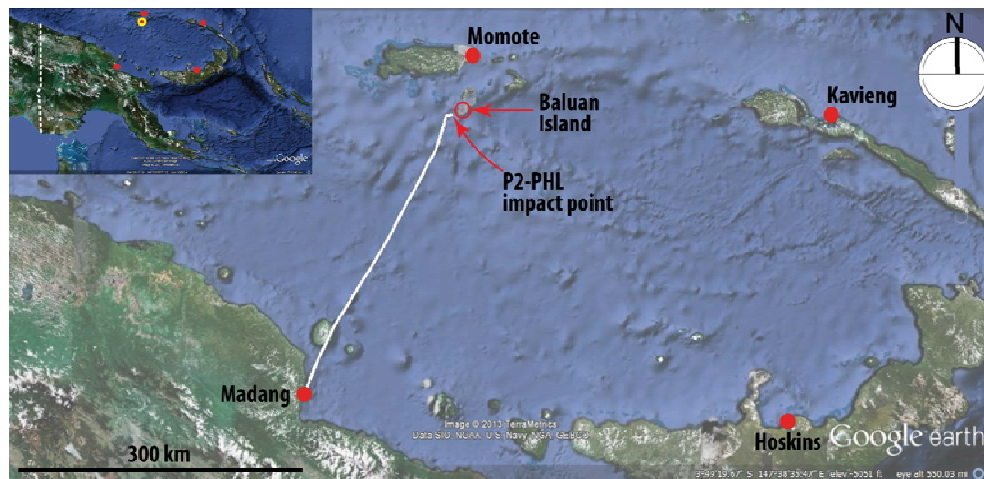
Figure 1: PHL's track from Madang to the point of impact near Baluan Island.

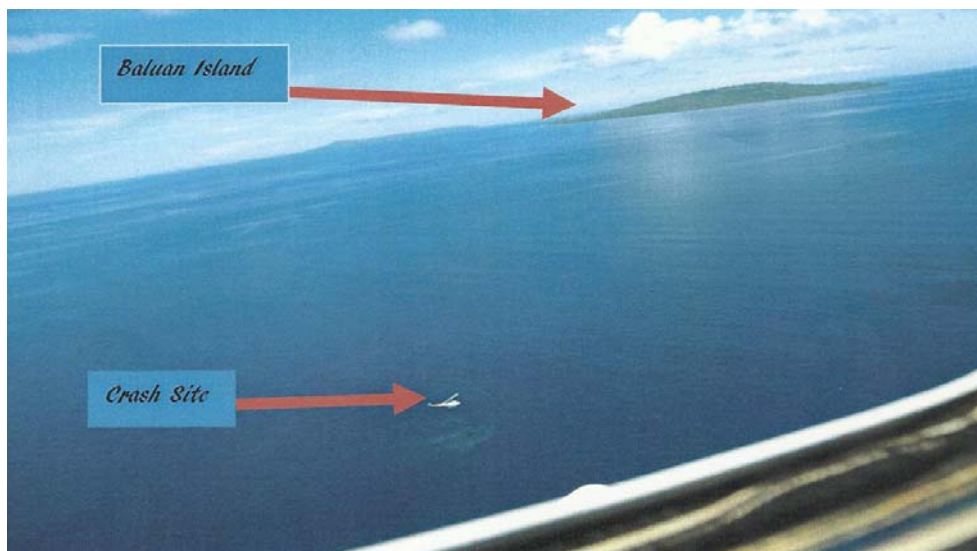
The surface of the ocean was reported to be calm (glassy) with the sun's reflection off the glassy surface at the time of the flight. This may have affected the pilot's depth perception, particularly when nearing the surface.

Figure 2: The accident site photo taken about 35 minutes after the accident, showing the glassy surface of the water.

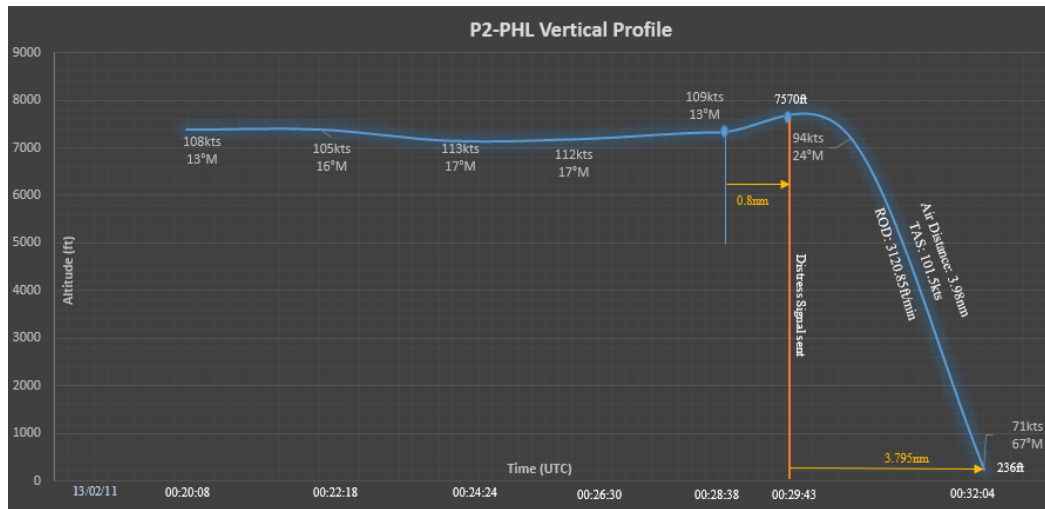
The recorded data showed that at 00:28.38 the helicopter was tracking 013°M and commenced climbing from 7,327 ft and was at 7,570 ft tracking 024°M at 00:29.43 (1 min later). During the climb the speed decayed from 109 kt to 94 kt.

⁶ The 'ground' distance travelled during the descent was 3.795 nm. The 'air' distance travelled in the descent gradient 3.978 nm. See figure 4.

Figure 4: PHL vertical profile using Sky Connect data

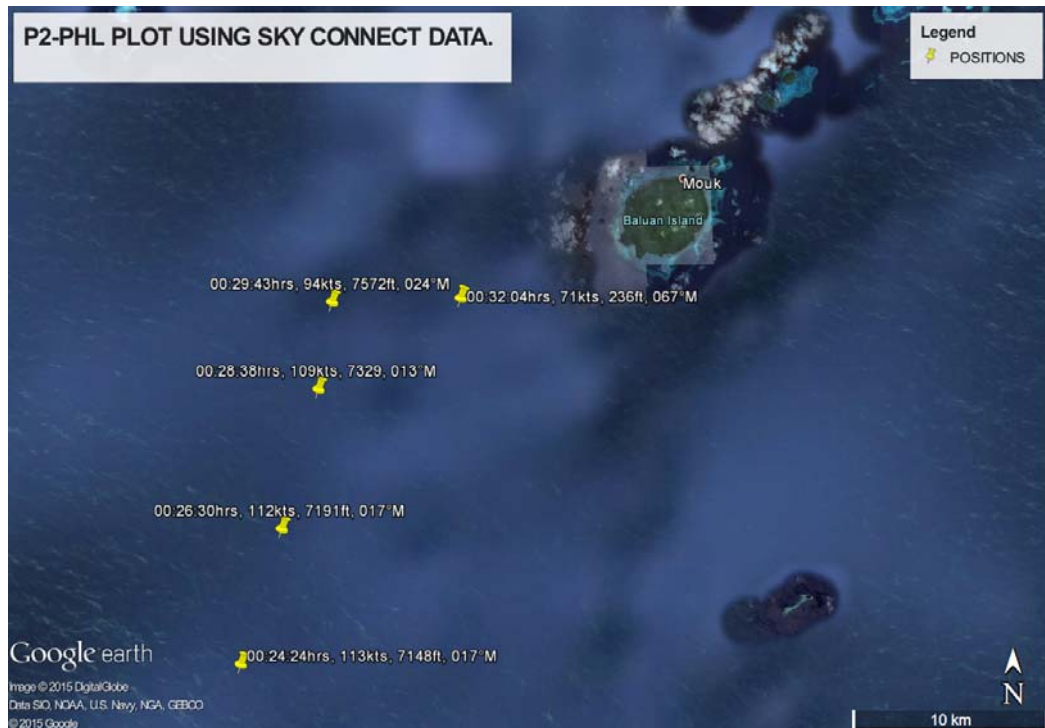
Figure 5: PHL plot using Sky Connect data

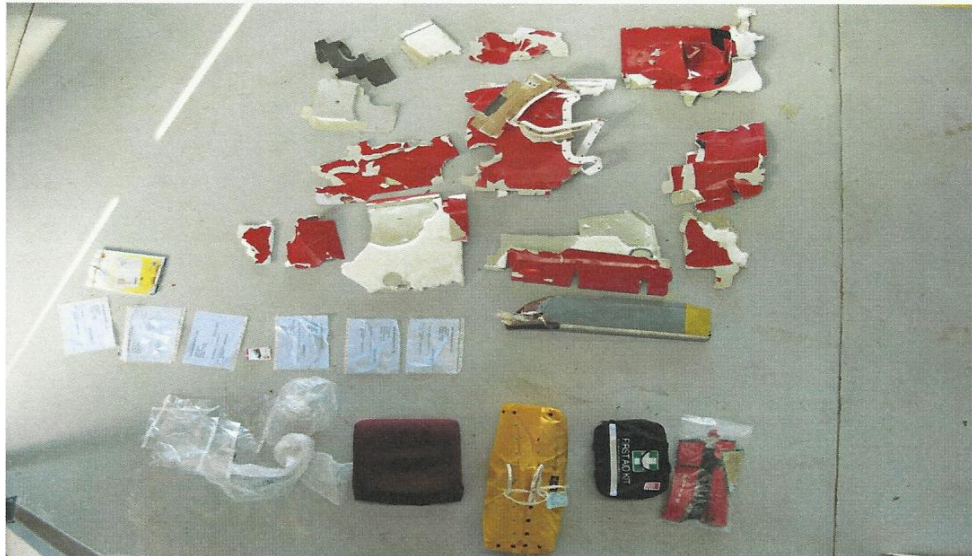
The eight items recovered from the ocean surface that came from inside the helicopter indicated that either a door was opened prior to impact, or the impact caused a door/s to pop open, allowing the recovered items to be washed out of the aircraft cabin.

Figure 6: Items recovered from the ocean

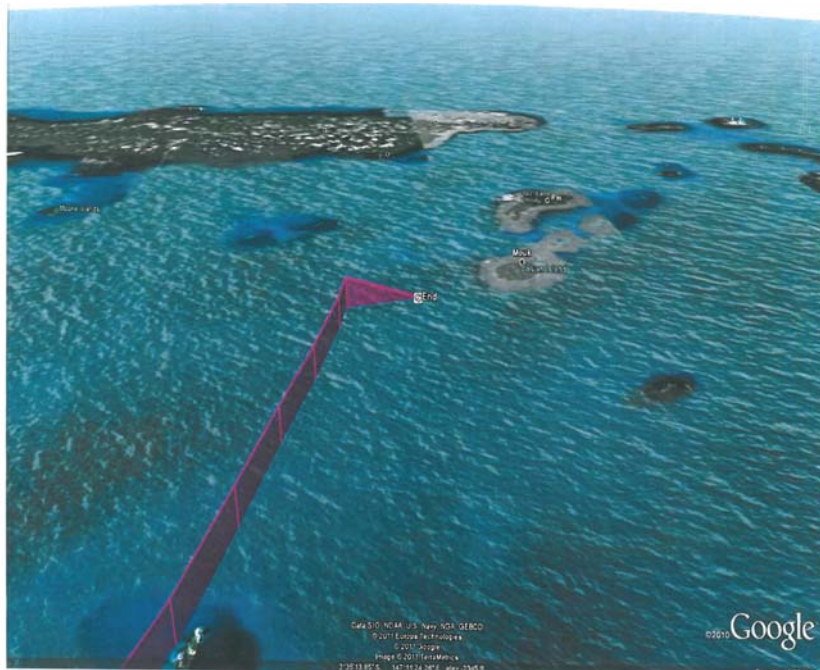
Figure 7: Satellite tracking of the helicopter flight path
