FINAL REPORT

AIC 16-1002

AIRCRAFT ACCIDENT INVESTIGATION REPORT

P2-SBC

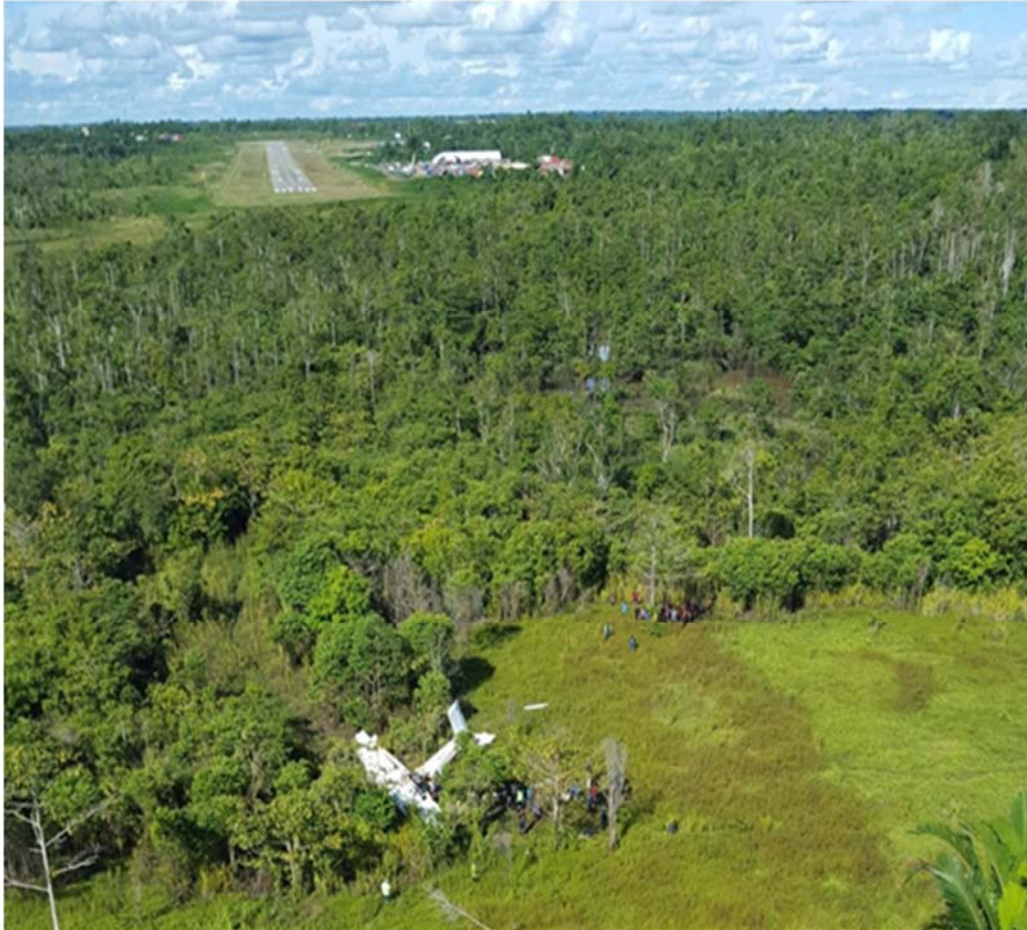
Figure 2: Accident site and wreckage looking in an easterly direction
(Taken 90 minutes after the accident).

The wreckage was confined to a small area during the near-vertical impact. It was situated in mixed grassland and low swamp forest, and there was no damage to the surrounding environment.

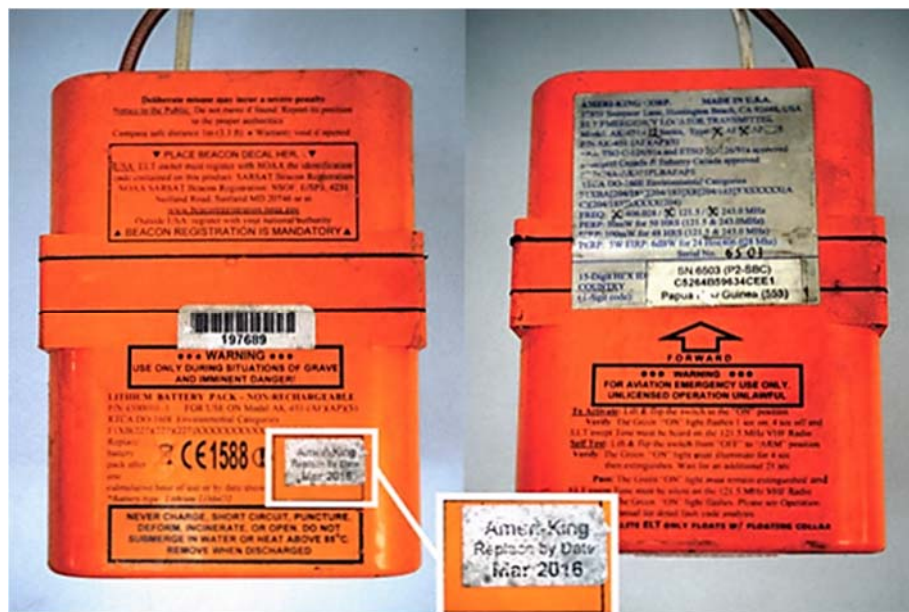
The emergency locator transmitter (ELT) fitted to SBC bore a label stating 'Ameri-King/Replace by Date/Mar 2016' (Paragraph 1.6.8 and Figure 5). Therefore, the ELT had been unserviceable for at least 2 weeks prior to the accident. In accordance with the operator's minimum equipment list, the ELT was required to be fitted and serviceable.

The ELT was not relevant to this accident, because the aircraft was immediately located by witnesses to the accident. However, the ELT was listed as a required item on the operator's MEL. Moreover, the carriage of a serviceable ELT on aircraft in PNG is mandated for the safety of aircraft occupants in the event of an aircraft accident away from habited areas. Because a serviceable ELT is a requirement for the safe operation of the aircraft in PNG, an out of date ELT rendered the aircraft unserviceable.

Figure 5: Emergency locator transmitter recovered from the wreckage of SBC

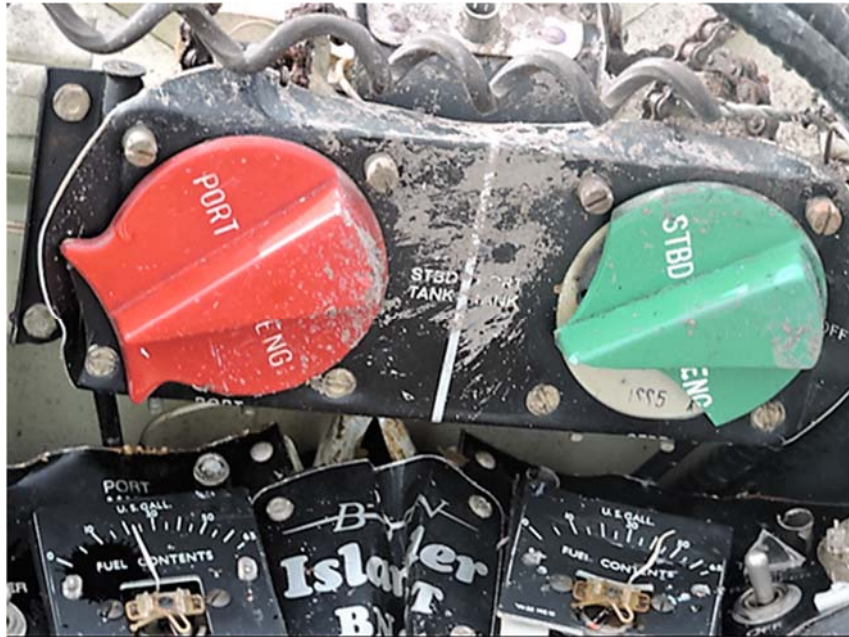
The left and right sides of the selector backing plate, under the selectors, was bent during the impact and there was no possibility of the left selector further rotating from its pre-impact position.

Figure 7: Fuel selectors powerplant systems

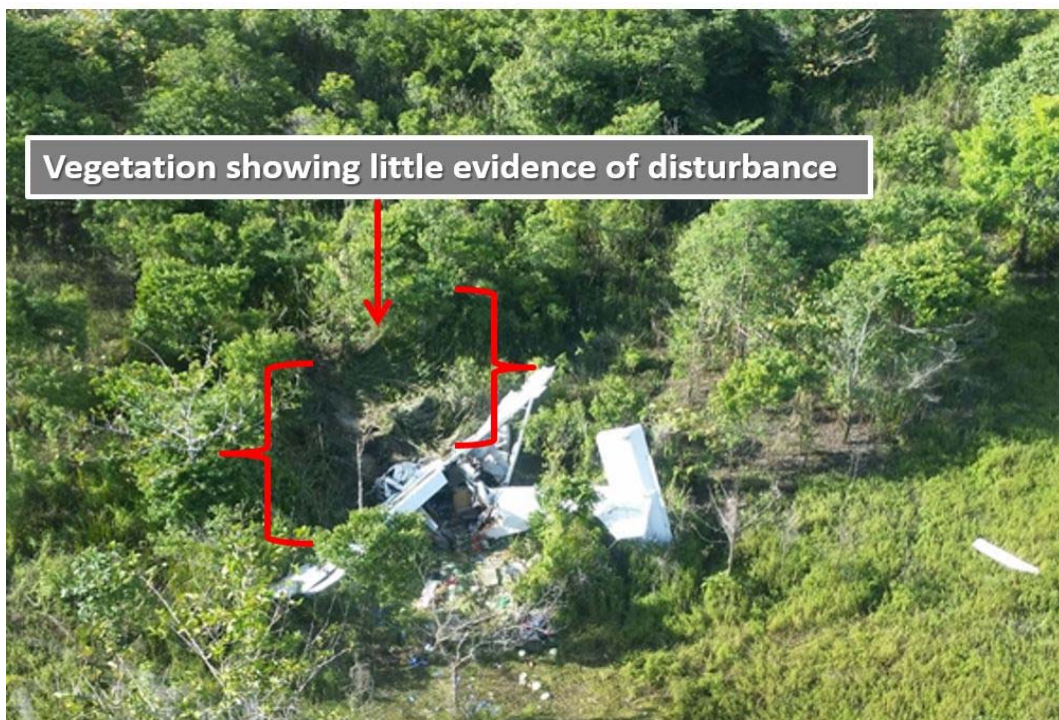
The aircraft impacted the ground almost vertically, consequently there was no wreckage trail. Vegetation approximately 4 to 5 meters in front of the aircraft's nose showed little evidence of disturbance as a result of the impact. Although substantially disrupted during the impact, the wreckage was largely confined to the immediate vicinity of the impact point.

Figure 9: Accident site showing wreckage confined to general dimensions of the aircraft

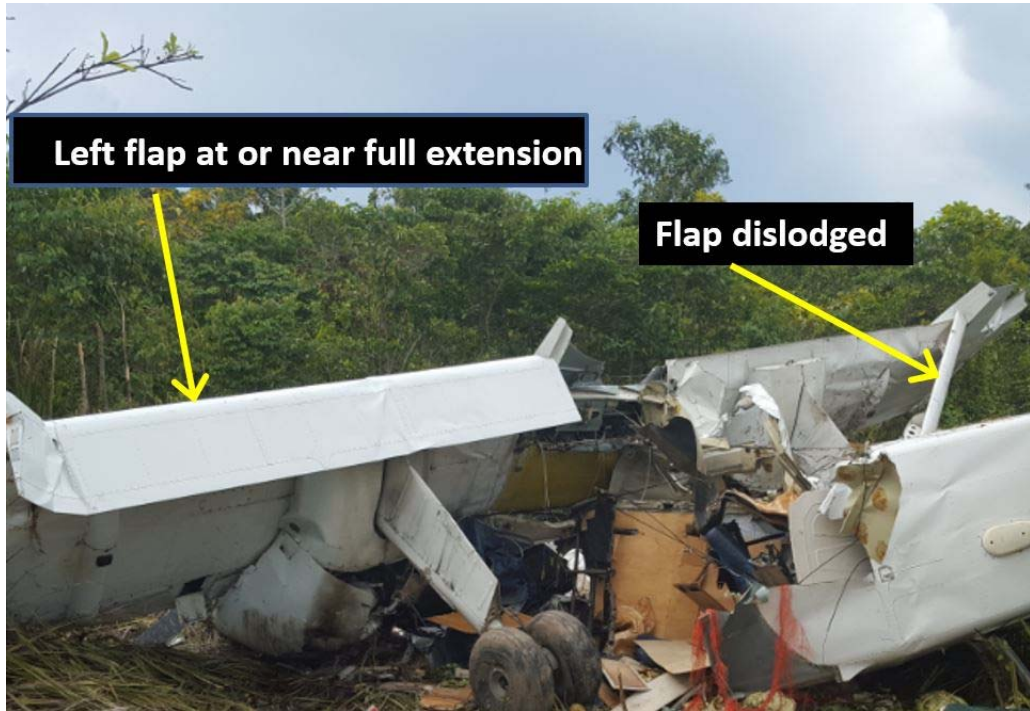
The fuselage had fractured around the rear cabin, separating the top mounted wing assembly and the forward cabin from the rear fuselage and empennage. The fuselage and wing were horizontal to the ground, and the rear fuselage was resting on its left side, with the attached empennage resting on the tip of the left tailplane.

Figure 10: Wreckage viewed from the left side behind the left wing

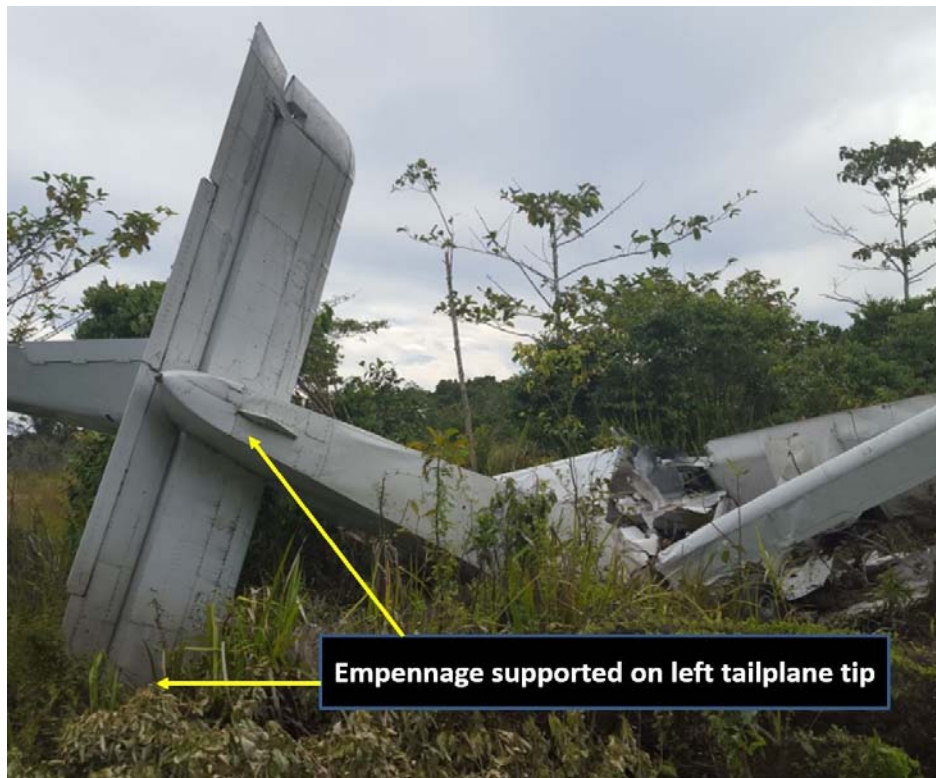
Figure 11: Empennage supported on the left tailplane tip

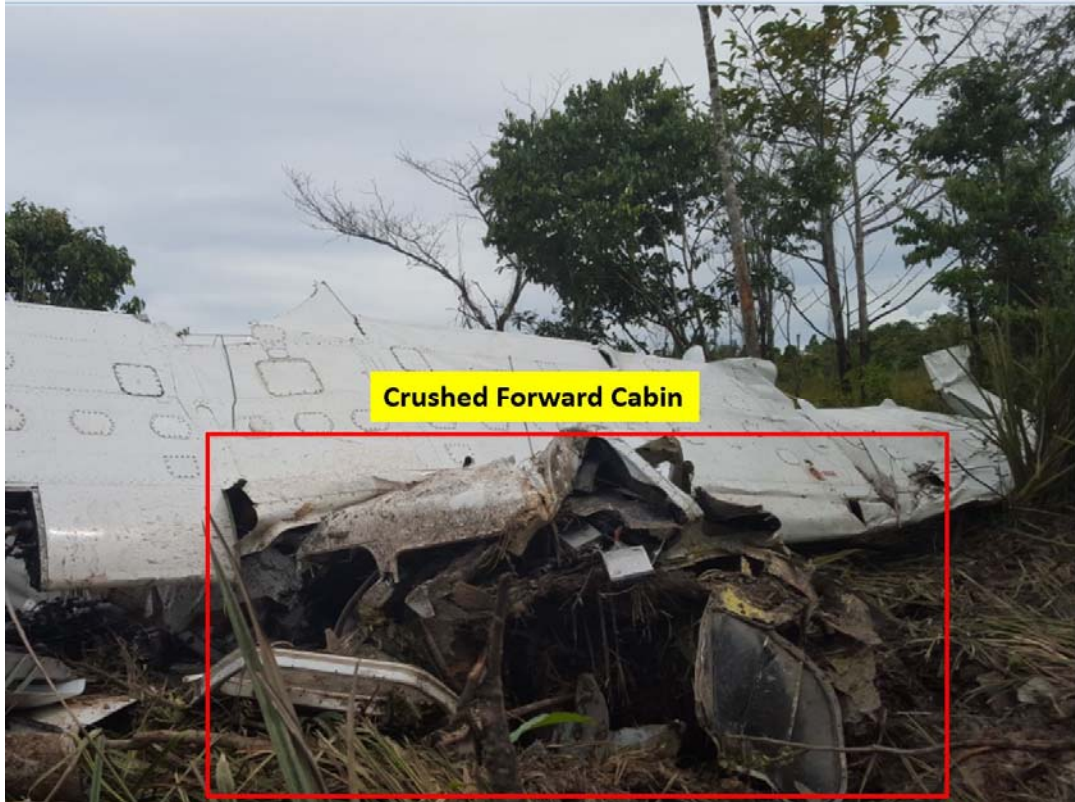
The cockpit could not be inspected at the accident site, due to it having been crushed by the forward movement of the cabin during the impact. The wreckage was airlifted to Kiunga, where detailed examination was carried out.

Figure 12: Compressed Forward Cabin

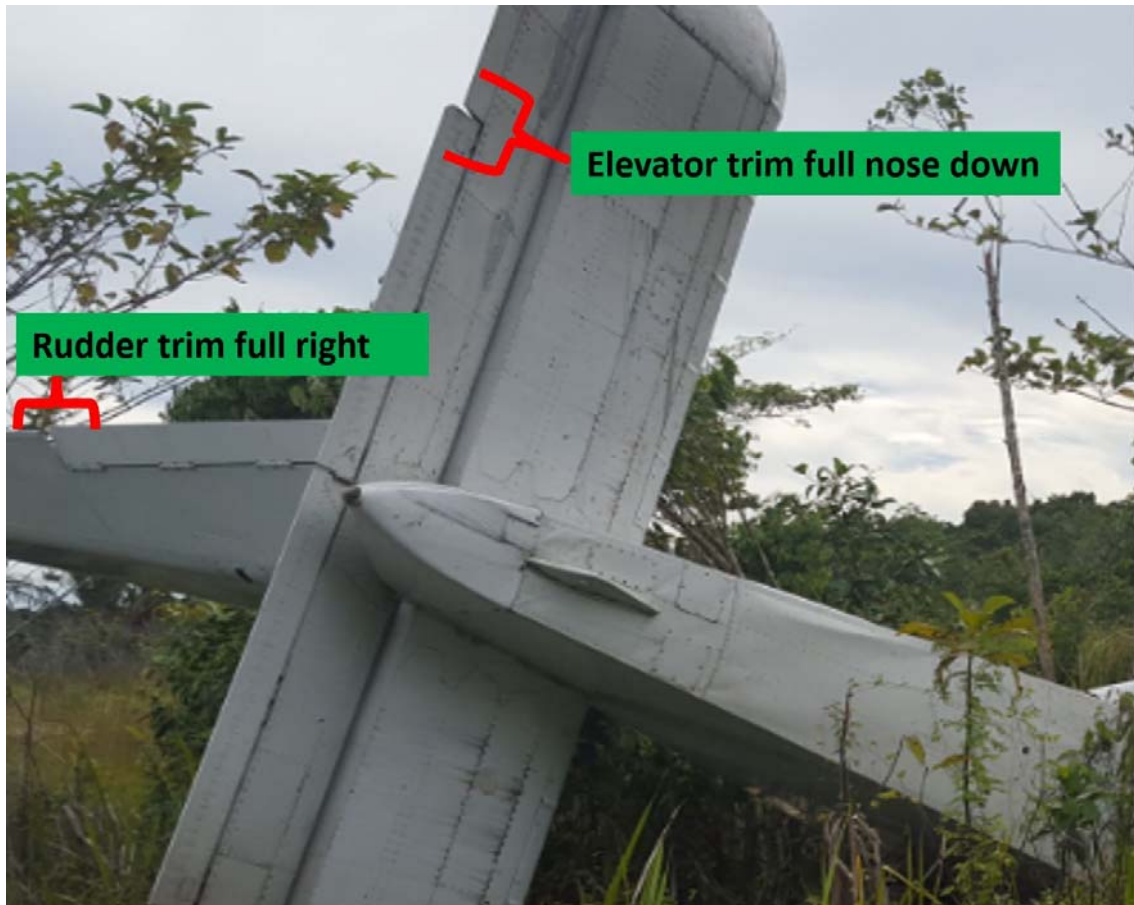
The investigation determined that the elevator trim tab was fully deflected nose-down. There was no damage to the screw jack and push rod systems. There was no evidence that impact forces influenced the length of the screw jack extension, and the position of the elevator trim tab with respect to the degree of deflection. (Appendix 3)

The investigation determined that the rudder trim tab was fully deflected nose-left. There was no damage to the screw jack and push rod systems. There was no evidence that impact forces influenced the length of the screw jack extension, and the position of the rudder trim tab with respect to the degree of deflection. (Appendix 3)

All flight control surfaces were accounted for and identified. The investigation determined that despite the significant disruption of the airframe due to the impact forces, with the exception of the right-wing flap, the control surfaces remained connected to their respective cockpit controls. The elevator trim tab was in the full nose-down trim position. The rudder trim was in the full nose-left trim position. The rudder position had been affected by cable disruption during the impact, but the rudder trim screw jacks and push rods were not disrupted and the rudder trim was in the full nose-right trim position.

Figure 13: Elevator and rudder trim tabs

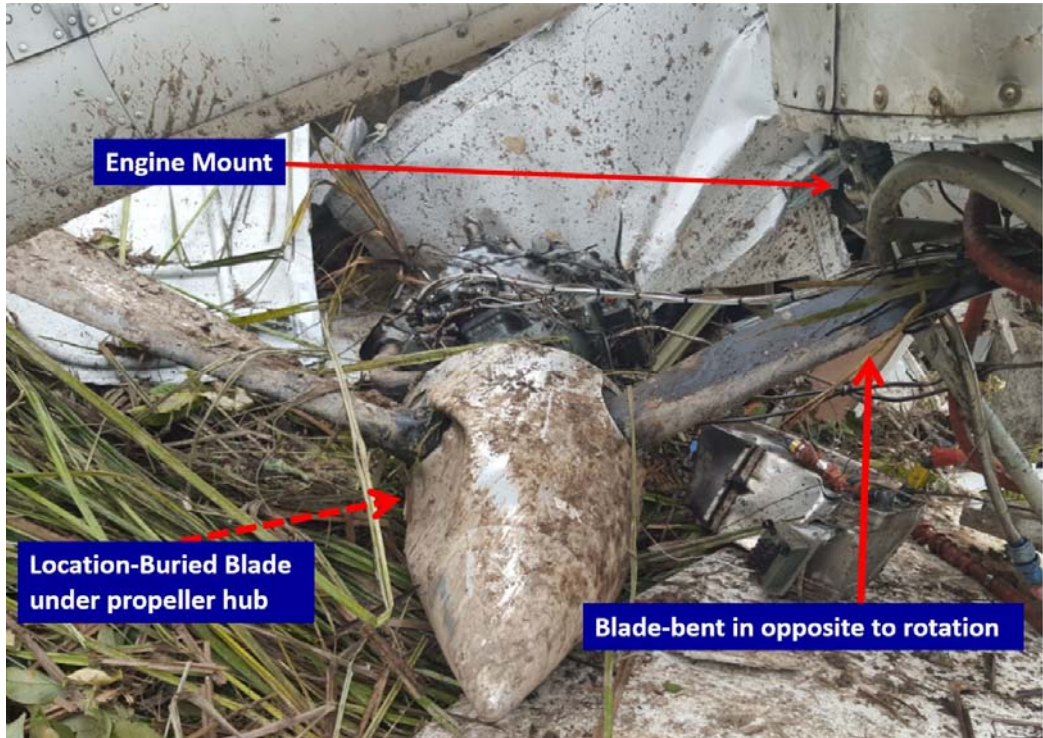
The force of the impact dislodged the right engine from its mount, with the right propeller assembly still attached. One propeller blade was buried in the mud. The propeller blades were identified in the feathered position. The blade buried in the mud was slightly bent in the opposite direction to the rotation of the propeller. Another blade was substantially bent in the opposite direction to the rotation of the propeller. However, that bending appeared to be largely due to it being tangled with the engine mount.

Figure 14: Right engine and propeller

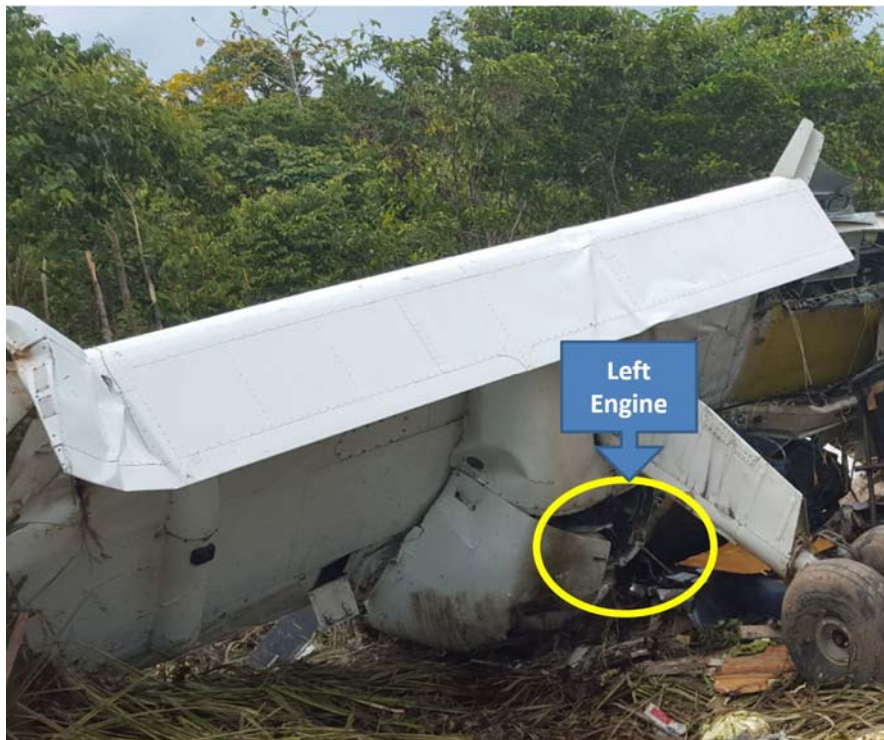
The left engine was found separated from the airframe, but remained attached to its mount. The left propeller assembly was sheared (in torsional overload) from its drive shaft. The propeller blades were in a fine pitch range at impact, with the two blades embedded in mud showing bending opposite to the rotation of the propeller.

Figure 15: Left engine still attached to its mount

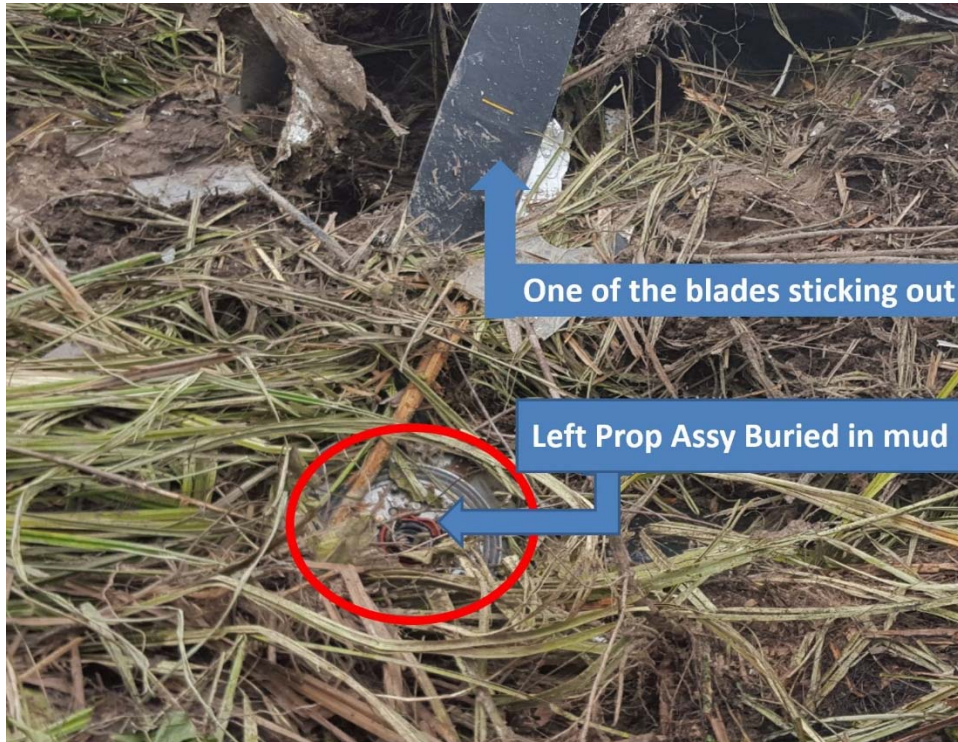
Figure 16: Left propeller

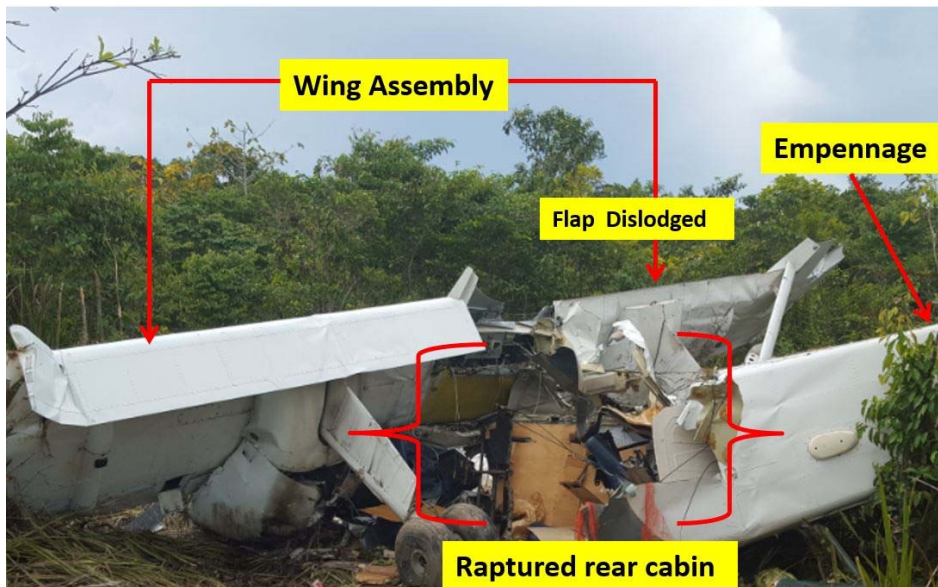
There was no evidence of in-flight structural failure of the wing flaps. The investigation determined that the wing flaps were at or near the fully extended position. There was no indication that impact forces influenced the position of the wing flaps with respect to the degree of deflection.

Figure 17: Left and right wing flaps

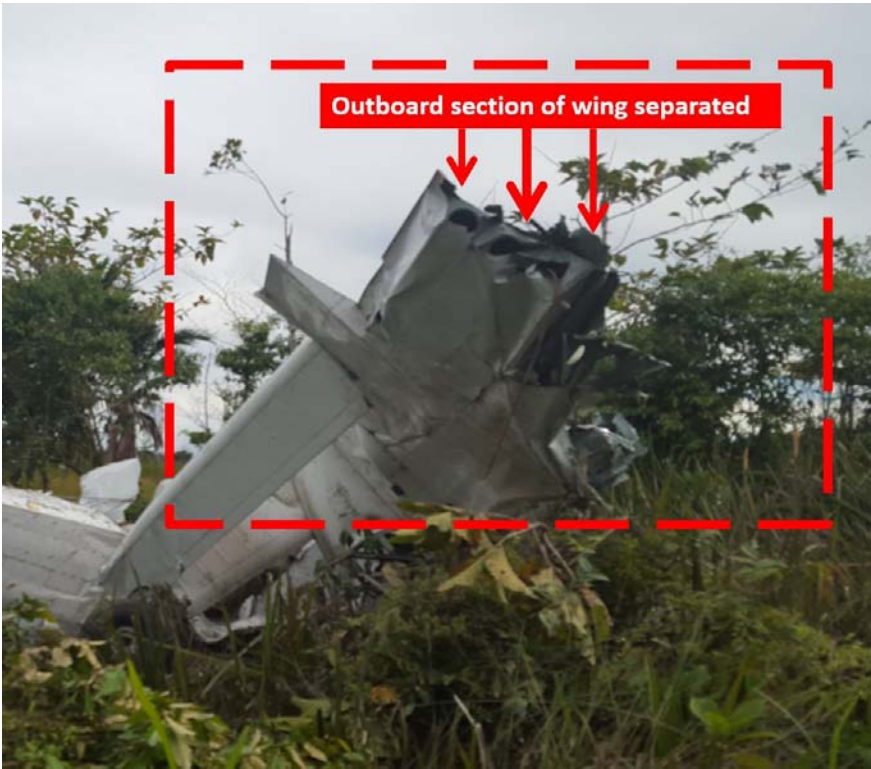
There were fractures along the whole wing assembly. The right wing outboard of the engine nacelle separated from the wing assembly during the impact. The aircraft's fuel tanks were not ruptured on impact.

Figure 18: Right wing outboard of the engine nacelle separated

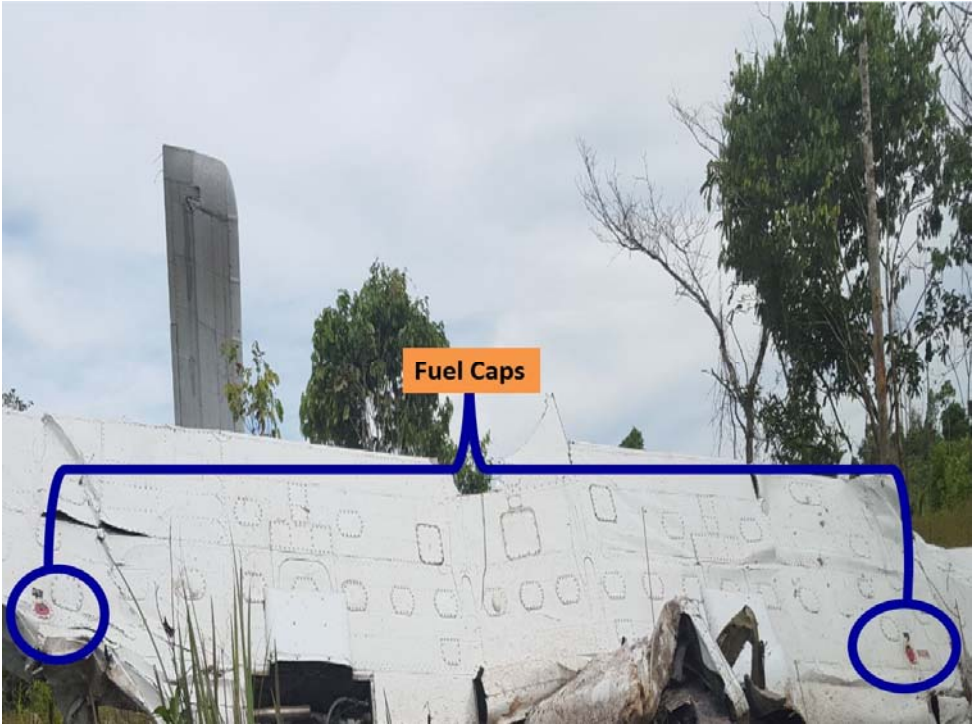
There was no evidence of pre- or post-impact leakage from the fuel tanks and the caps of both fuel tanks were securely fastened. There was evidence of some fuel in the left main fuel tank, but the right main tank was dry.

Figure 19: Wing assembly showing caps of both fuel tanks secured

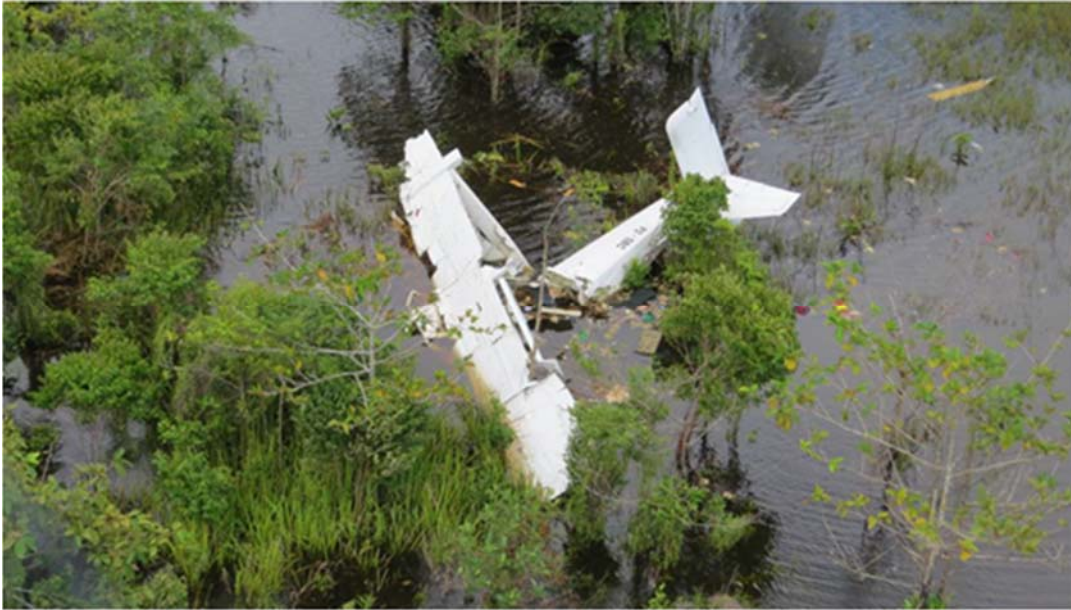
During the days following the accident, and the initial on-site examination of the wreckage, the weather prevented the full examination of the wreckage at the crash site by the AIC investigation team, and the manufacturer's representative from Rolls-Royce Corporation. There was torrential rain and flooding at the crash site. The wreckage remained partially submerged for 5 days, before being airlifted by helicopter to Kiunga Aerodrome.

Figure 20: Wreckage submerged
(Source: Rolls-Royce Corporation)

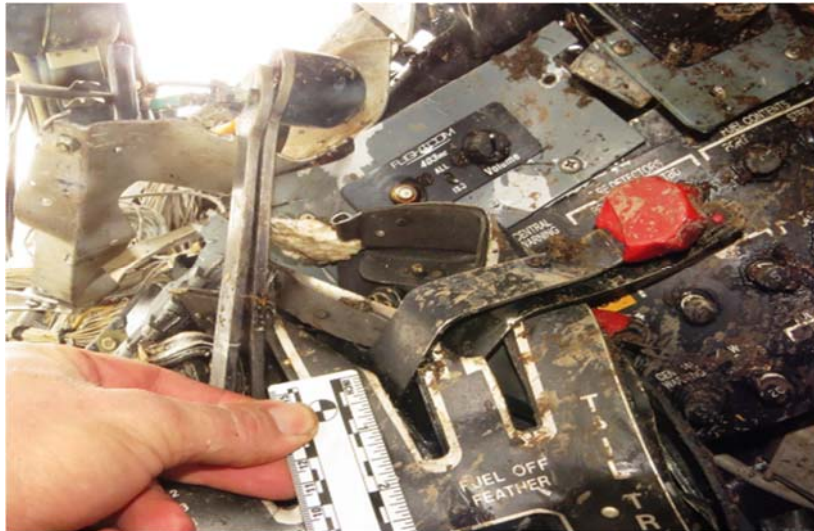
The power levers and propeller (condition) levers in the cockpit had sustained a heavy impact from the left side, bending the levers to the right and effectively locking them in-place at their last setting immediately prior to impact. Both engines were set to low power (approximately 4cm above 'IDLE')¹⁰ and both propellers were at the Minimum setting (above the aft detent), both typical settings for an aircraft on a short final approach to landing.

Figure 21: Power and Control Lever approximately 4cm above IDLE

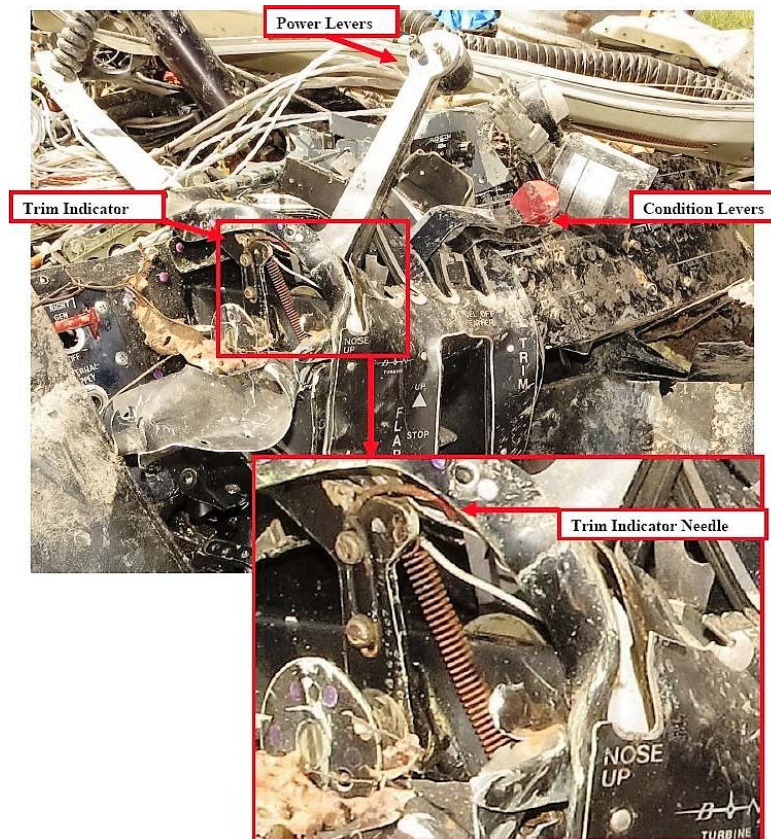
Located immediately adjacent to the engine controls was the elevator trim control and position indicator. Like the engine controls, the trim indicator had received impact from the left side, jamming it in-place. The trim indicator needle had been forced against its associated housing, leaving clear witness marks of its position at impact. The trim indicator needle was found at the full nose-down (- 4) trim position. The elevator trim tabs were also found to be in the full nose-down trim position.

Figure 22: Cockpit Levers and Indicators were distorted due to force impact

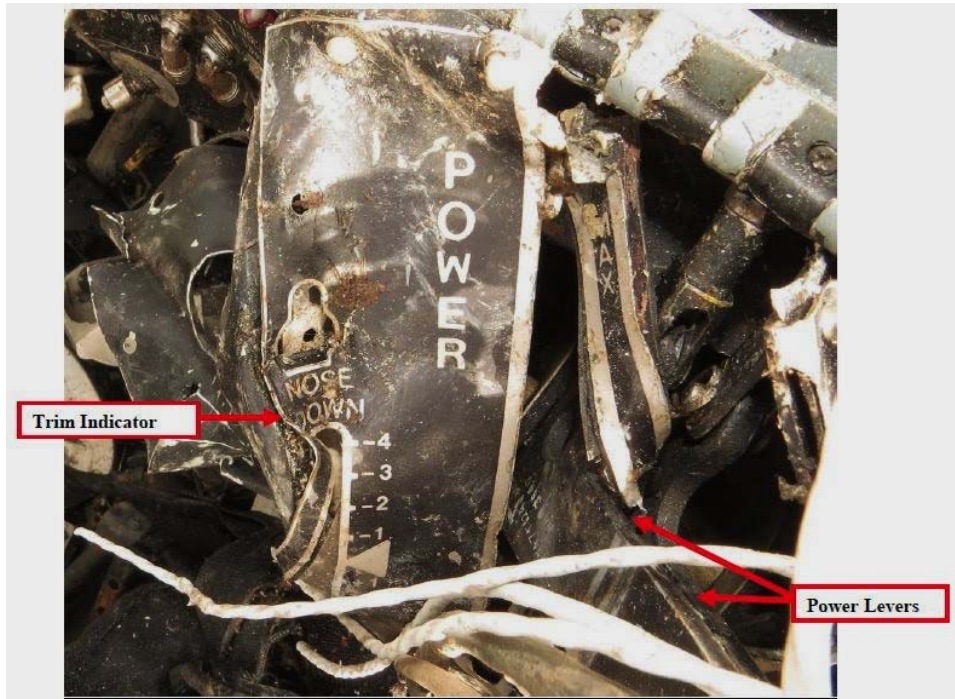
Figure 23: Trim Indicator scale

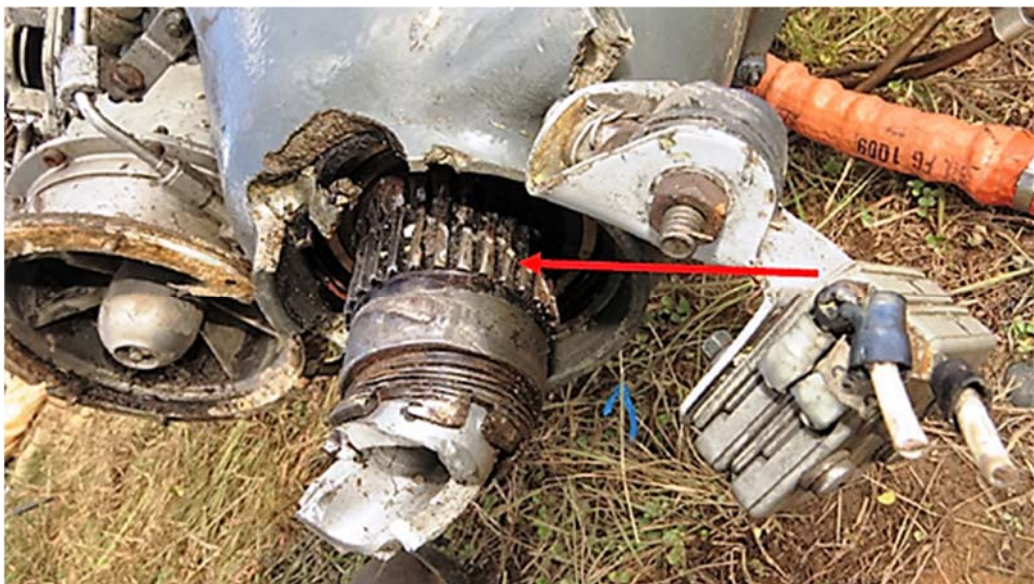
The left engine remained attached to the left wing by its engine mounts and associated control cables. The engine's propeller had detached from the propeller drive shaft during the accident sequence. The propeller drive shaft had failed in torsional overload. The propeller had penetrated the cockpit, and left evidence of rotation within the cockpit. Spiral witness marks on the propeller drive shaft splines are consistent with shaft rotation as the propeller was torn from the drive shaft.

Figure 24: Spiral disengagement witness marks (arrows) on the left propeller drive shaft

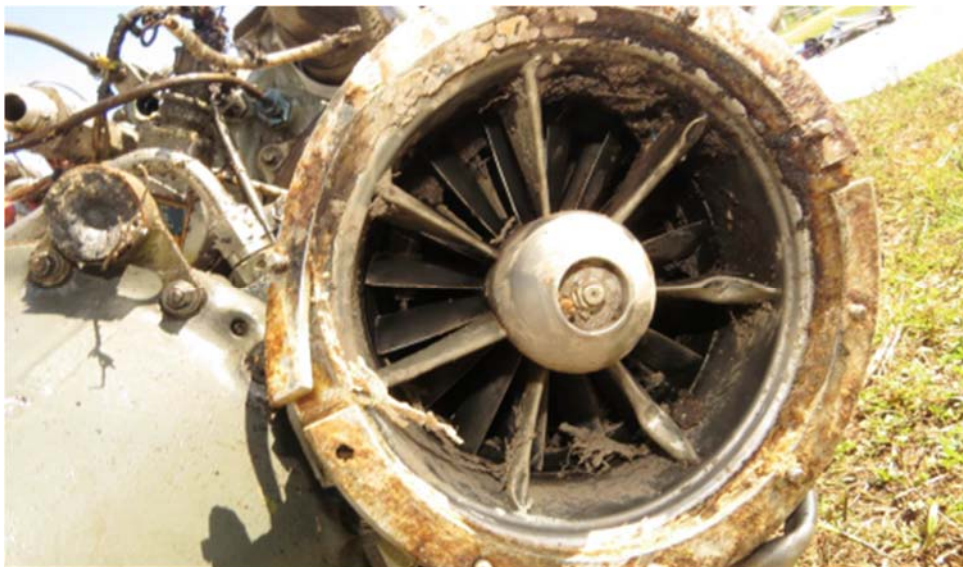
There was evidence of minor foreign object damage (FOD) to the compressor blades; with leading edge damage and minor tip bending in the direction opposite of rotation. Grass and leaves had been ingested by the compressor and were chopped progressively finer within the compressor, suggesting continued compressor rotation following impact.

Borescope examination of the compressor showed no evidence of blade or vane failure or operational distress. The compressor lining was intact and exhibited no evidence of erosion, cracking or flaking. The compressor could be rotated by hand.

Figure 25: Left engine Compressor Inlet

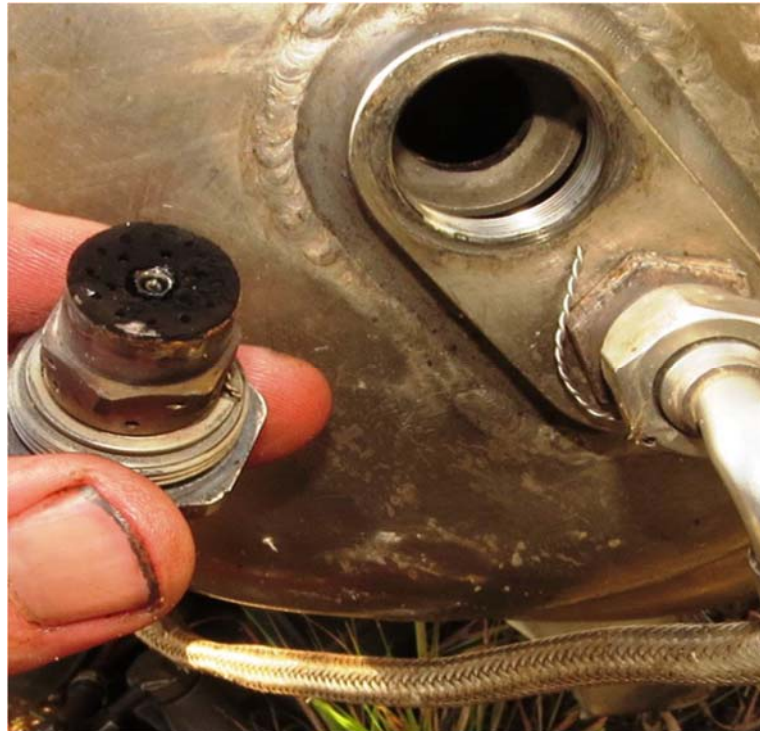
The fuel spray nozzle was removed and examined. The spray face exhibited minor corrosion, which was expected after the wreckage was submerged by flood water. The nozzle was disassembled and the fuel filter examined for contamination; the filter was free of any contamination.

Figure 26: Left engine fuel spray nozzle removed from combustor

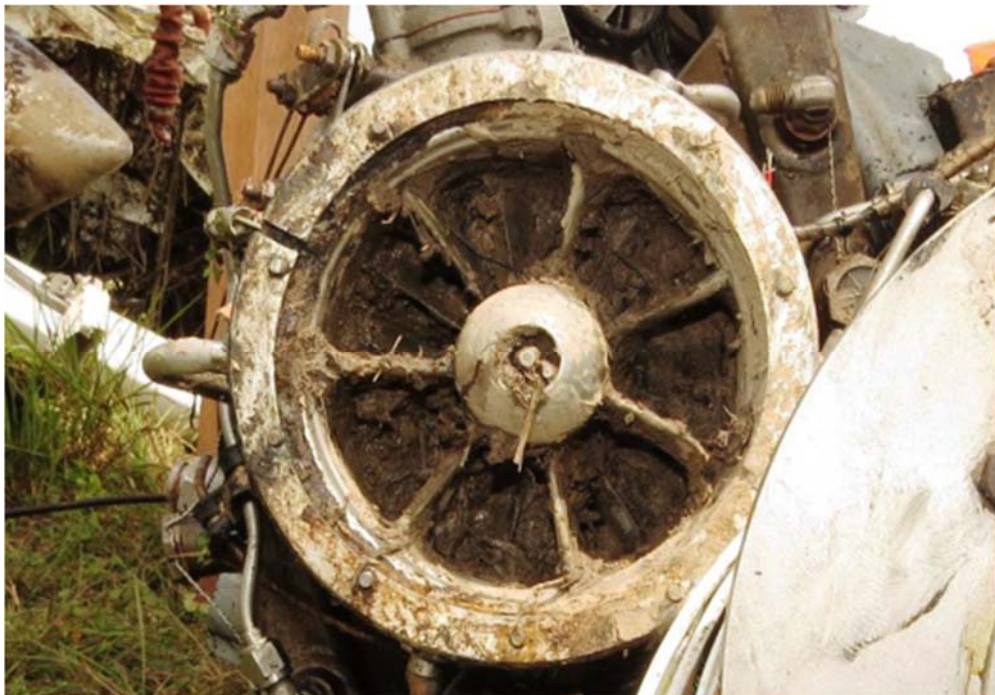
Figure 28: Right engine compressor mud extruding from compressor bleed valve

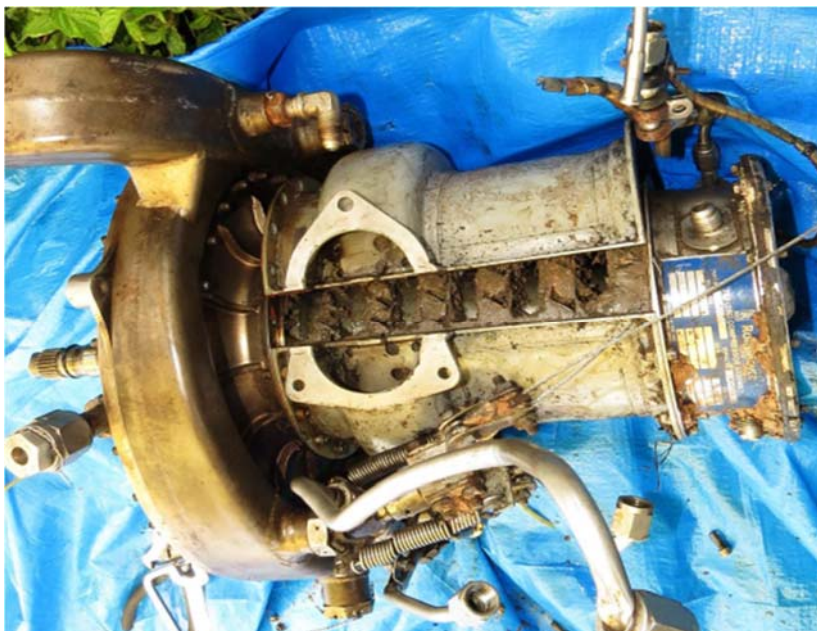
The engine's compressor module was removed for detailed examination. Removal of the compressor allowed the N1 drive train to be rotated by hand. Rotation was smooth, and produced corresponding rotation of the gas-generator turbine and starter/generator, thus confirming N1 continuity.

Figure 29: Compressor module, removed from right engine

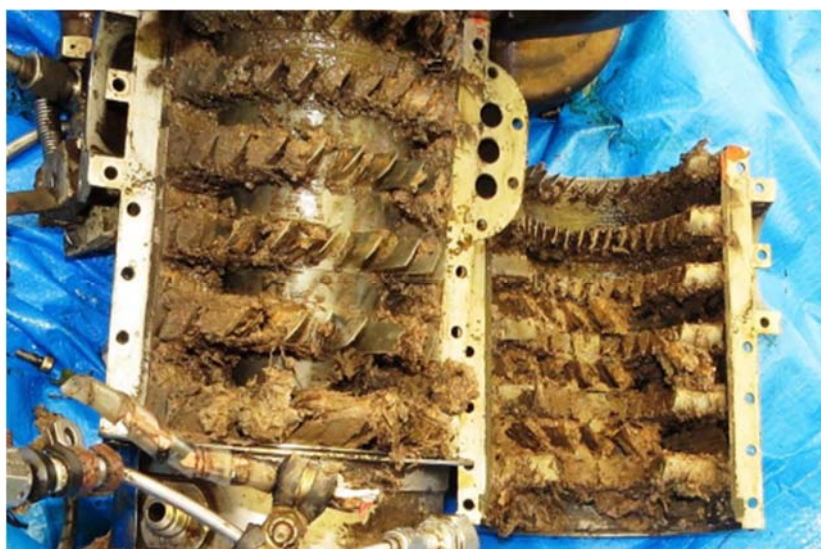
Figure 30: Split-line bolts removed, exposing mud and grass

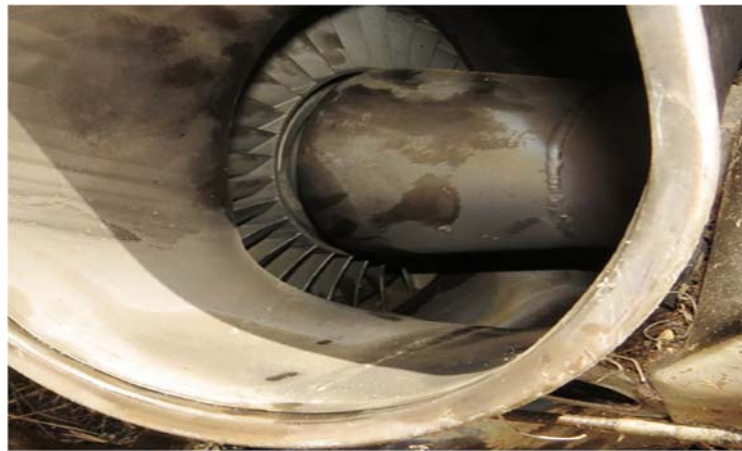
The N2 power turbine was also rotated by hand. Rotation was smooth and produced corresponding rotation of the propeller drive shaft, thus confirming N2 drive continuity.

Figure 31: Right engine's 4th stage (Power) Turbine

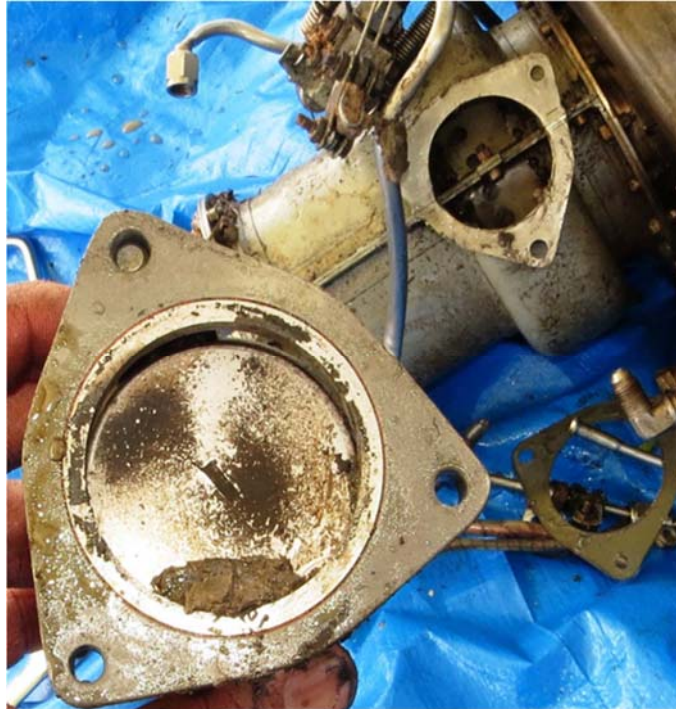
The compressor bleed valve was removed and examined. The valve poppet cycled normally by hand and exhibited no radial play.

Figure 32: Bleed valve face
(Source: Rolls-Royce Corporation)

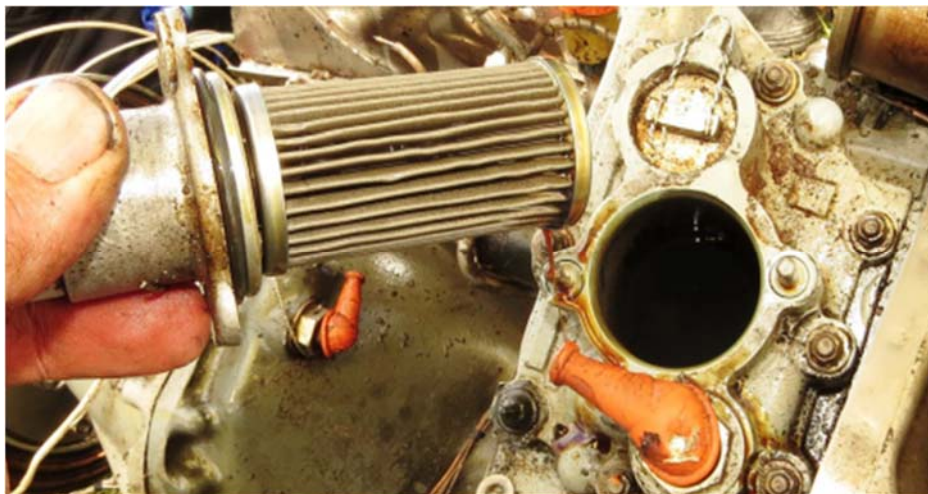
The engine-mounted oil filter was removed and examined; it contained no metallic debris. The oil within the filter bowl was free of debris and exhibited no unusual odour. Both the upper and lower main chip detectors were examined and found to be free of any ferrous debris.

Figure 33: Oil filter and filter housing
(Source: Rolls-Royce Corporation)

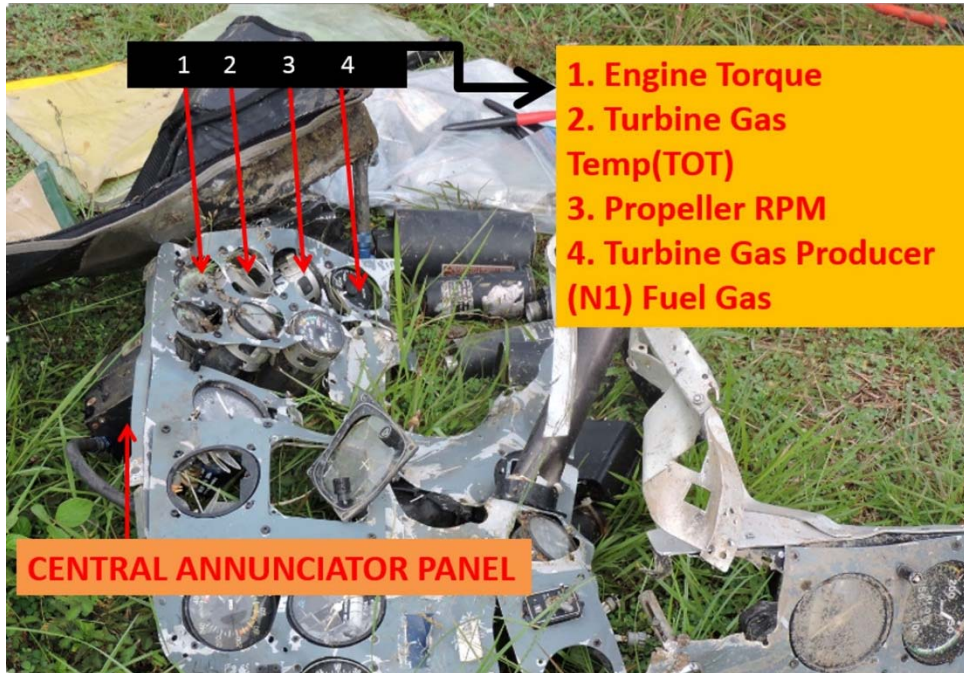
While some gauges had signs of possible needle rub, chatter, or slight indentation, the evidence was inconclusive due to the disruption of the gauges during the impact, and therefore was considered unreliable. There was no evidence found to suggest that any warning lights from the annunciator panel were illuminated at the time of impact.

Figure 34: Cockpit instruments
