**FINAL REPORT**

**AIC 18-1004**

**AIR NIUGINI LIMITED**

**Boeing 737-8BK**

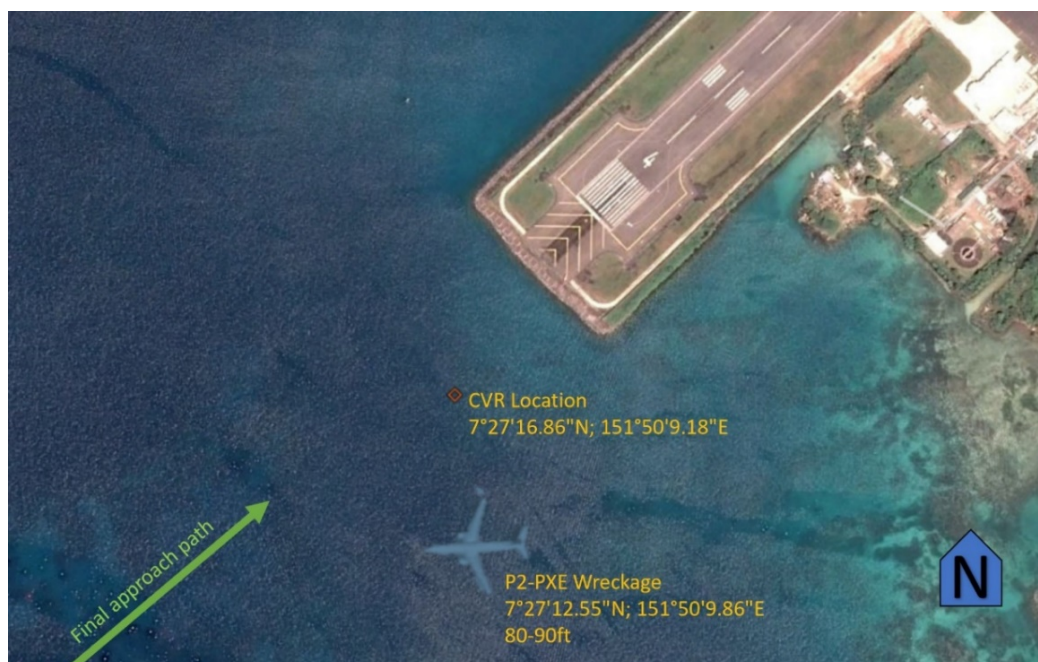
The aircraft deflected across the water several times before it settled in the water and turned clockwise through 210 deg and drifted 460 ft (140 m) south east of the runway 04 extended centreline, with the nose of the aircraft pointing about 265 deg.

**Figure 1: Depiction of aircraft in relation to Chuuk International Airport runway 04 threshold.**

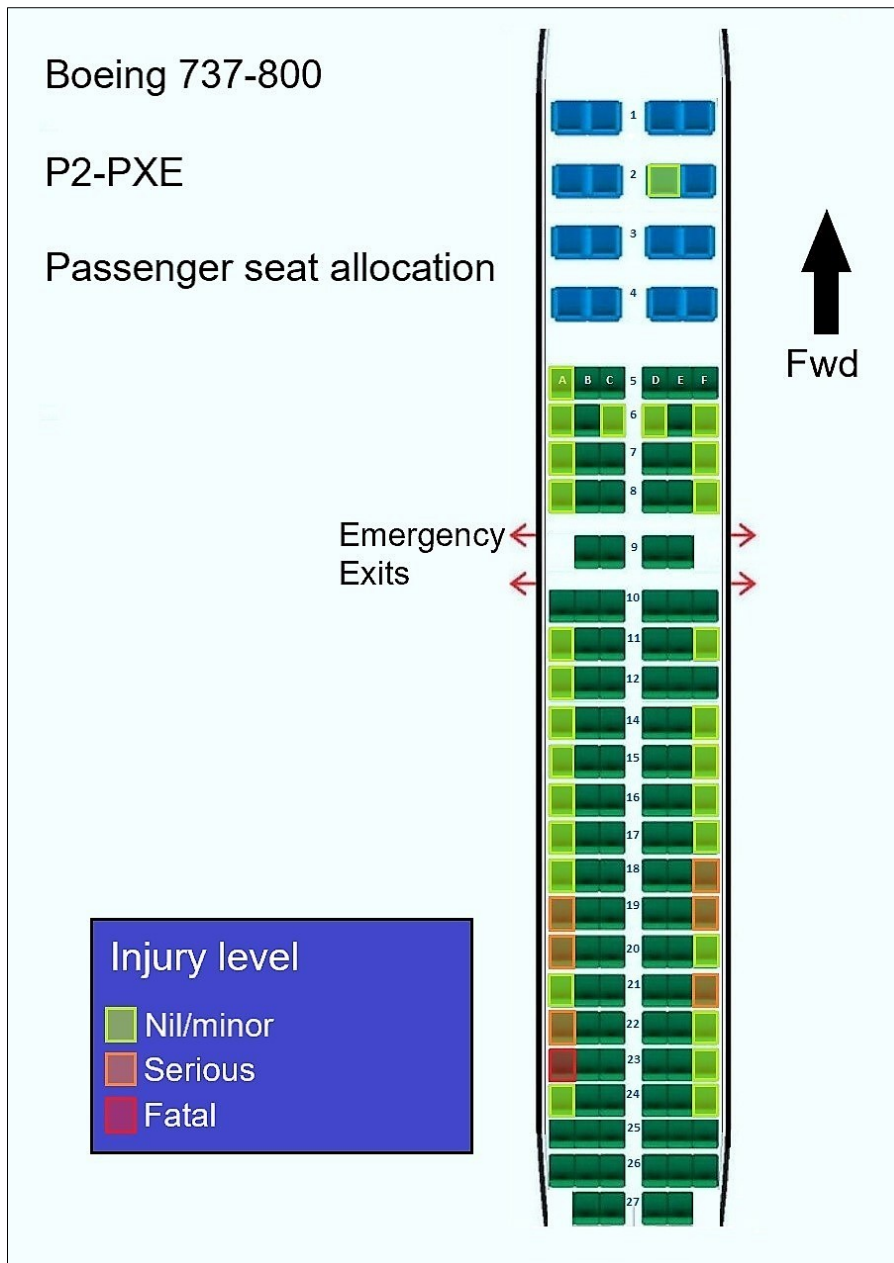
Figure 2: Passenger seating allocation showing injury status.

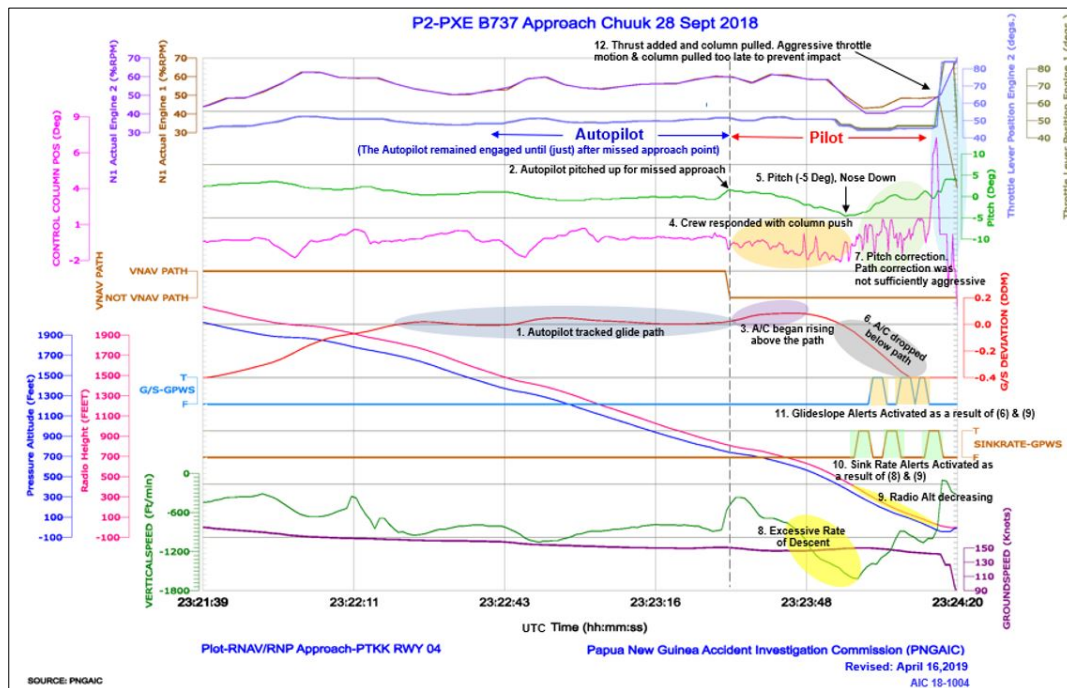
The SSFDR data revealed that during the approach from 1,000 ft amsl, with the auto-pilot engaged, the aircraft flight path was relatively constant and consistent with the RNAV profile. The rate of descent was around 600 to 800 ft/min and the groundspeed remained between 149 and 151 kts. The approach was stable.

**Figure 6: FDR data plot**  
 (Refer to Chapter 5 Appendices, Section 5.7 Appendix F for larger version)

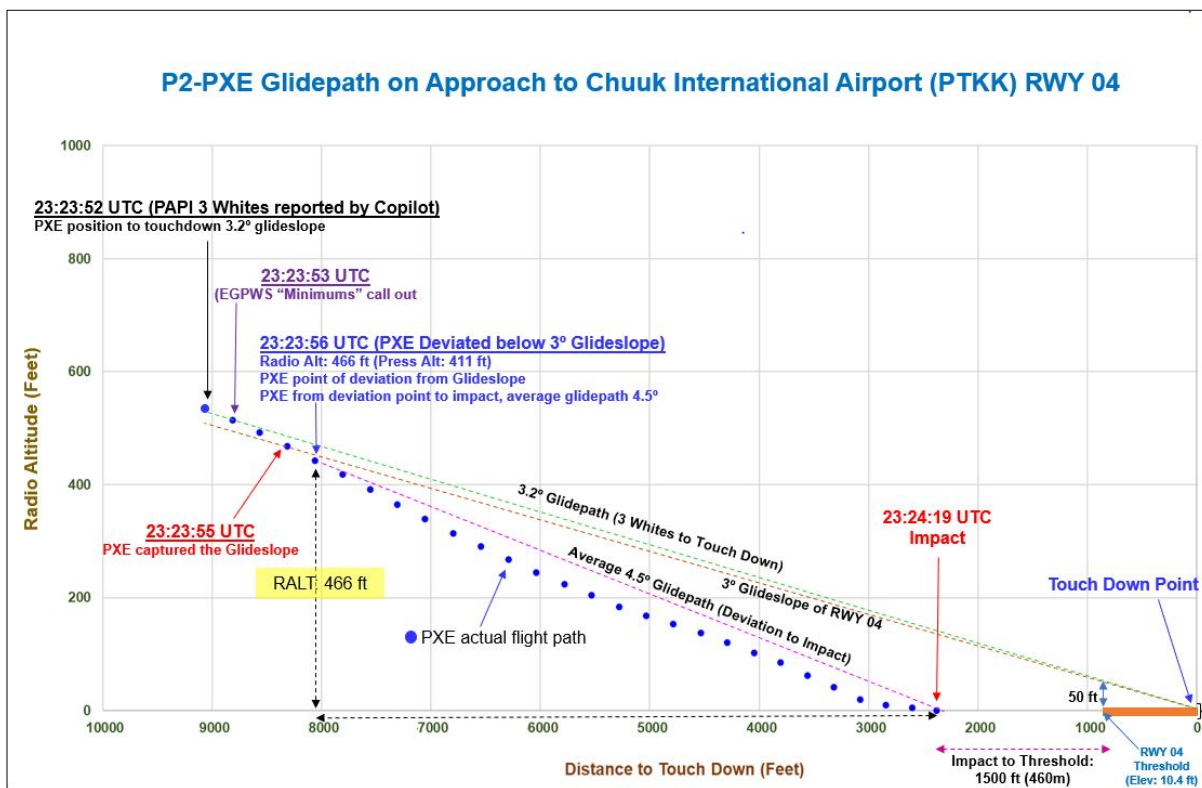
The FDR data showed an unstable approach from 625 ft (**677 ft**) and a flight path deviation from the 3° glideslope to an approach path profile averaging 4.5°.

**Figure 7: Diagram showing glidepath deviation**

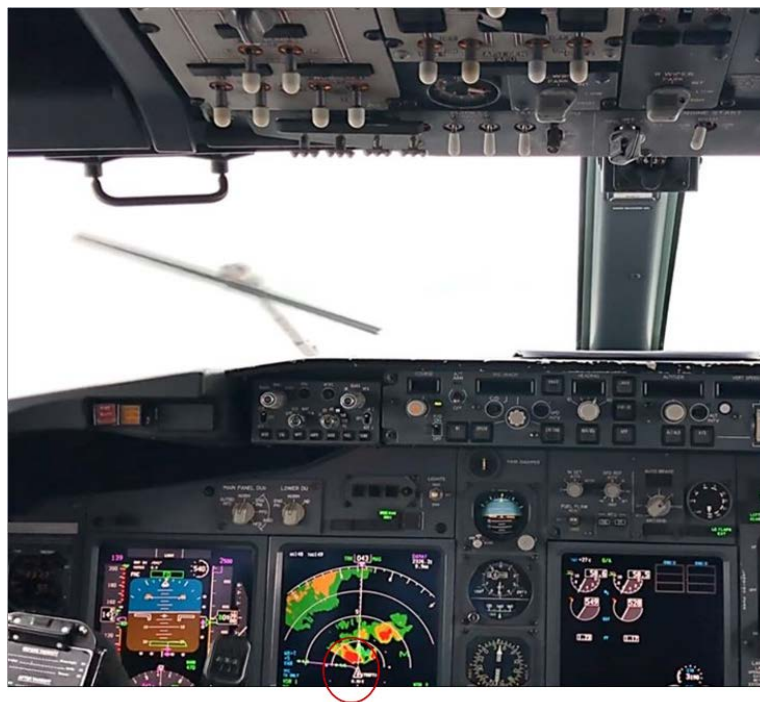
A storm cell situated immediately after the missed approach point was *painted*<sup>45</sup> on the weather radar on the PIC's Navigation Display.

**Figure 9: PFD and NAV display<sup>46</sup> showing weather and missed approach track.**

**NOTE:** In Figure 9, the windscreen wipers are ON (activated). The Triangle circled on the NAV display represents the aircraft.

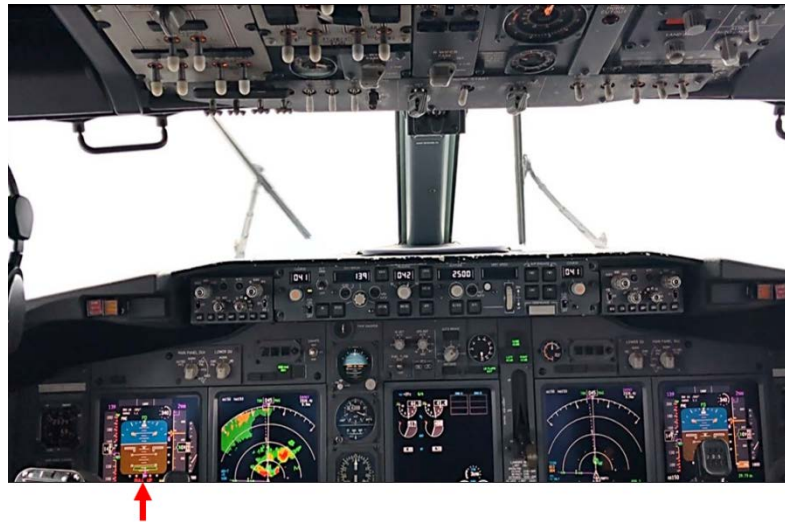
Figure 10: Passing 370 ft on descent. Showing **PULL UP** on PFD display<sup>47</sup>

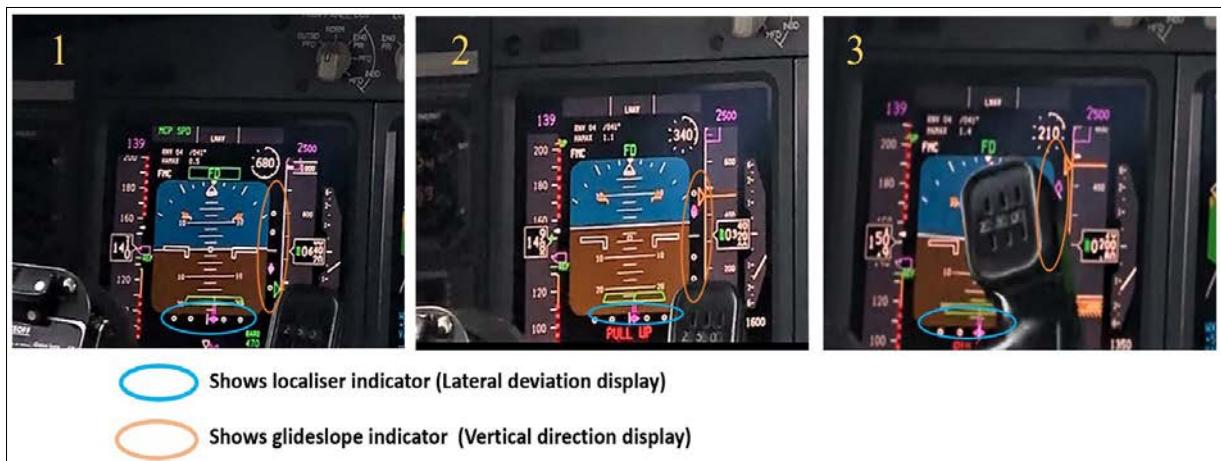
Figure 11: PFD display<sup>48</sup> showing location of aircraft with reference to the localiser (Loc) and glideslope (GS) indicators.<sup>49</sup>

Picture	Pressure Alt	Radio Alt	GS Indicator	Loc Indicator	Remarks
1	625 ft	677 ft	1 dot low	Half dot right	Autopilot disengaged
2	333 ft	392 ft	1 dot high	Slightly half right	“Sink Rate” aural alert Visual “ <b>PULL UP</b> ” on PFD
3	210 ft	259 ft	Above 2 dots	On the Localiser	Visual “ <b>PULL UP</b> ” on PFD
<b>Note:</b>	The <i>GS</i> and <i>localiser</i> indicators showed that the aircraft rapidly deviated from the glideslope. However, the aircraft was manually flown back on the localiser as shown on picture 3 above. Furthermore, the <i>localiser</i> indicator provided lateral navigation assistance to the PIC and the words “ <b>PULL UP</b> ” were displayed in bold red print directly below the <i>localiser</i> indicator.

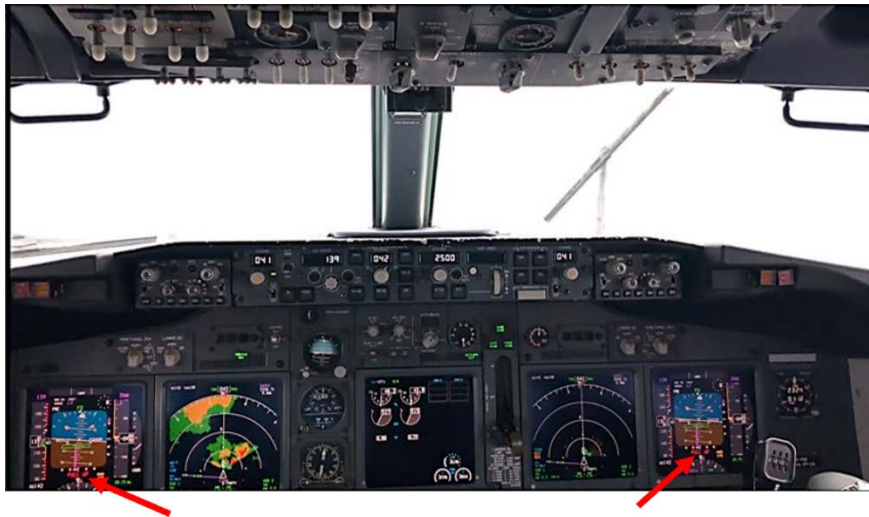
Figure 12: One second before impact. Showing **PULL UP** on PFD display<sup>50</sup>

There was no evidence that the high rate of descent (ROD) was caused by environmental forces. The CVR data and video synchronizations do not show any sign of the crew noticing any unusual aircraft displacements against control inputs, nor a notion of a subtle recovery. There was evidence, though, that aircraft movements during the approach were in response to positive control inputs by the PIC.

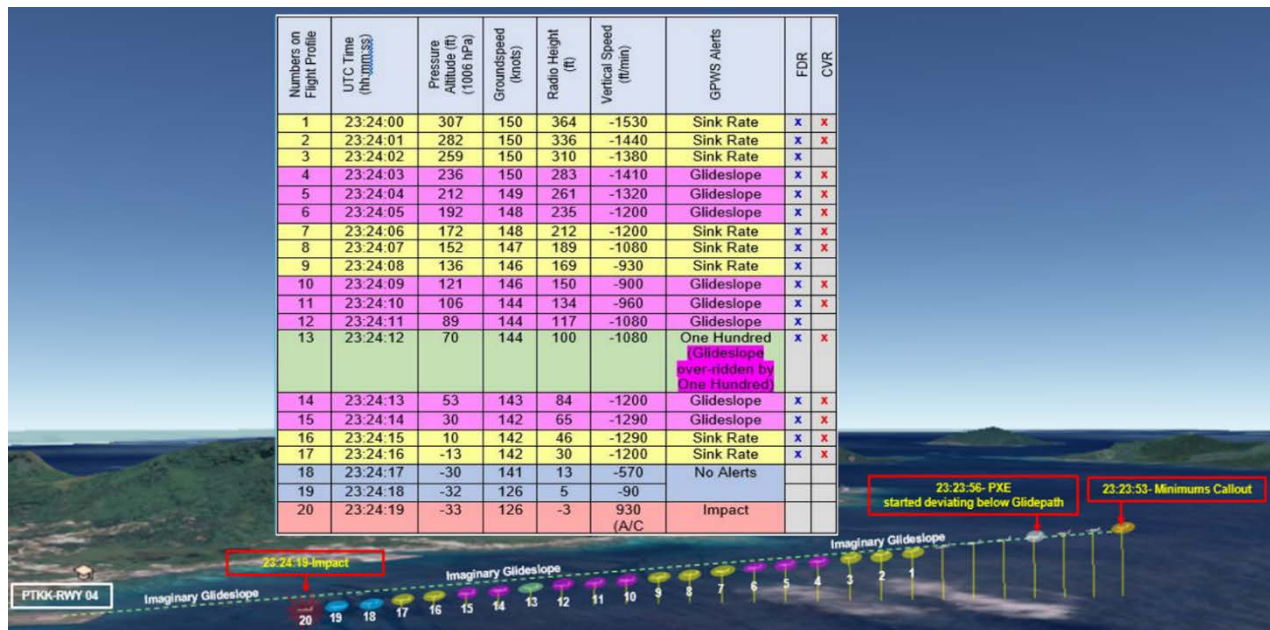
Figure 13: Glideslope and Sink Rate aural alerts graphic plotted using Derived Data

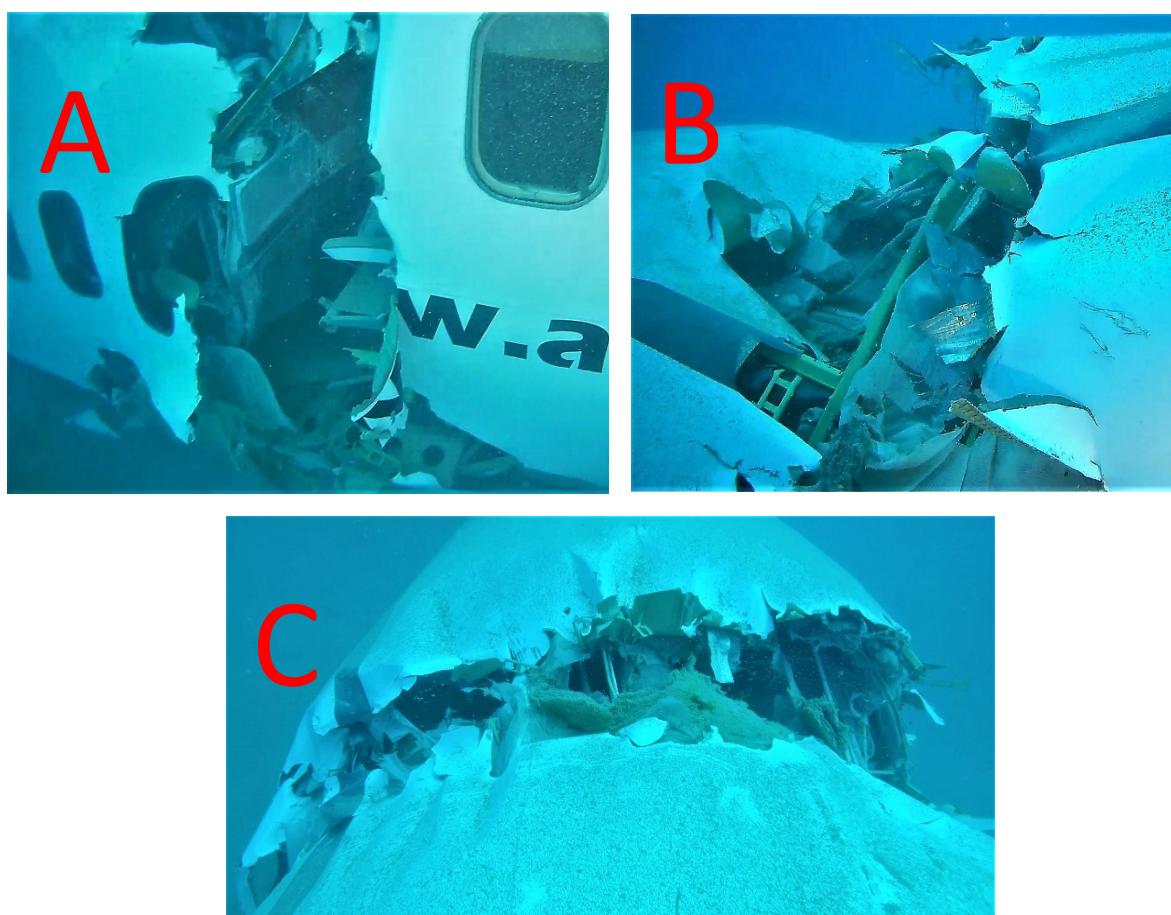
Prior to the wreckage sinking to the seabed of the Chuuk Lagoon, the rear fuselage had fractured around the lower fuselage behind the wings adjacent to seat rows 17 and 22. The aircraft sank in 90 ft of water to the Lagoon before impacting and coming to rest on the seabed. The impact with the seabed caused the fracture to extend across the upper fuselage (See Figure 14).

**Figure 14: In the area of seat row 22. A Fuselage fracture left side and behind the wing. B Upper fuselage fracture behind wing. C Rear fuselage fracture behind wings**

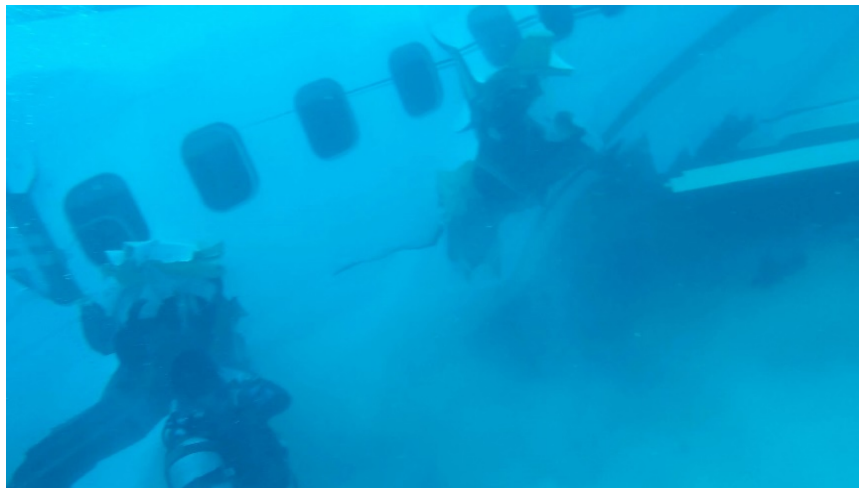
**Figure 15: Fuselage fracture right side behind the wing at wing root, in the area of seat row 22**

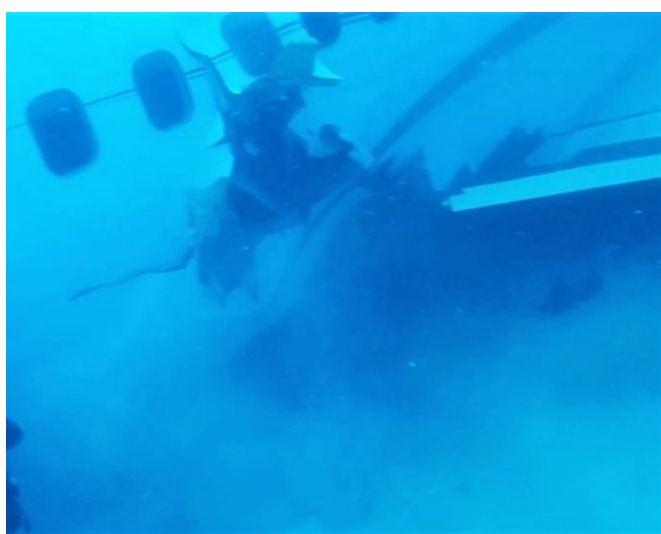
**Figure 16: Fuselage fracture right side behind the wing showing wing flap separation**

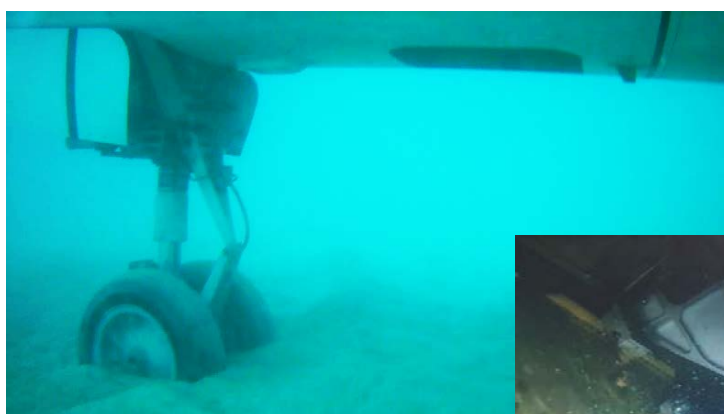
The main landing gear separated from the aircraft during the water impact, but the nose landing did not appear to have sustained impact damage.

**Figure 17: Nose landing gear assembly  
(Avionics bay in belly behind landing gear)**

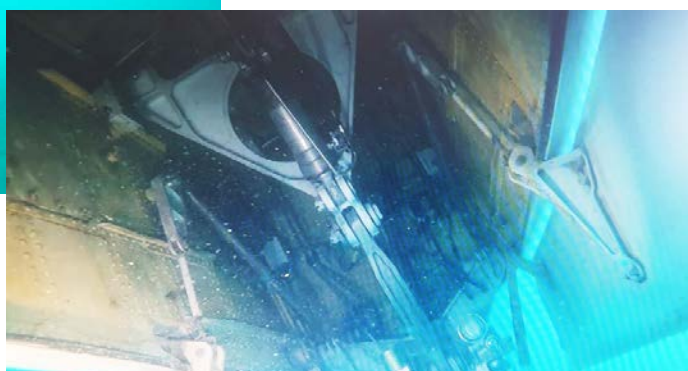
**Figure 18: Nose landing gear assembly looking into the landing gear bay**

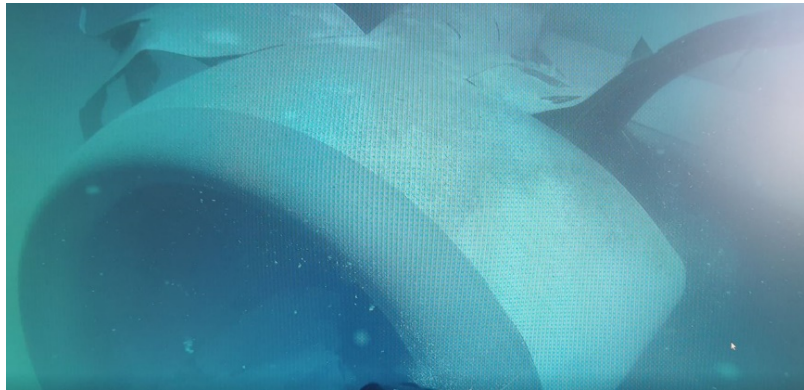
The engines remained attached to the wings' pylons, but sustained major impact damage.

**Figure 19: Right engine attached to wing pylon**

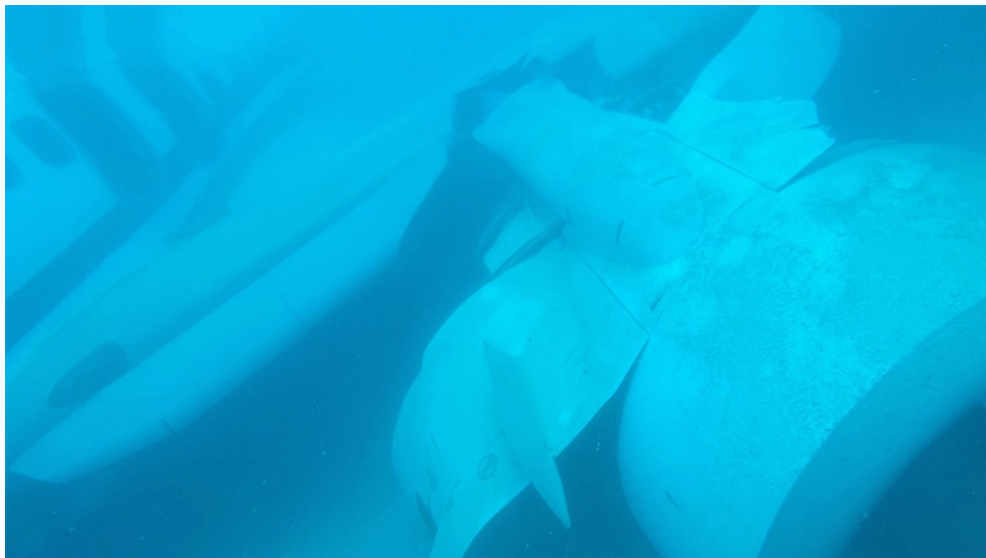
**Figure 20: Left engine attached to wing pylon**

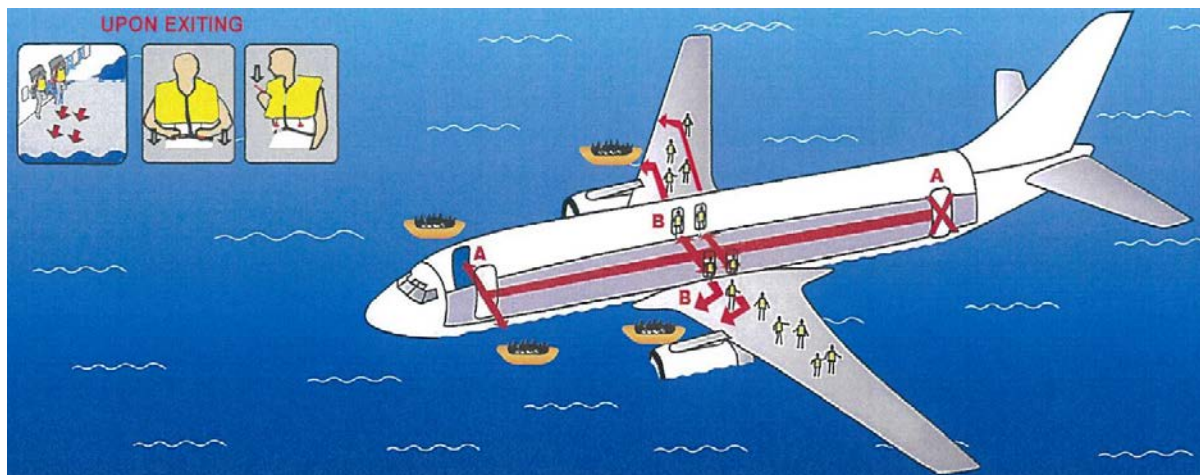
The investigation determined that the *Safety on Board Card* (passenger briefing card) for P2-PXC and P2-PXE incorrectly showed a path to the doors 1L and 1R with a life raft deployed from each door.

**Figure 23: Safety on Board Card (Version PX3-11009 Rev.A) Incorrect depiction.**

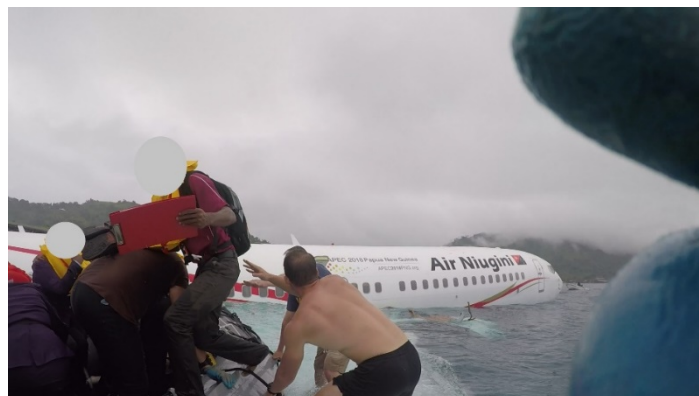
One of the cabin crew members took a uniform issued hand-bag from the front of the aircraft, through the cabin to the right over wing exit. Likewise, the load master carried a backpack, a clipboard and shoes off the aircraft. Both of his hands were full.

**Figure 25: Load master getting into a rescue boat with baggage taken from the aircraft, both hands full.**

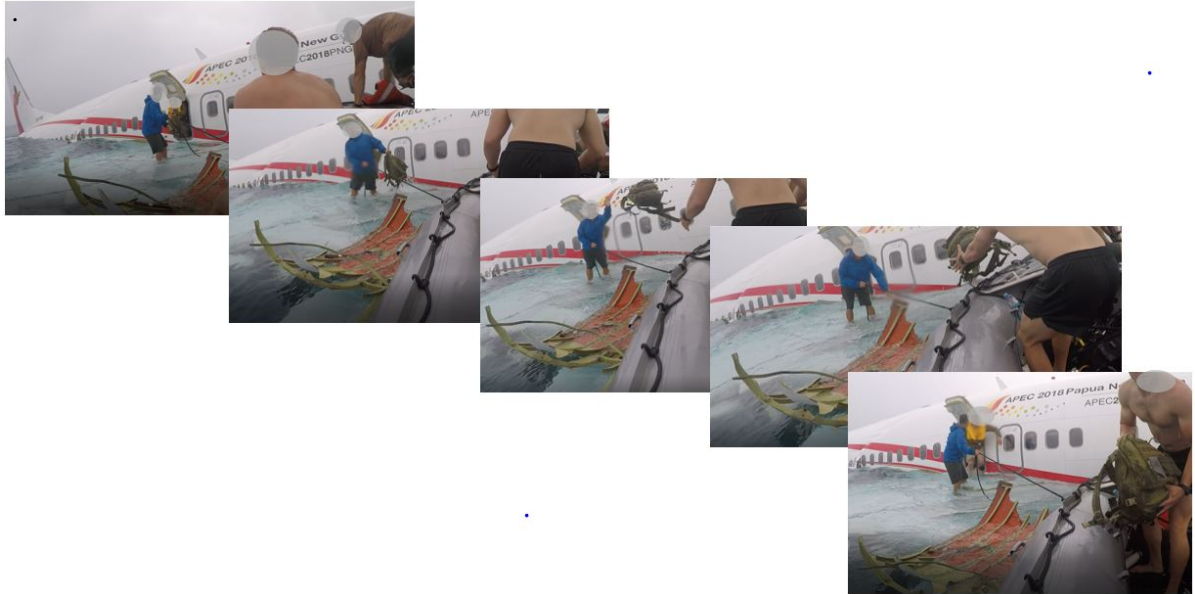
When the passenger was on the wing, he removed his life jacket and he was then observed to be wearing a shirt with US NAVY printed on it. He remained on the wing for a short time trying to assist the US Navy divers evacuate passengers, cabin crew and the Load Master egressing via the same over-wing exit, which gave the appearance that he was part of the US Navy rescue group.

**Figure 26: The first passenger exiting via the right aft over-wing exit after passing a bag to US Navy diver who threw it to divers in the boat.**

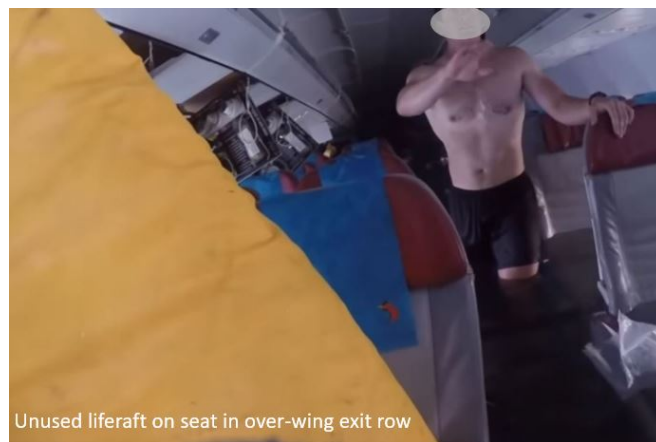
Video footage also showed a US Navy diver standing in thigh deep water two rows behind the over-wing exit in the cabin cautioning fellow rescuers and aircraft crew standing at the exit not to go further aft. He also exclaimed for them all to be careful as he did not know the depth of the water.

**Figure 27: US Navy diver cautioning not to go aft due unknown water depth**

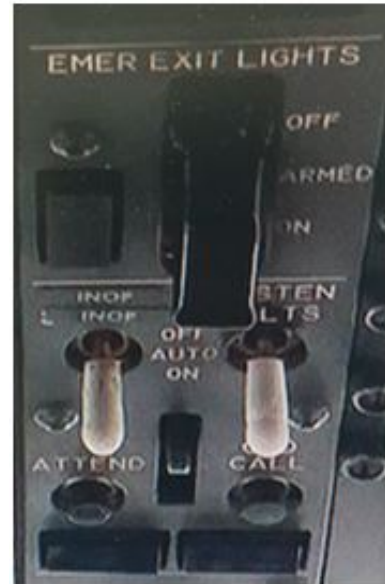
**Figure 29: P2-PXE Cockpit Overhead Panel Emergency Light switch during the approach**  
 (Source: Snapshot taken from video taken by jump seat occupant from top of descent to impact.)

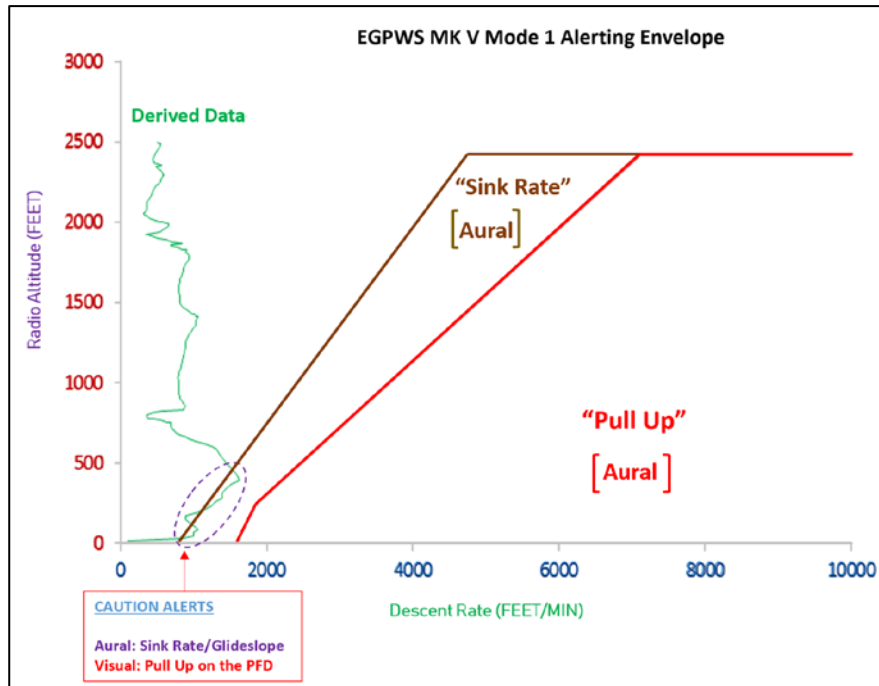
Much more research is required and the AIC is actively working with the US NTSB, FAA, Honeywell, and Boeing. The *Safety Recommendations AIC 19-R02/18-1004* and *AIC 19-R17/18-1004* addressed to Honeywell and FAA respectively will remain **Active** pending the results of the ongoing research.

Figure 32: Derived Data plotted against Honeywell EGPWS MK V Mode 1 Graph

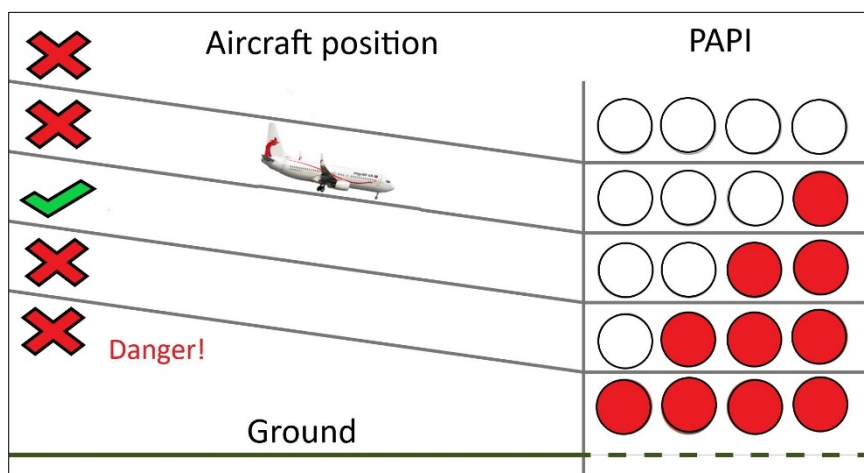
After the auto-pilot was disengaged at 625 ft (**677 ft**), the aircraft's descent rate increased from 750 ft/min and a groundspeed of 146 kts to 1,380 ft/min and a groundspeed of 149 kts, at 420 ft.

PXE actual glidepath at the MDA is depicted in the figure 44 below.
