AIC 12-1007

**PAPUA NEW GUINEA
ACCIDENT INVESTIGATION COMMISSION
AIRCRAFT ACCIDENT REPORT**

P2-HCY

Bell 206L-1/C30P

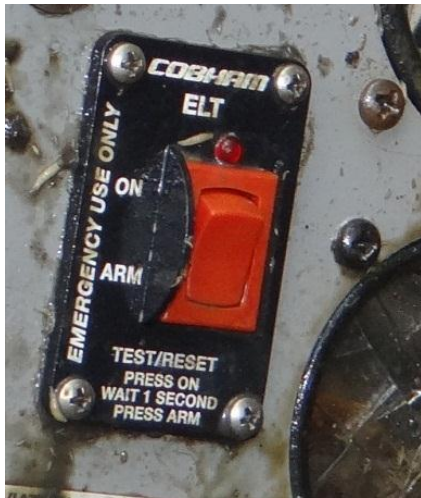
The ELT switch on the instrument was identified as being in the ARM position in the initial on-site Australian Army photographs, however, due to the dynamics of the accident, its position prior to impact could not be determined (Figure 8). Neither of the two PLBs was found at the accident site, and neither could be found in the wreckage after it was moved to Port Moresby.

Figure 8: ELT switch in the ARM position

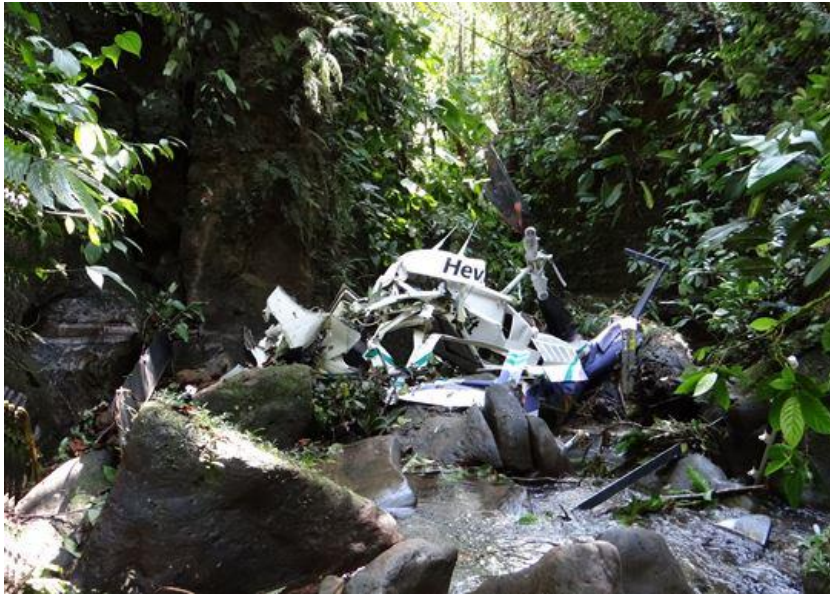
The Australian Army images indicated that the helicopter descended through the dense jungle tree canopy, then continued a vertical descent of about 100 ft to the rocky creek. Between the time of the accident and the time the wreckage was recovered from the creek, there had been several heavy rains, and the water in the creek had flowed over and through the wreckage.

Figure 9: Wreckage of HCY
Source: Australian Army

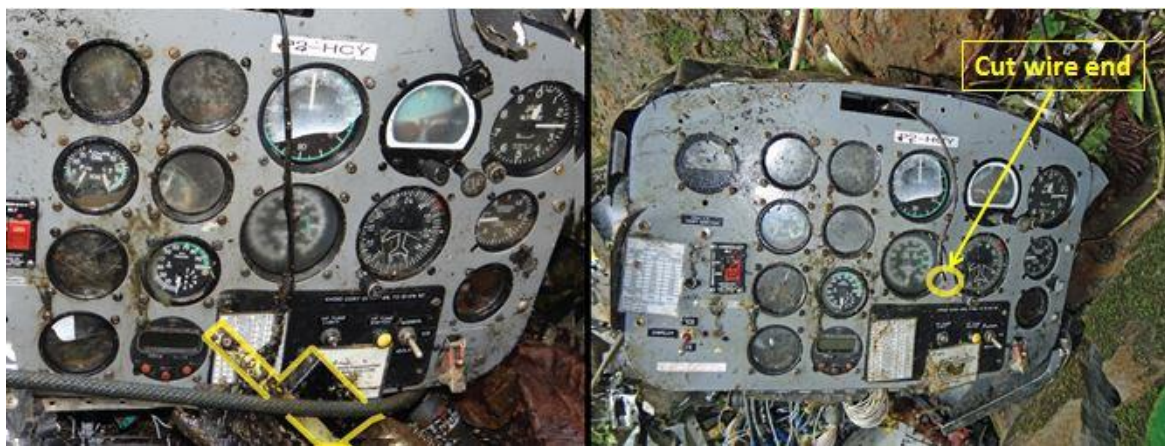
Figure 10: HCY instrument panel at the accident site
Source: Australian Army

In some of the photographs of the wreckage, the caution and warning panel was visible hanging from the instrument panel by its wiring (Figure 10, left image, caution and warning panel outlined in yellow). In photographs taken a few minutes later⁶, the wiring appeared to have been cut and the caution and warning panel was gone (Figure 10, right image, yellow circle shows the cut end of the caution and warning panel's wiring).

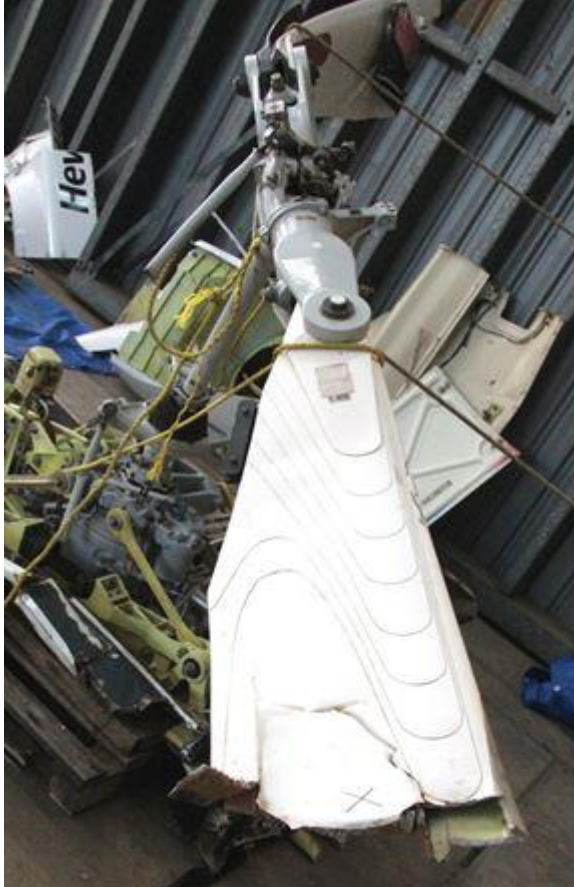
The helicopter was fitted with a 2-blade main rotor system. The main rotor mast nut was identified as being installed and locked. The main rotor pitch links had both failed as a result of bending overstress. Both of the main rotor blades had fractured outboard of the blade root doubler fingers (Figure 12).

Figure 12: Main rotor blade roots

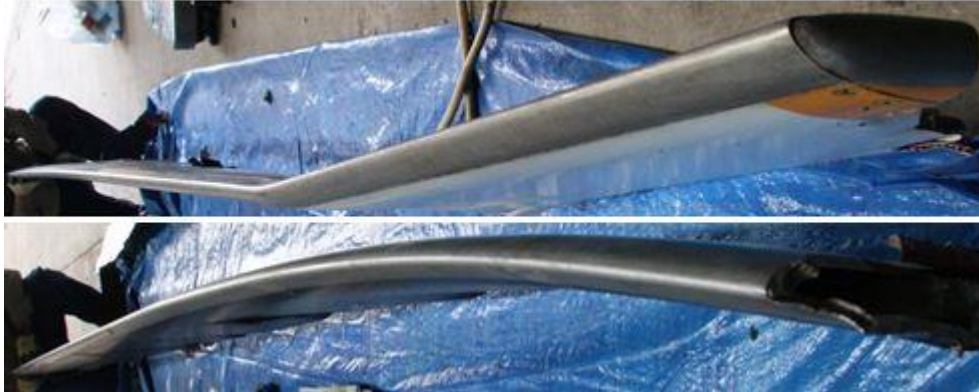
The blades showed the characteristics of having stopped rotating altogether within a very short time after the first physical contact with terrain, and the blade root separations showed little evidence of the in-plane directional deformation expected if the rotor was being positively driven with torque from the engine and transmission.

Figure 13: Main rotor blade deformation upward and downward respectively

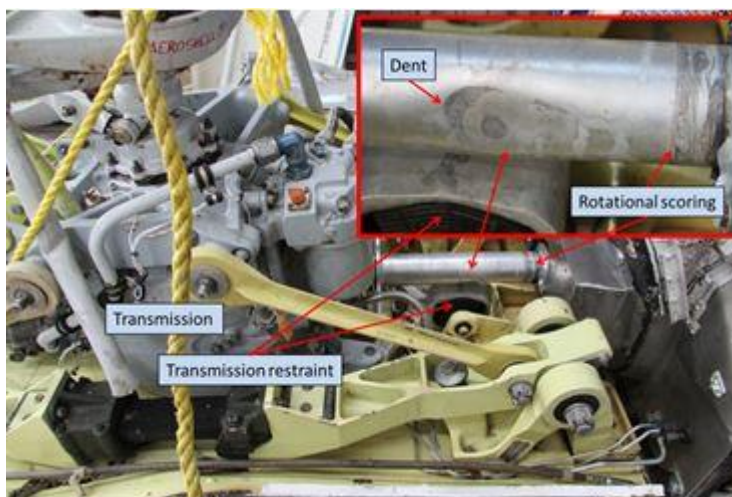
The main rotor transmission remained attached to its suspension nodal-beam system, and this remained attached to the cabin roof and box-beam structure. Drive integrity through the transmission was confirmed from the input coupling to the mast. The filter, magnetic chip detectors for the transmission, mast and freewheel unit were examined and found to be free of metallic debris. The free-wheel unit was confirmed to be capable of normal operation. The engine-to-transmission KAflex drive shaft had failed at the engine/freewheel unit coupling although the forward coupling remained intact. Rotational scoring was observed on the KAflex driveshaft where it passed through the engine firewall. This was most likely due to the movement of the transmission while the main rotor RPM decreased and the main rotor blades impacted terrain. The KAflex shaft also had a large dent where it ran above the transmission restraint (Figure 14). The dent had fore-aft scoring, indicating that the driveshaft was not rotating at the time of the dent formation, which was most likely at the time of impact with the creek bed.

Figure 14: Engine to transmission KAflex driveshaft

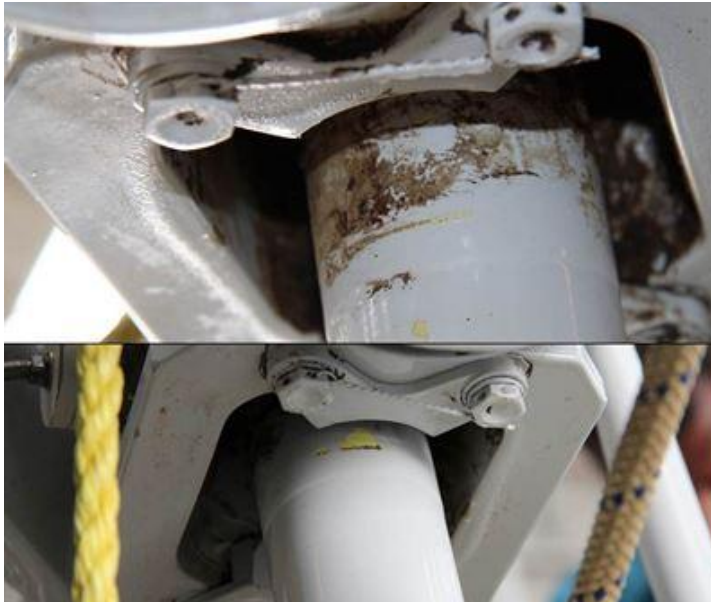
The main rotor mast was examined around the main rotor head static stop contact area. No evidence of excessive static stop contact or mast bending (mast bump) on the main rotor mast was observed, and only paint deformation consistent with normal static contact was visible (Figure 15).

Figure 15: Static stop contact area on either side of the main rotor mast

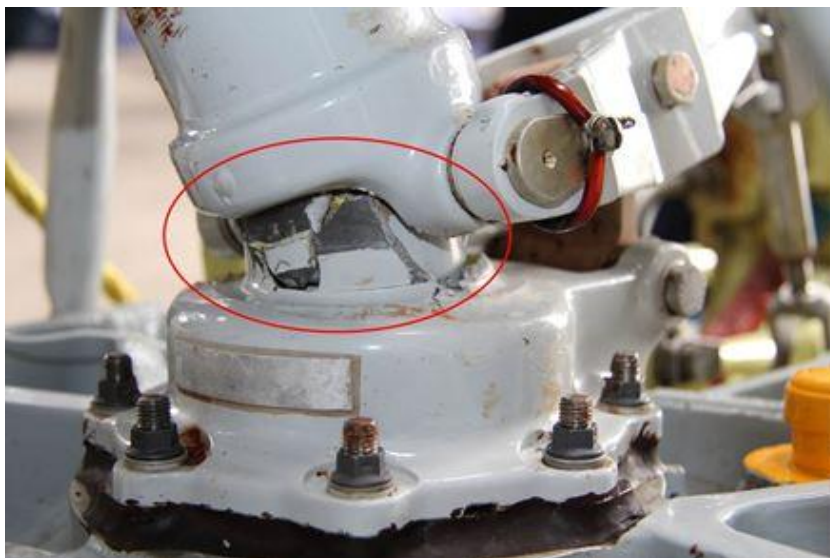
The main rotor mast had been bent at the base of the mast, in the swashplate support area (Figure 16). The swashplate support had fractured as a result of overstress at the lower radius, most likely as a result of the mast deformation. The deformation in the lower part of the mast was most likely as a result of the impact with terrain.

Figure 16: Fractured swashplate support

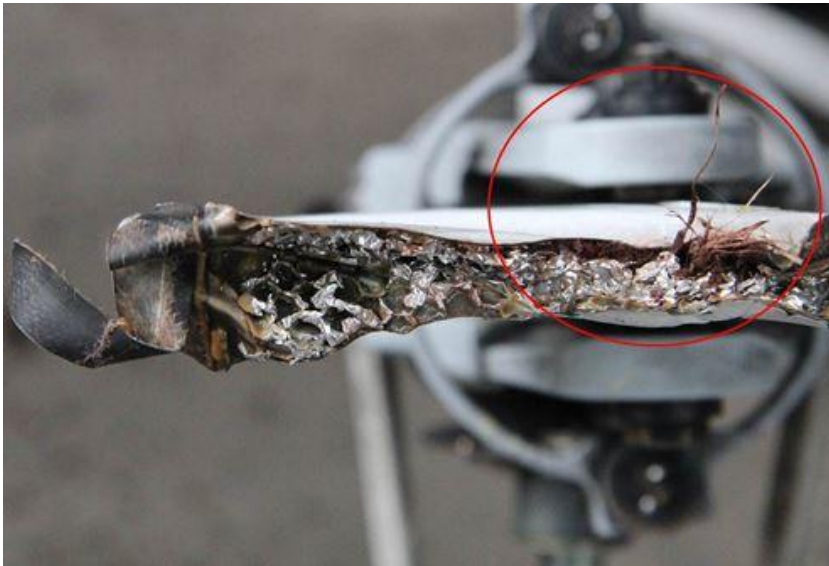
The helicopter was fitted with a 2-blade tail rotor system. One of the tail rotor blades had separated just outboard of its root end doubler as a result of overstress, and was located with the main wreckage. Wood fibres had been forced into the exposed blade root end, between the outer skin and its honeycomb core (Figure 17). Both tail rotor blades displayed compression from their tips towards their root ends (Figures 18 and 19). The leading edges of the blades were unremarkable, with no impact damage evident.

Figure 17: Tail rotor blade root with wood fibres in the fracture surface

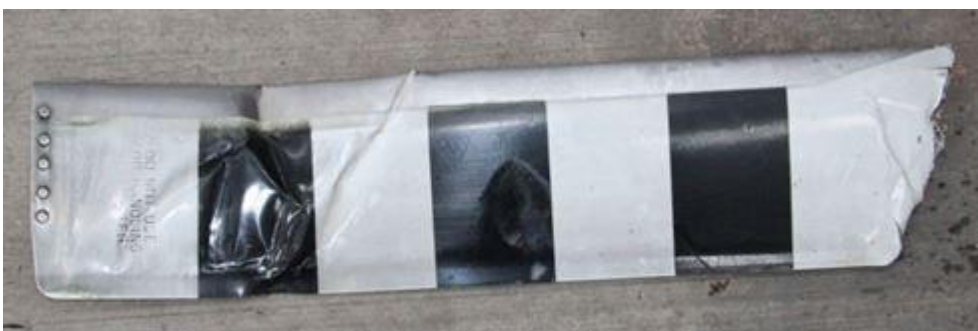
There was a lack of in-plane directional deformation, unlike what would be expected if the rotor was being positively driven with torque from the engine and tail rotor gearbox. Continuity of the drive was confirmed through the tail rotor gearbox, and the magnetic chip detector for the tail rotor gearbox was examined and found to be free of metallic debris.

Figure 18: Tail rotor blade displaying a compression load from tip to root

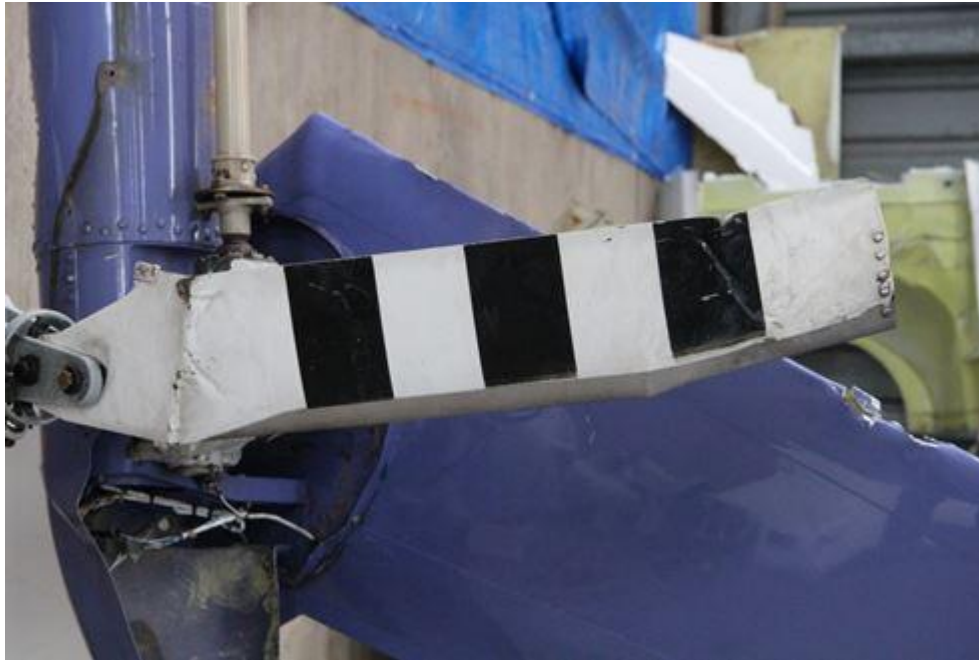
Figure 19: Fractured and compressed tail rotor blade

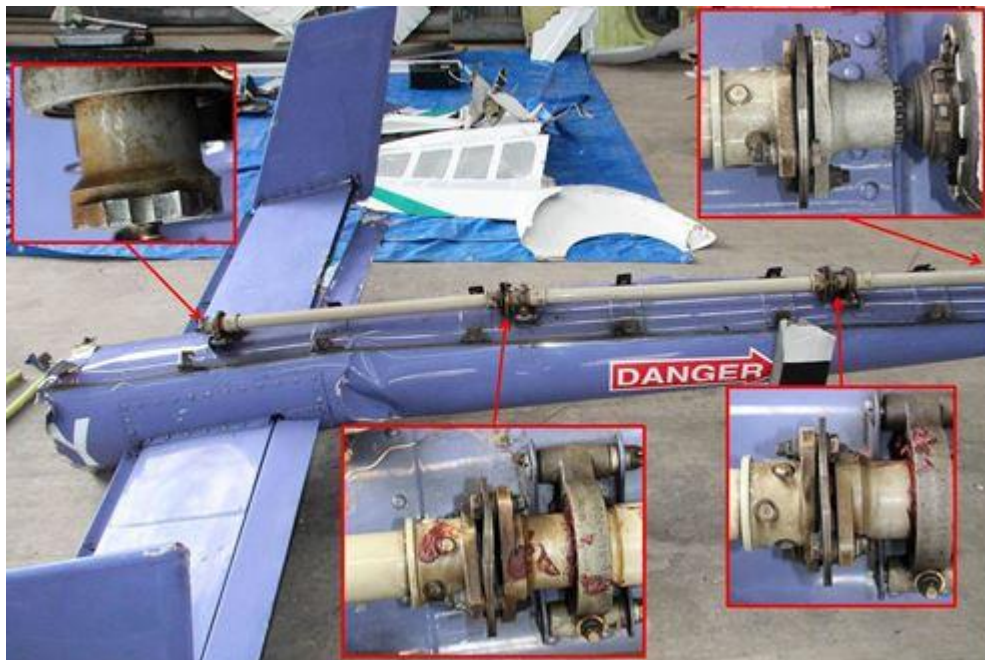
The rear three tail rotor driveshaft segments, associated hangers, and flexible couplings were all intact and displayed minimal damage (Figure 20). The forward driveshaft segment had been broken away from the forward hanger and rear flange.

Figure 20: Tail rotor driveshaft segments

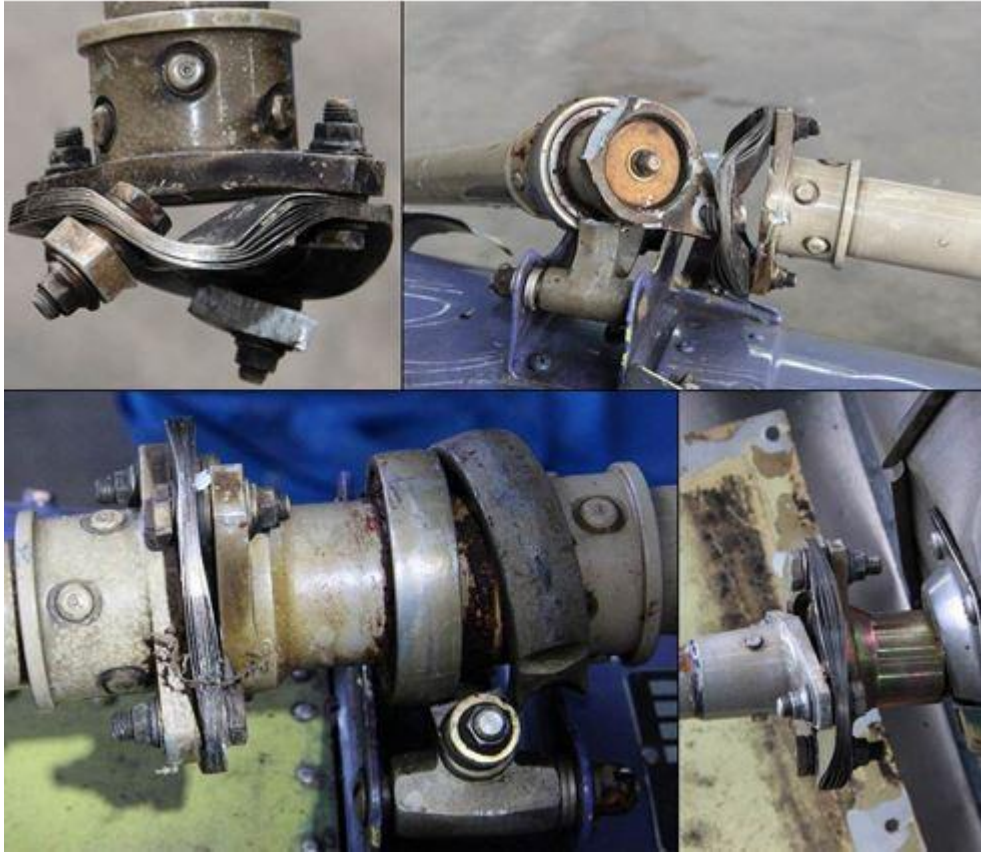
The flexible couplings (flex plates) indicated axial distortion, but no torsional distortion was identified (Figure 21). The tail rotor drive shaft had been pulled vertically through the tail rotor driveshaft cover. The lack of torsional damage to the flexible driveshaft couplings was consistent with minimal torque being provided by the engine and main rotor transmission to the tail rotor drive shaft at the time of impact.

Figure 21: Flex plates

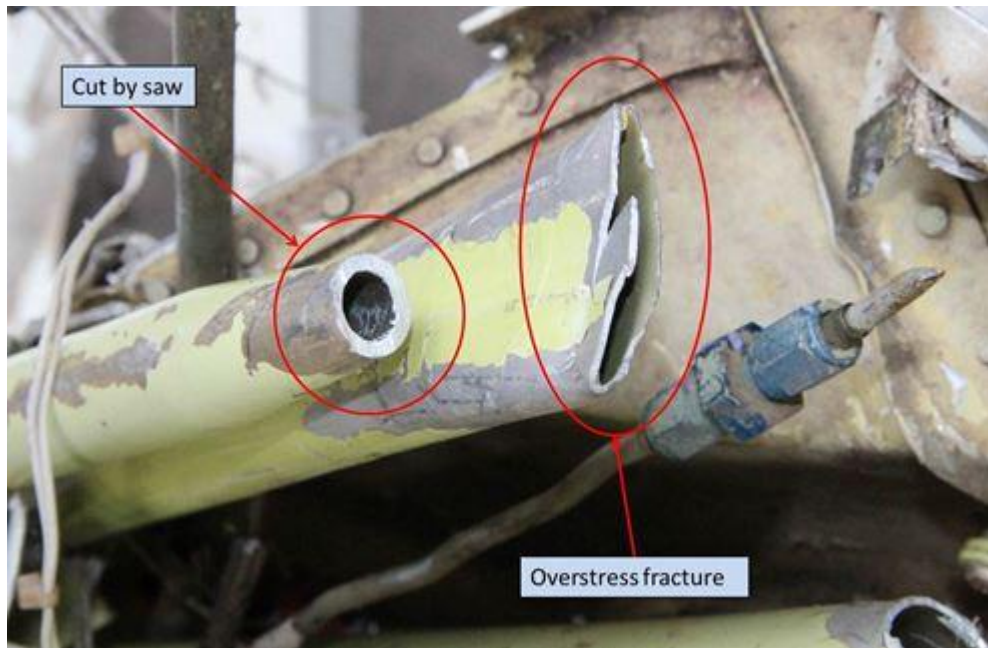
The flight control system was inspected from the main rotor head through to the cockpit, as well as from the tail rotor to the cockpit. All control rods were found to be connected correctly and split-pinned as required. Of the control rods that had separated, two separation modes were identified. They had either fractured as a result of overstress or had been cut, most likely as a result of the recovery effort (Figure 22).

Figure 22: Flight control tubes

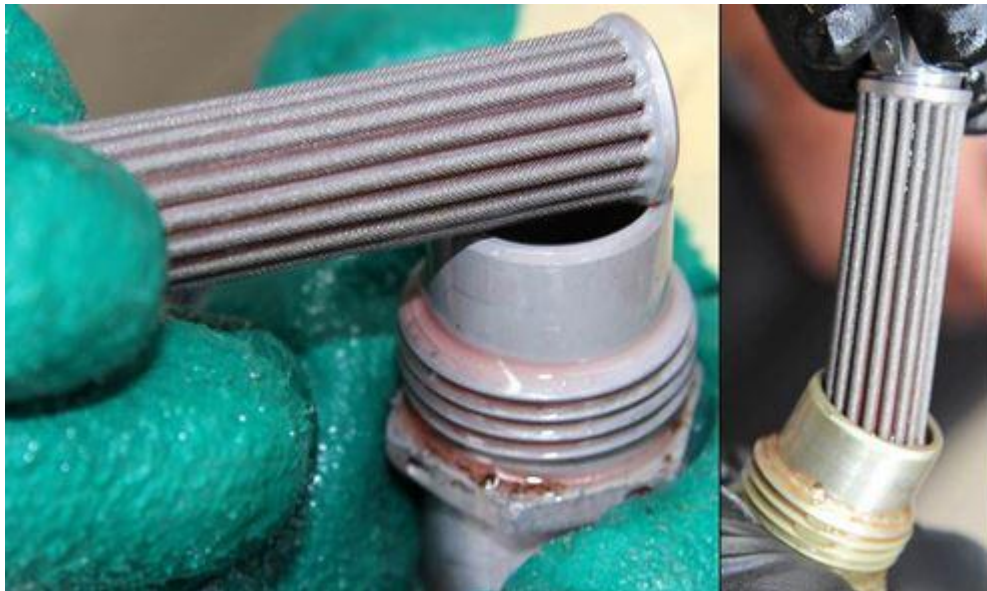
The main rotor system hydraulic actuators could be moved smoothly through their operating range. The hydraulic pressure and return system filters were inspected and found to be clean, and the bypass indicators had not ‘popped’ (Figure 23). Minimal hydraulic fluid was present in the hydraulic reservoir. However, the helicopter spent some time rolled on its side during the wreckage recovery, so some fluid loss was expected.

Figure 23: Hydraulic filters

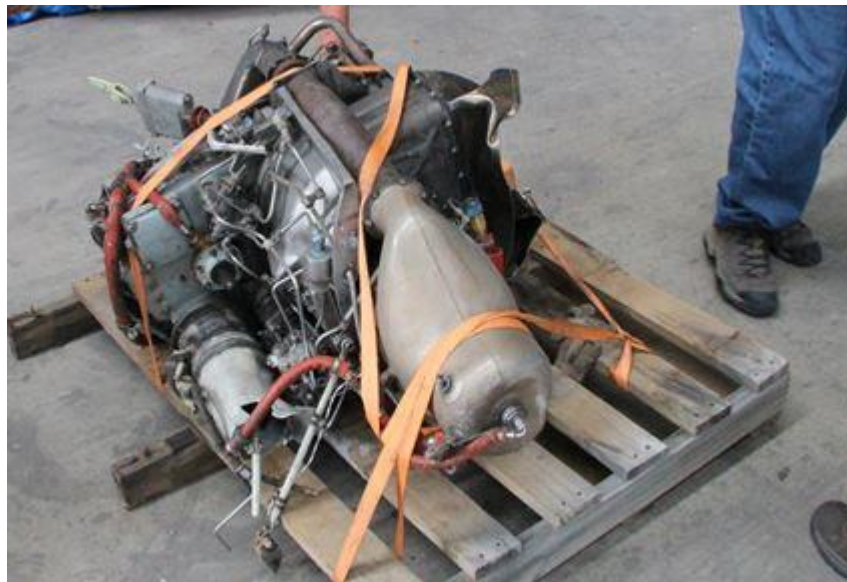
The helicopter was fitted with a Rolls-Royce 250-C30P engine. The engine was recovered from the accident site and transported to the PNG Defence Force hangar at Jacksons Airport, where it was examined by AIC and ATSB investigators (Figure 24).

Figure 24: Engine after transport to Port Moresby

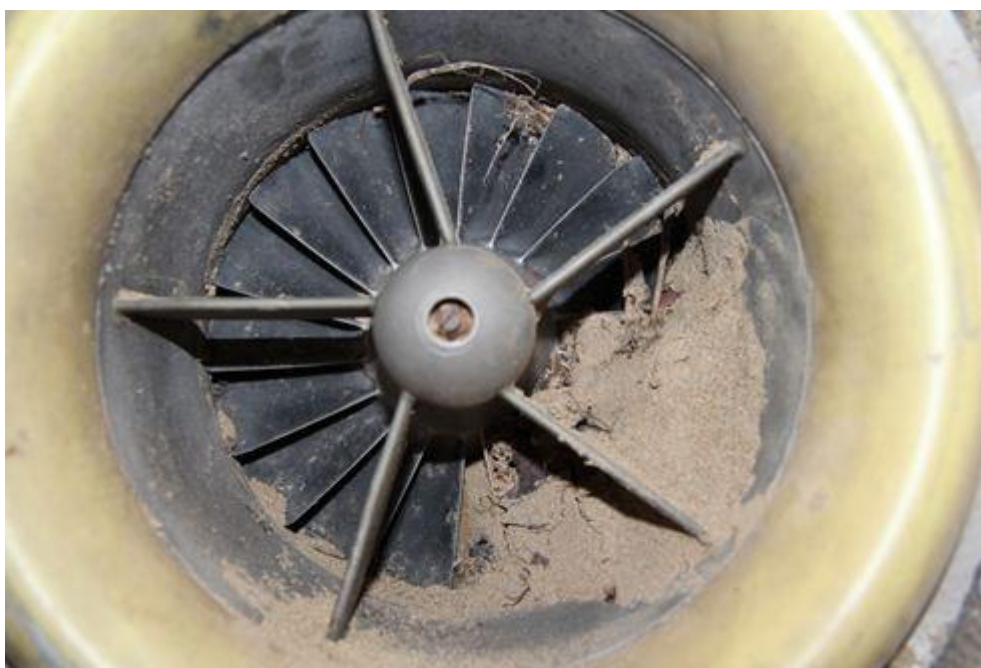
Dirt [sand/silt] was found in the engine compressor inlet, which was most likely deposited while the wreckage was immersed in the creek (Figure 25). The engine's rotating assemblies could not be rotated easily; however, with some force, the Rolls-Royce investigator was able to rotate the N₁⁸ and N₂⁹ drivetrains. All of the pipes and flexible lines were checked and confirmed to be secure. An initial inspection of the engine confirmed that all of the required components were installed and secure. The two magnetic chip-detector plugs were removed and examined. No metallic debris was present. Fuel was identified in the flexible fuel line from the lower fire shield to the fuel nozzle.

Figure 25: Sand/silt in the compressor inlet

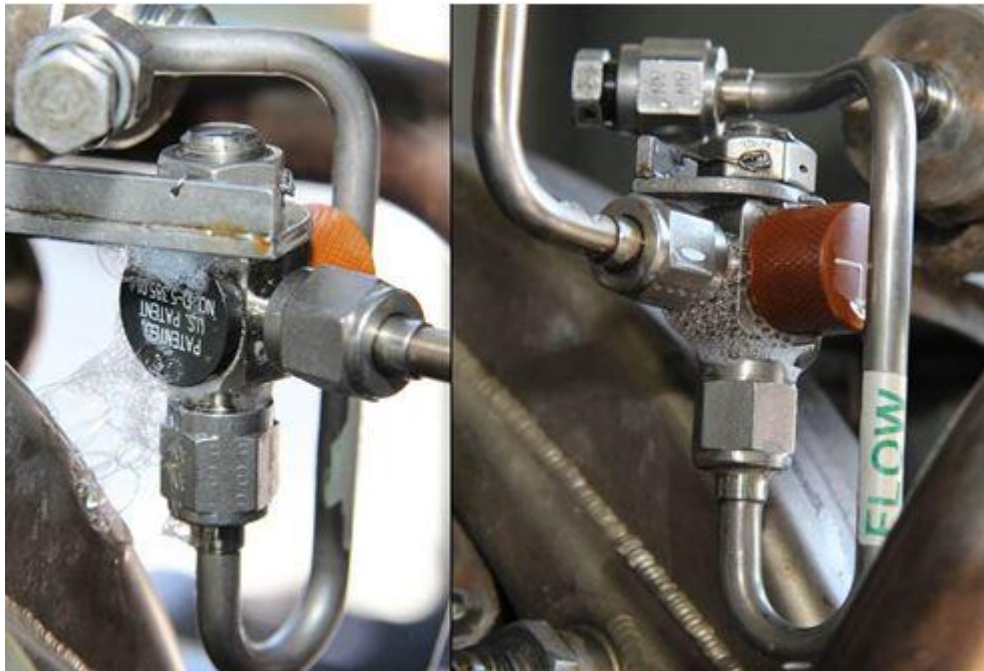
An aftermarket Pc valve safety kit¹² was fitted to the engine (Figure 26). The valve was isolated from the Pc system for the purpose of checking for leaks. A slight slow leak was noted around the selector of the valve.

Figure 26: Pc valve safety kit leak identified by a soapy solution

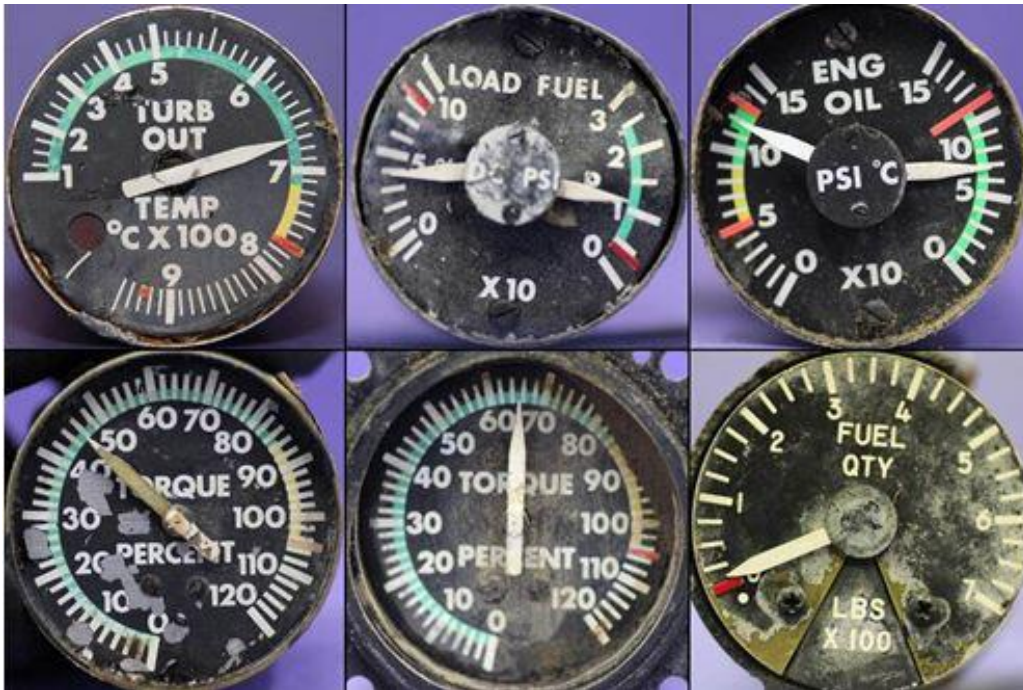
Some of the instrument pointers were in a position that may have coincided with an operational range (Figure 27), but these positions could not be confirmed due to the instruments being subjected to airframe disruption, sand/silt and water, and the subsequent recovery effort. There was no evidence of pointer contact on any of the instrument faces, and no evidence of filament stretch on the turbine outlet temperature (over-temperature) gauge lamp. There was no evidence of faults in the N_1 gauge.

Figure 27: Examples of instruments coinciding with operational values

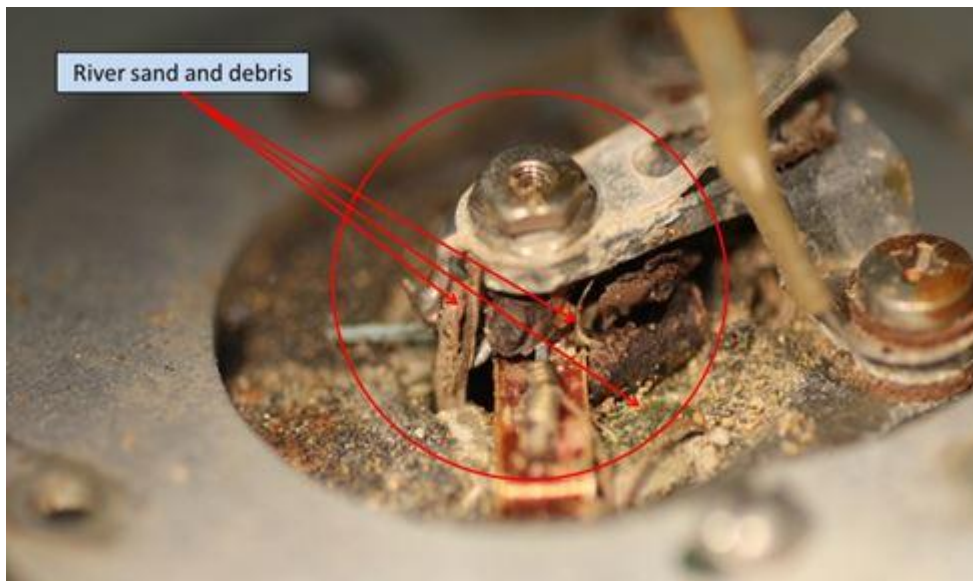
Figure 29: Debris jamming the fuel quantity indicator gauge pointer movement mechanism
