**FINAL REPORT
AIC 16-2001**

AIRCRAFT SERIOUS INCIDENT REPORT

**Air Niugini & SIL Aviation
P2-AND & P2-SIR
Fokker 100 & Quest Kodiak-100
TCAS RA 3.5 nm (6.4 km) northwest of Nadzab Airport
Morobe Province
PAPUA NEW GUINEA
16 December 2016**

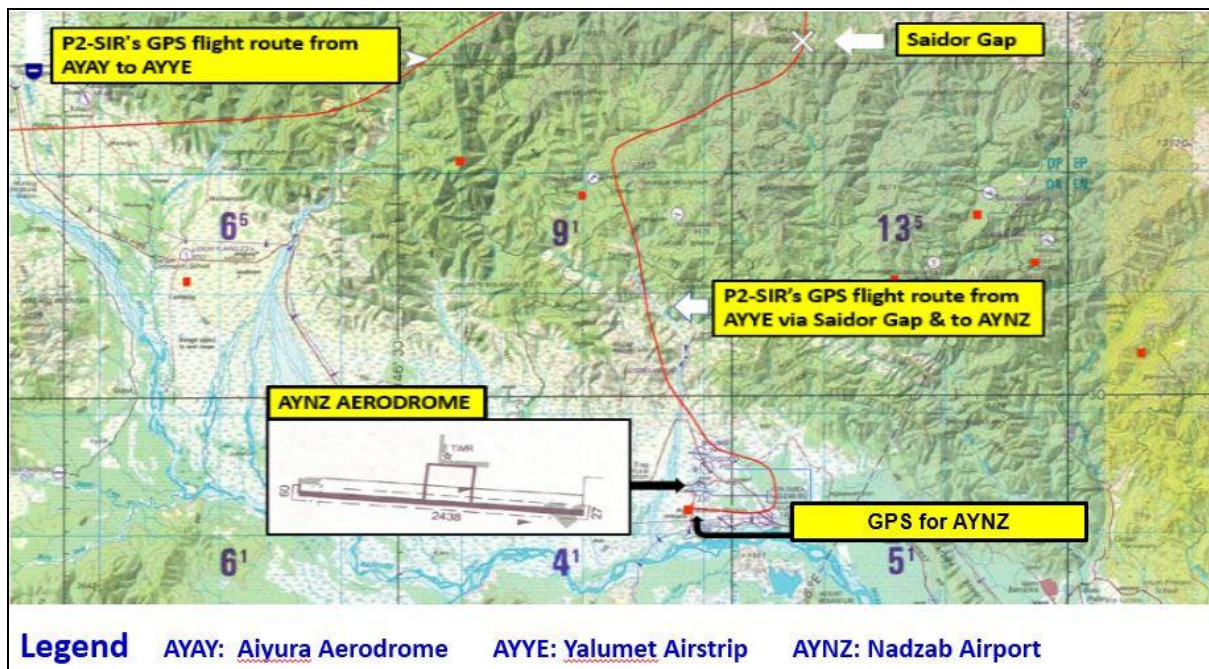
Figure 1: GPS flight Route for P2-SIR
(Source: SIR GPS track. Image enhanced by the AIC)

To avoid the traffic displayed as a symbol on the Multi-Function Display⁹ (MFD), the pilot of SIR immediately stopped the descent and commenced climbing to 7,000 ft at a rate of 1000 ft per minute.

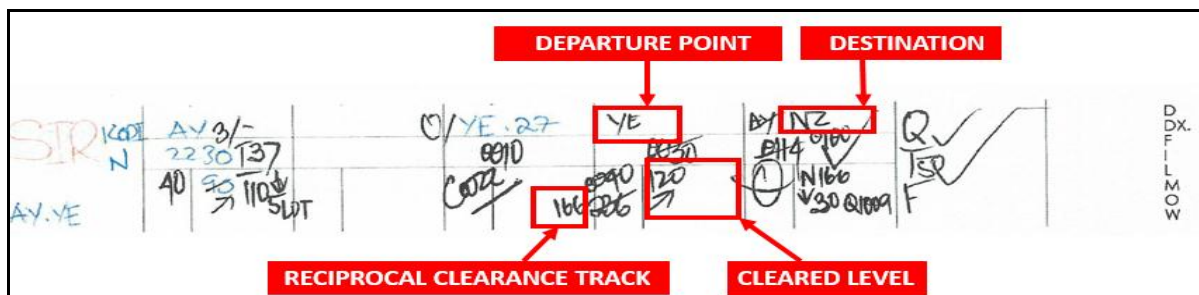
Figure 5: Flight Service Flight Progress Strip

The Port Moresby (Moresby) Flight Services Flight Progress Strip (Fig 5) showed that SIR, after departing the Yalumet area, had been issued with a clearance to track 166°, and to climb to 12,000 ft enroute to Nadzab.

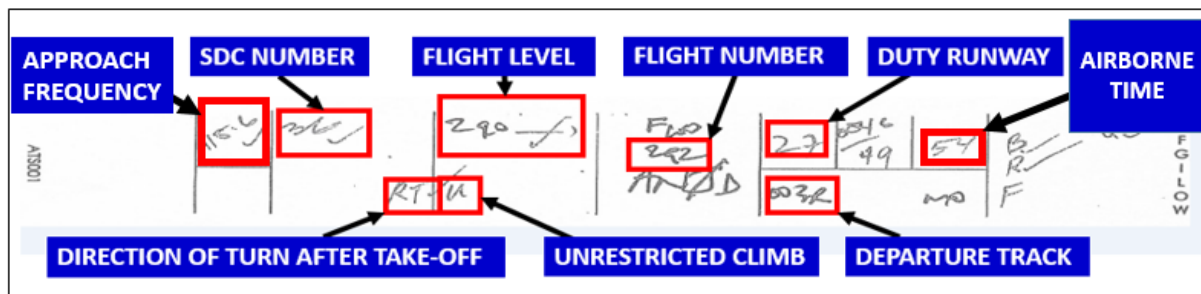
Figure 6: Extract of Nadzab ATC Flight Progress Strip (ADC/AND)

The Aerodrome Controller's (ADC) Flight Progress Strip (Fig 6) for AND, showed that AND had been issued with a SDC 36, on an unrestricted climb to FL 290 (29,000 ft). It also showed that AND was cleared to take off from runway 27 with an airborne time of 54 (00:54:00), and made a right turn, with a departure track 003°R [The 003° radial of the Nadzab VOR].

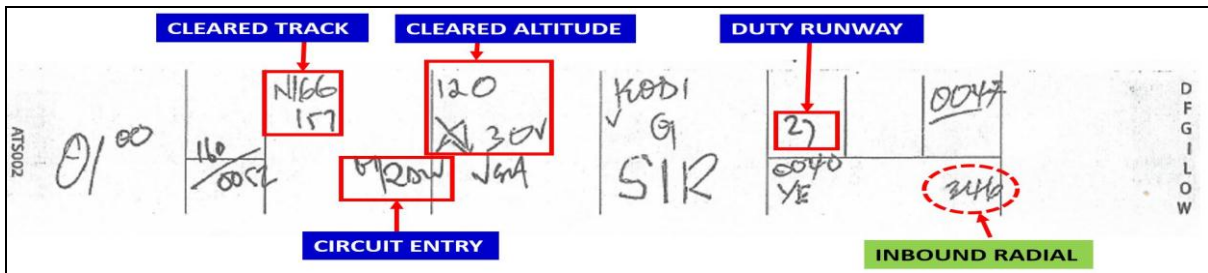
Figure 7: Extract of Nadzab ATC Flight Progress Strip (APP/SIR)

The Approach Controller's (APP) Flight Progress Strip (Fig 7) for SIR, showed that SIR was cleared to track 166° to Nadzab, and shortly after that clearance was changed to 157°. (166° was not deleted on the flight strip). It also noted a track inbound on the 346° radial, which is the reciprocal of the inbound track. SIR was operating a VFR flight. The altitude annotation showed descent from 12,000 ft initially to 3000 ft, then on a visual approach and cleared to join circuit on a mid-right downwind for runway 27.

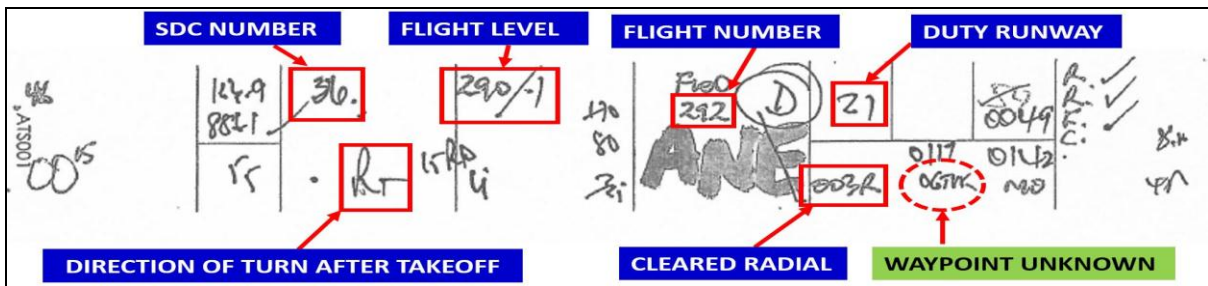
Figure 8: Extract of Nadzab ATC Flight Progress Strip (APP/AND)

The Approach Controller's (APP) Flight Progress Strip (Fig 8) for AND contained the same basic information as on the ADC's Flight Progress Strip, with the addition of a waypoint OGTVK. [This 5LNC is unknown]

The PNG Accident Investigation Commission recommends that PNG Air Services Limited should review the list of unique 5-letter waypoints to ensure that “sound-like” words are not used for routes in proximity. Refer *ICAO Annex 11, and ICAO Codes and Route Designator (ICARD), 5 Letter Name Code (LNC) Guidelines, Section 4, Posting a Request and Checking Proximity of 5LNC*.

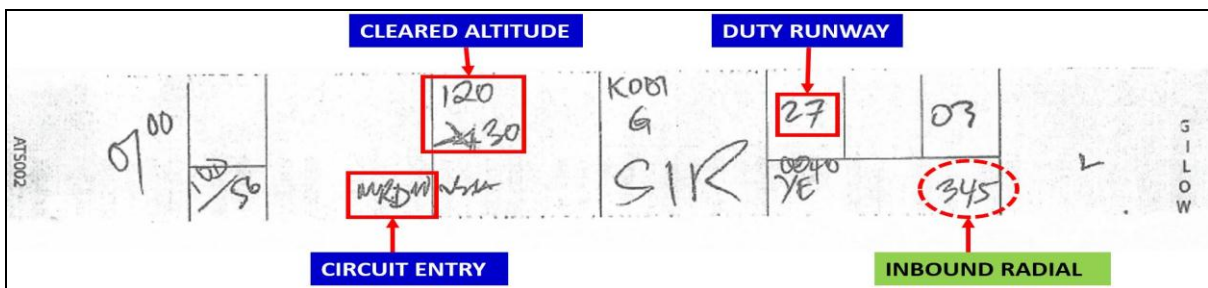
Figure 9: Extract of Nadzab ATC Flight Progress Strip (ADC/SIR)

The Aerodrome Controller's (ADC) Flight Progress Strip (Fig 9) for SIR, showed that SIR was cleared to descend to 3000 ft and further cleared to join the Nadzab circuit on a mid-right downwind for runway 27. It also noted a track inbound of 345°, which was actually the reciprocal of the inbound track, and a radial of the Nadzab VOR

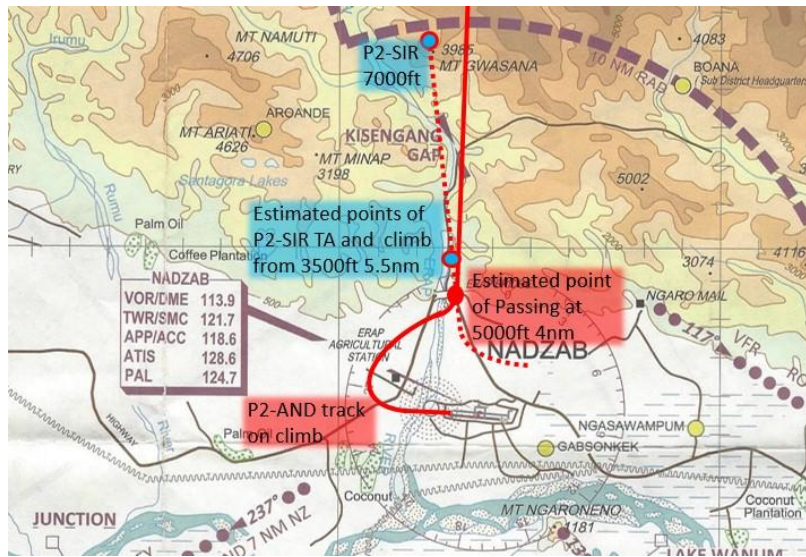
Figure 10: Estimated tracks of P2-AND and P2-SIR at time of incident
(Source: PNG Visual Terminal Chart. Image modified by AIC)

Figure 10 depicts the estimates points where SIR reversed the descent and commenced climb from 3,500 ft to 7,000 ft, and the estimated point SIR passed AND.

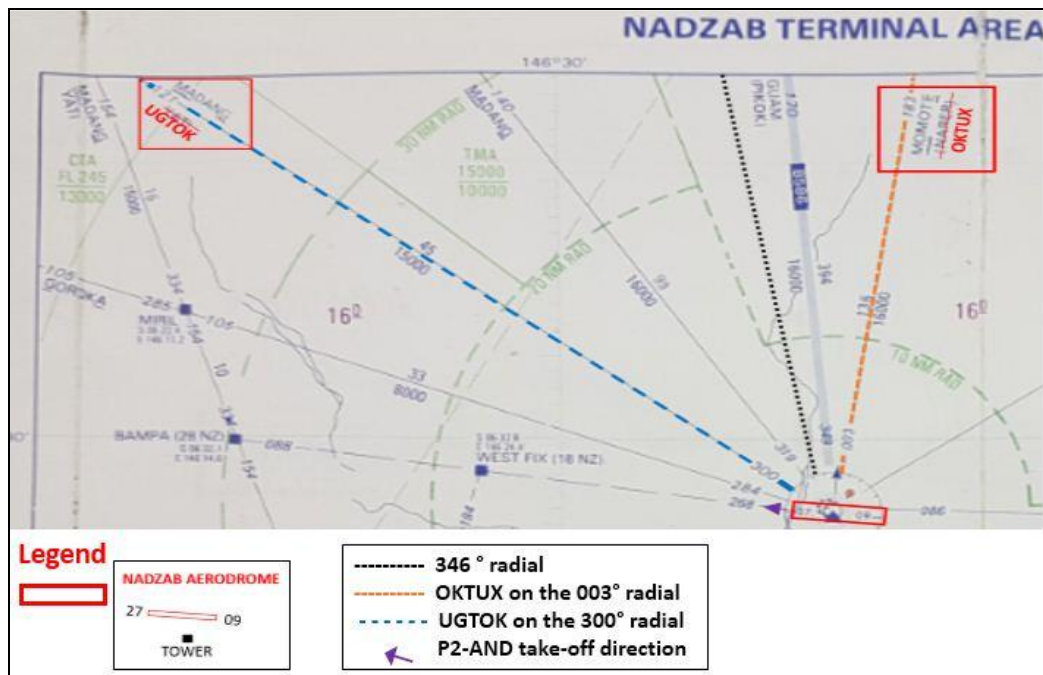
Figure 11: Tracks to OKTUX and UGTOK
(Source: PNG Radio Navigation Chart shown on Appendix 1. Image modified by AIC)

The Standard Departure Clearance 36 track to waypoint OGTUX for AND, and the inbound track for SIR on the 346° radial are highlighted on the following extract from the Radio Navigation Chart (RNC) (Figure 11). Also highlighted is the track to waypoint UGTOK on the 300° radial.

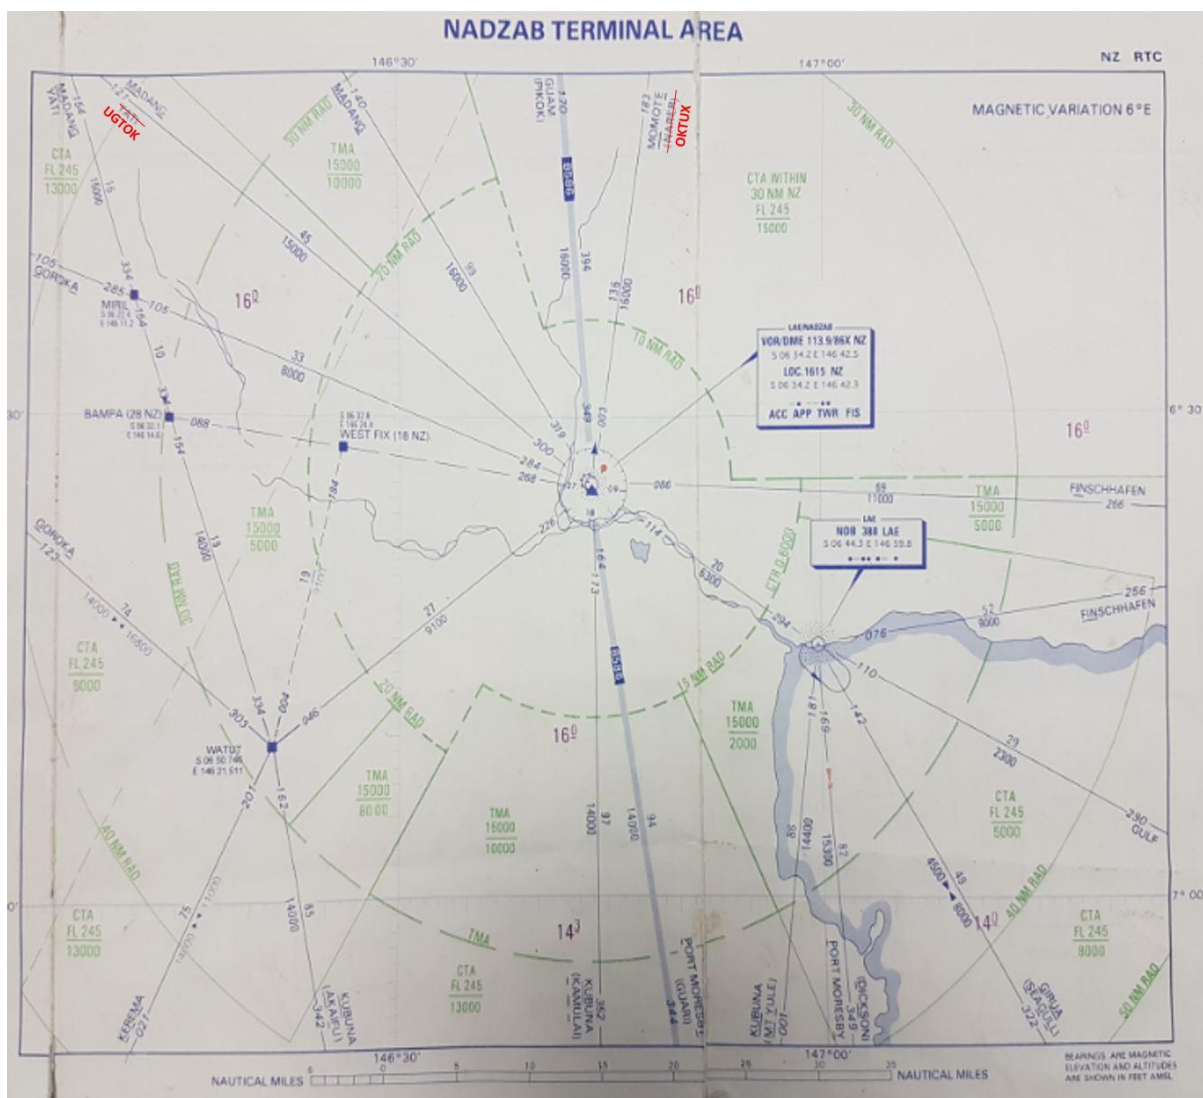
The waypoint names OKTUX and UGTOK had been promulgated by PNG Air Services Limited in *AIP Supplements* dated 28 April and 21 July 2016 respectively requiring hand amendment to the *Radio Navigation Chart (RNC)*. The AIP Supplement amendment date was the date of effect of the change, and therefore was in use at the time of the incident. The replacement *RNC* with the names UGTOK and OKTUX was not effective until 2 February 2017.

The RNC depicted below is the chart at the time of the incident with the waypoints hand amended.
