AIC 16-1001

**PAPUA NEW GUINEA
ACCIDENT INVESTIGATION COMMISSION
SHORT SUMMARY REPORT**

P2-NCA

Nose wheel into soft ground during take-off roll involving P2-NCA PAC-750XL

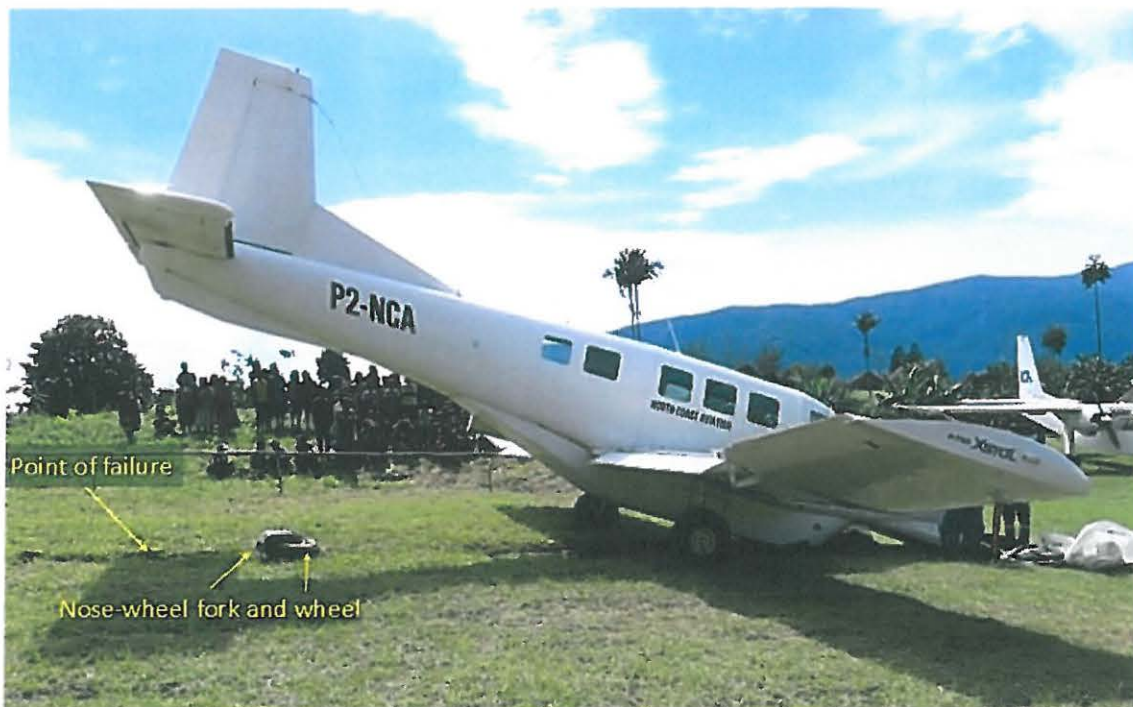
Figure 1: P2-NCA at Bunguwat

The pilot stated that the aircraft had performed normally before the accident. The nose-wheel fork with the attached wheel separated from the nose landing-gear oleo on impact, when the attaching bolts fractured (Figure 1). The propeller was substantially damaged when the aircraft's nose dropped and the propeller blades, rotating under take-off power, struck the ground. The propeller assembly, still attached to the reduction drive gearbox, separated from the engine. Subsequently the engine and its mounts sustained substantial damage.

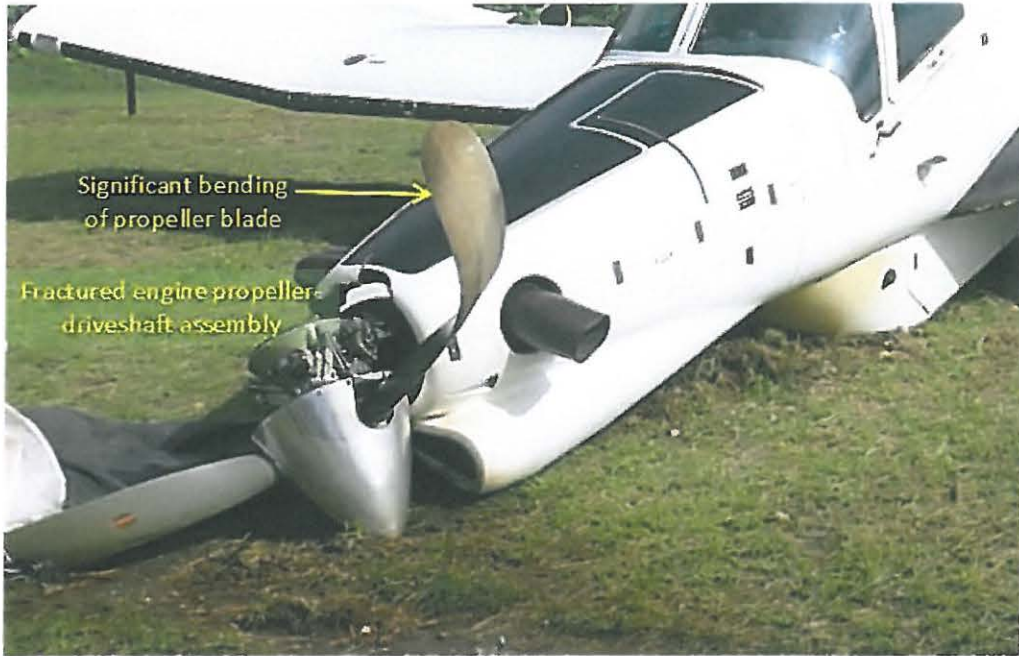
Figure 3: Propeller Damage

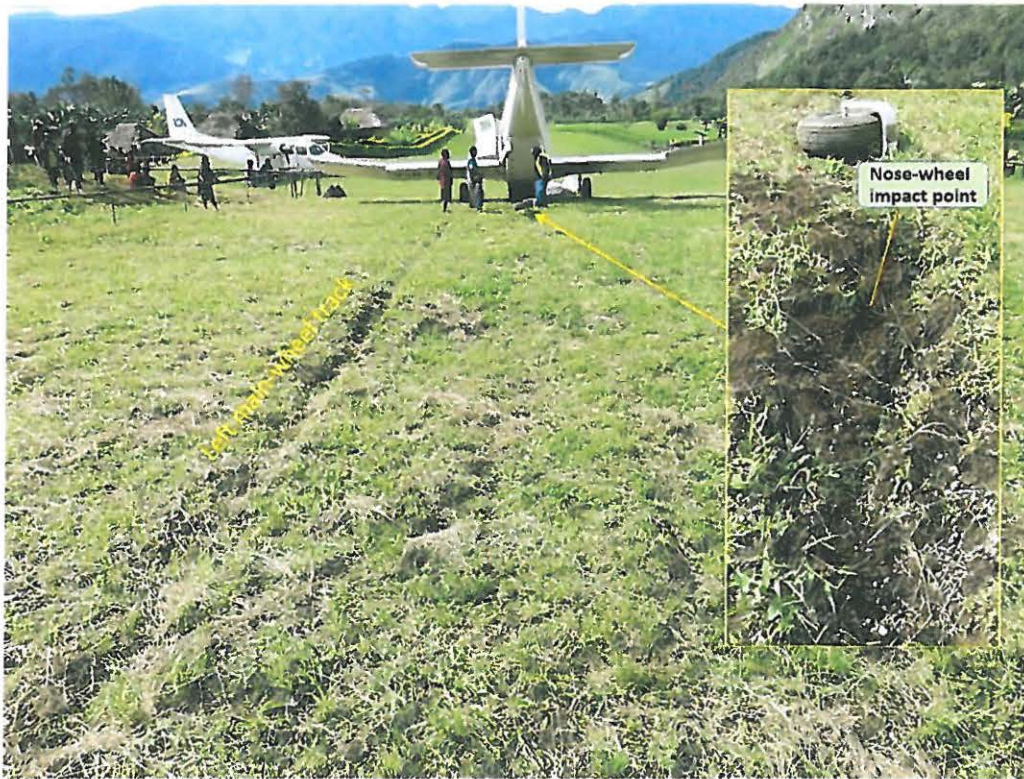
Figure 4: Aircraft track and impact point

- During his interview with the AIC investigators, the pilot stated that he misjudged the general surface condition of the airstrip, and chose the left side of the airstrip for his take-off roll, which he subsequently found was soft/boggy compared to the centreline.

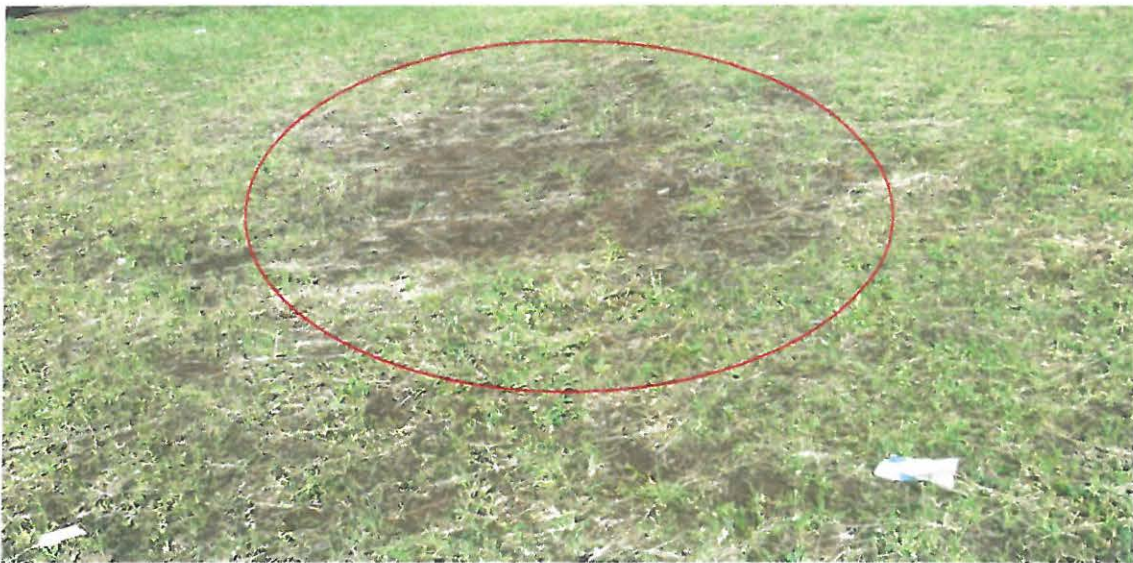
Figure 5: Patch referred to by pilot as appearing dark and damp on the day of accident

During his interview, the pilot stated that he decided to line up on the left side of the strip (well left of the centreline), because he observed a patch of bare earth on the right side which, to him appeared darker than other parts and damp (Figure 3). However, he did not walk along the strip, along his intended take-off path, to check the integrity of the surface and suitability for the take off.

- It is likely that the cut/dead grass lying on the strip surface would prevent evaporation and drying, and allow the ground beneath it to hold water for longer periods.
