**FINAL REPORT
AIC 15-1001**

**PAPUA NEW GUINEA
ACCIDENT INVESTIGATION COMMISSION
AIRCRAFT ACCIDENT REPORT**

**Helifix Ltd
P2-HFZ
Bell 206
Bobcat Rig Site
Gulf Province
PAPUA NEW GUINEA
15 February 2015**

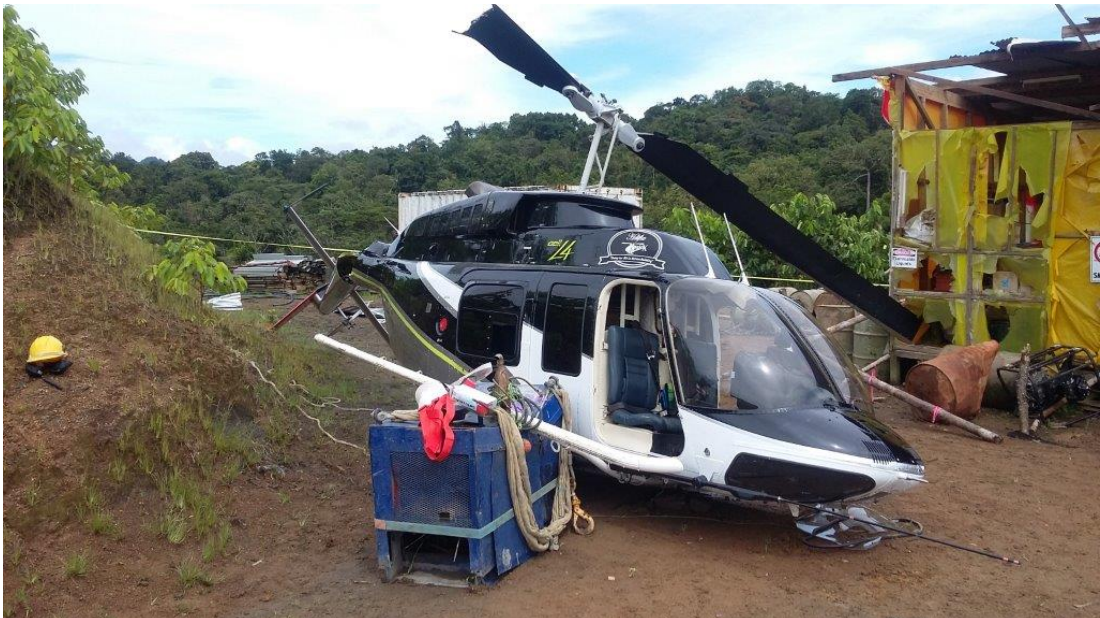
The helicopter was substantially damaged due to the heavy landing, coming into contact with uneven ground and the generator that had just been airlifted by sling, and the hut housing the camp generator.

Figure 2: P2-HFZ impact site next to the generator

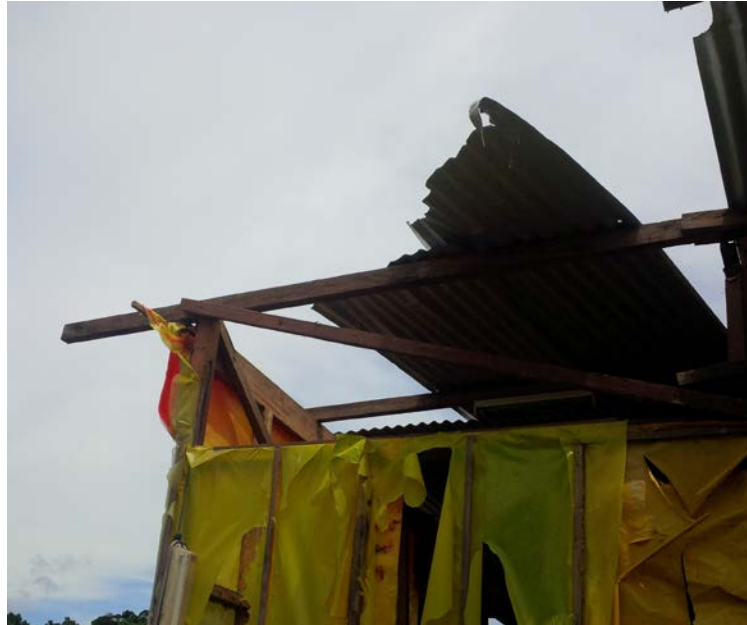
Sheets of roofing iron from the hut housing the camp generator were dislodged from the roof when struck by the main rotor blades during the descent. There was no other damage to property and/or the environment.

Figure 3: Damage to generator shed roof

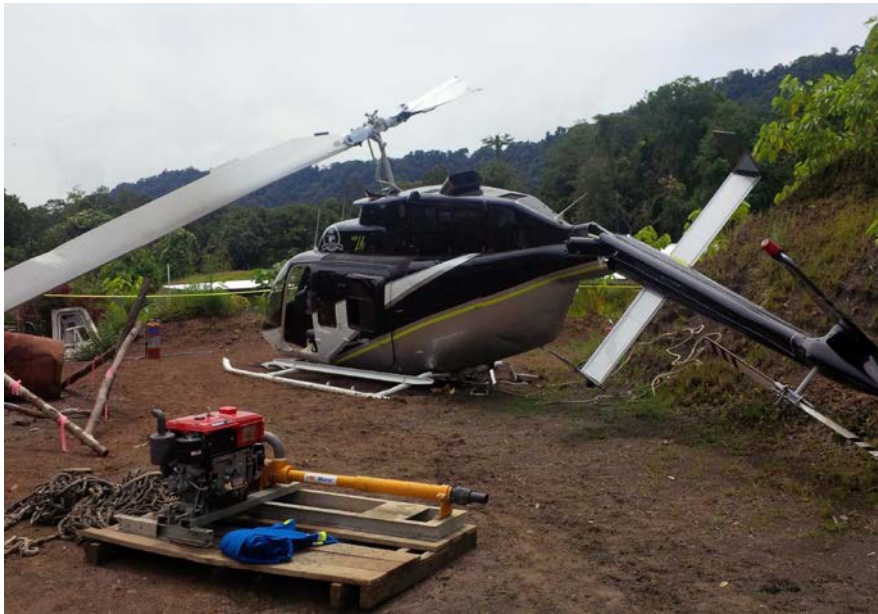
Figure 4: P2-HFZ impact site from rear of aircraft

The landing gear skids collapsed as a result of impact forces. The tail boom fractured and bent down immediately behind the fuselage. One main rotor blade fractured on impact and came to rest approximately 50 metres from the helicopter.

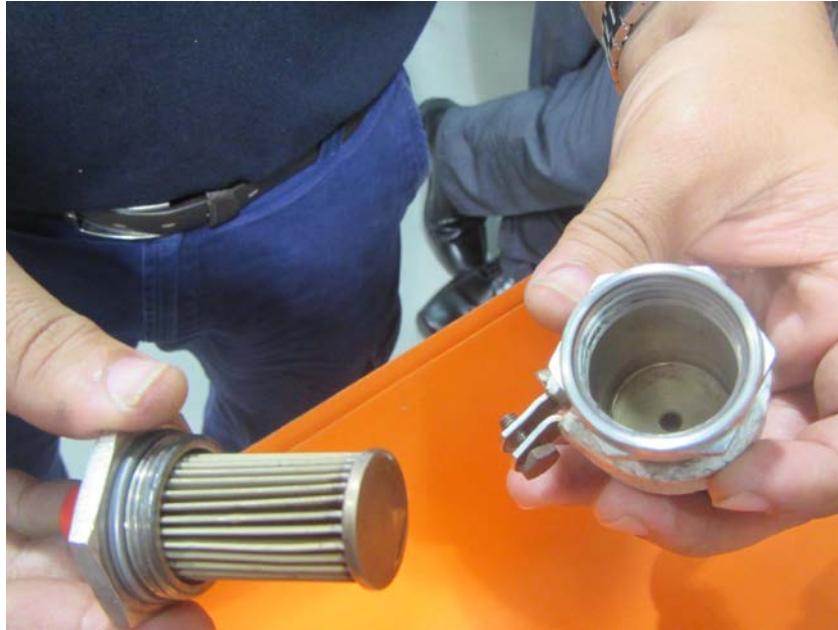
Figure 6: Disassembled Pc filter

Additional inspections and checks of the engine and accessories were carried out. The fuel nozzle was shimmed and subsequently changed, and leak checks on all Pc air system pneumatic lines and unions were carried out before further starts were attempted. The Pc filter was removed and checked.

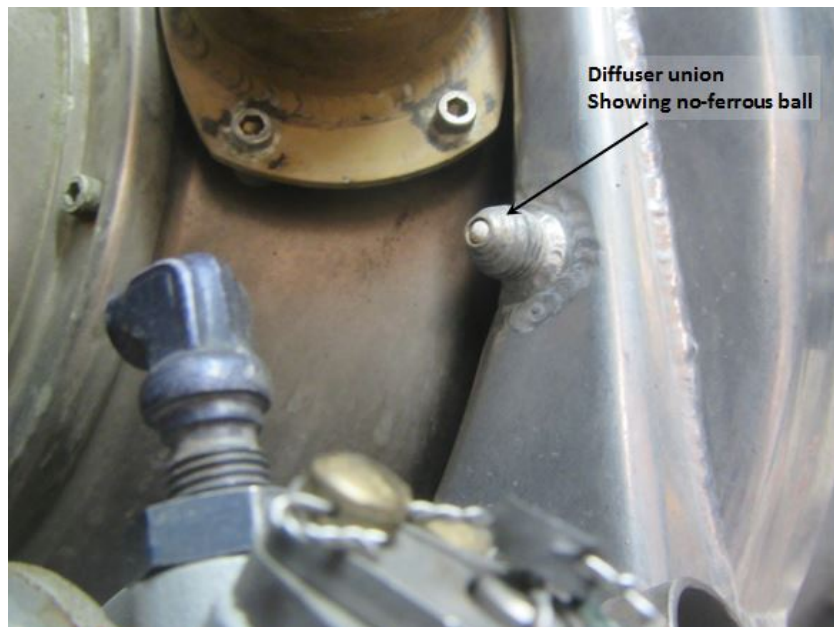
After failure on the seventh start attempt, the decision was made to remove all Pc air lines and inspect them individually. First, the line from the diffuser to the Pc filter was removed. It was discovered that the union mount welded on the diffuser appeared to have an obstacle stuck in its orifice (it had the appearance of a drain valve). The bleed valve was removed to provide access for a boroscope to inspect the union internally. A ball-like foreign object stuck at the orifice of the Pc diffuser union was found. The engine manufacturer informed the AIC that ‘the foreign object which blocked the engine’s Pc air flow was consistent with the ceramic media used to provide a fine finish to various engine components. This finish is not provided by the Rolls-Royce factory, but is provided by third-party companies’.

Figure 7: The ‘foreign object’ stuck on inside of the union mount on diffuser

All technical personnel present agreed that the object lodged in the orifice was likely to have been the cause the engine's failure in service and all the hung on the test cell.

The small non-ferrous ball found in the Pc diffuser union orifice was of the material type used in pressure blast cleaning/polishing similar to the glass bead blasting process.

During a sling load release under the direction of a ground-based load master, the Bell 206 Long Ranger's engine failed. The investigation found that a small ball of non-ferrous material used in pressure cleaning had become lodged in the orifice of the Pc diffuser union effectively blocking the Pc air line.

The blocked Pc air line caused a loss of air pressure to the engine's fuel control and power turbine governor, which caused engine power to hang at 'Ground Idle'. That was insufficient power to maintain flight.

The Accident Investigation Commission recommends that Gas Turbine Overhaul Pty Ltd review its maintenance practices to ensure that pressure bead blasting during cleaning and polishing cannot cause foreign objects ingestion/damage during engine overhaul.

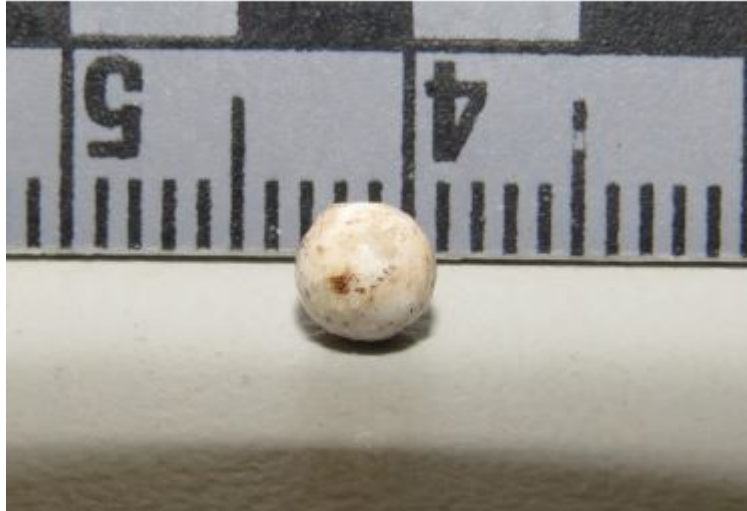
Figure 8: 'Foreign object' against a ruler in millimetres.
