PRELIMINARY REPORT

AIC 18-1003

P2-NTZ

NOSE WHEEL SEPARATION ON LANDING

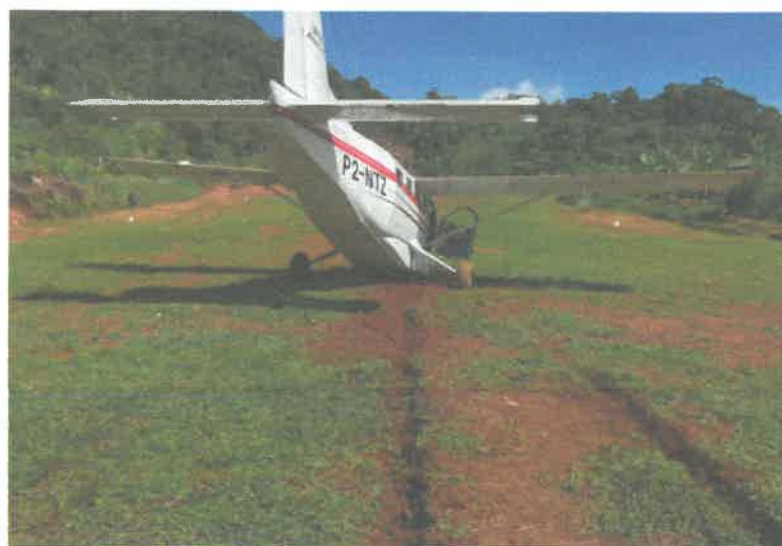
At about 23:25 UTC¹, during the landing roll, the aircraft's nose wheel sank into a soft patch on the strip surface. The aircraft came to an abrupt stop and the nose-wheel fork fractured on both sides of the oleo attachment plate resulting in the nose-wheel and nose-wheel fork assembly separating from the oleo. The pilots, the sole occupants, were not injured.

Figure 1: P2-NTZ at Mibu Airstrip showing wheel tracks in strip soft surface

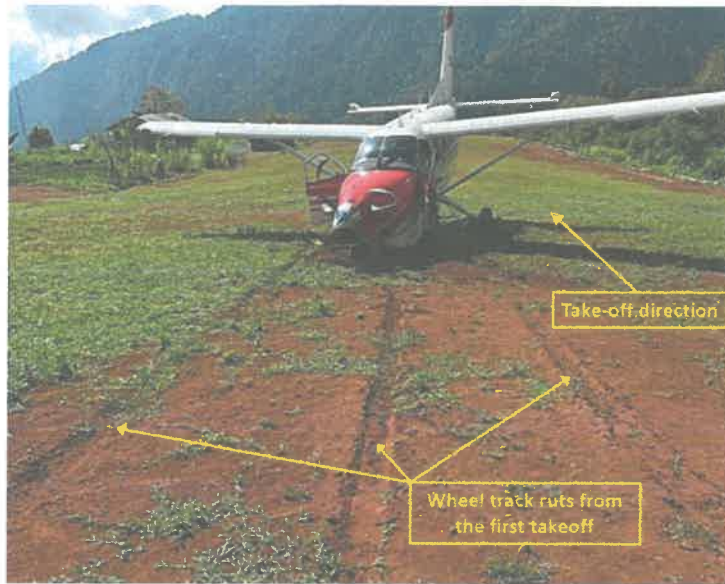
The nose of the aircraft dropped as the fork separated from the oleo and dug further into the soft ground until the bottom of the engine cowling was on the ground (See figure 2).

Figure 2: View of P2-NTZ showing the ruts in the soft strip surface from the first takeoff

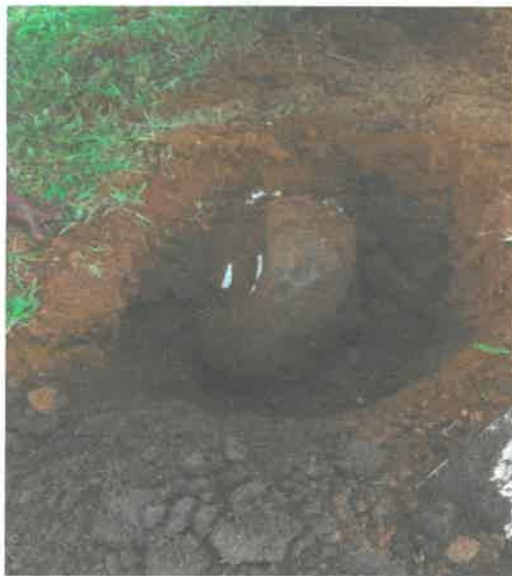
Figure 3: Nose wheel and fork assembly in bog hole Figure 4: Propeller assembly

The AIC sent the fractured nose landing gear fork assembly to the Australian Transport Safety Bureau in Canberra, Australia for materials failure analysis in the ATSB's Engineering Laboratory. The examination of the failed components will seek to establish the mode of failure.

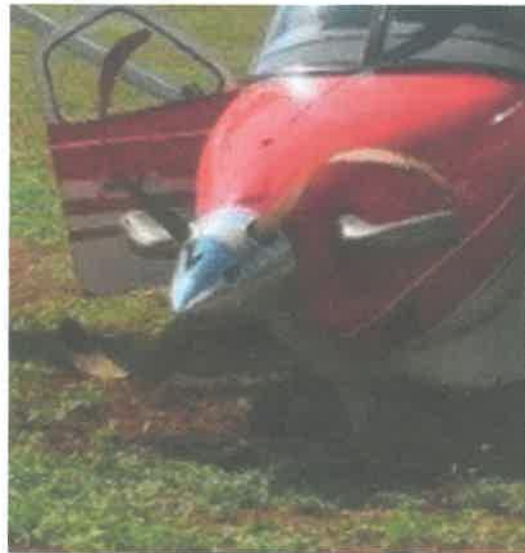
The PIC stated that he added power soon after touching down to maintain a 20kt speed up the 17% slope towards the end of the strip. The engine and propeller, under significant power, were substantially damaged as they impacted the ground.
