**PRELIMINARY REPORT**

**AIC 19 -1004**

**P2-ASZ**

**Landing Gear Collapse**

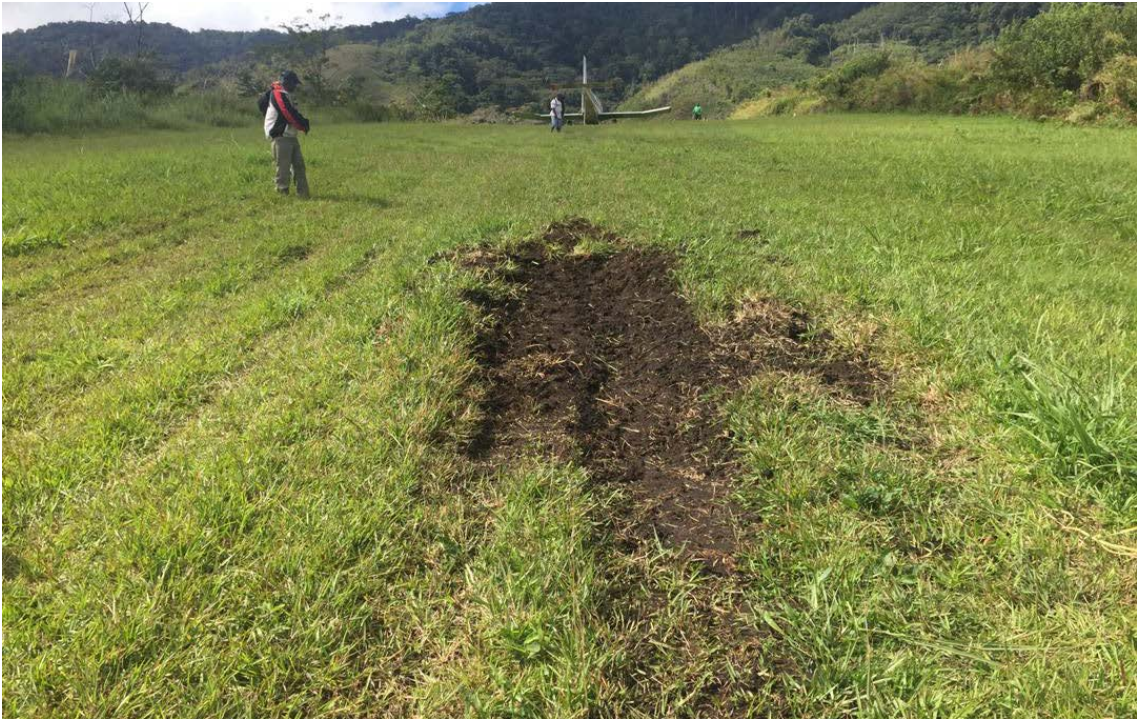
The pilot subsequently informed the AIC that during the landing at Efogi Airstrip the aircraft was affected by a tailwind gust, and the aircraft's nosewheel impacted the up slope of the airstrip. The nose landing gear, cargo pod, engine and propeller were substantially damaged. The seven occupants were uninjured.

**Figure 2: Impact nosewheel mark and the aircraft in its final position.**

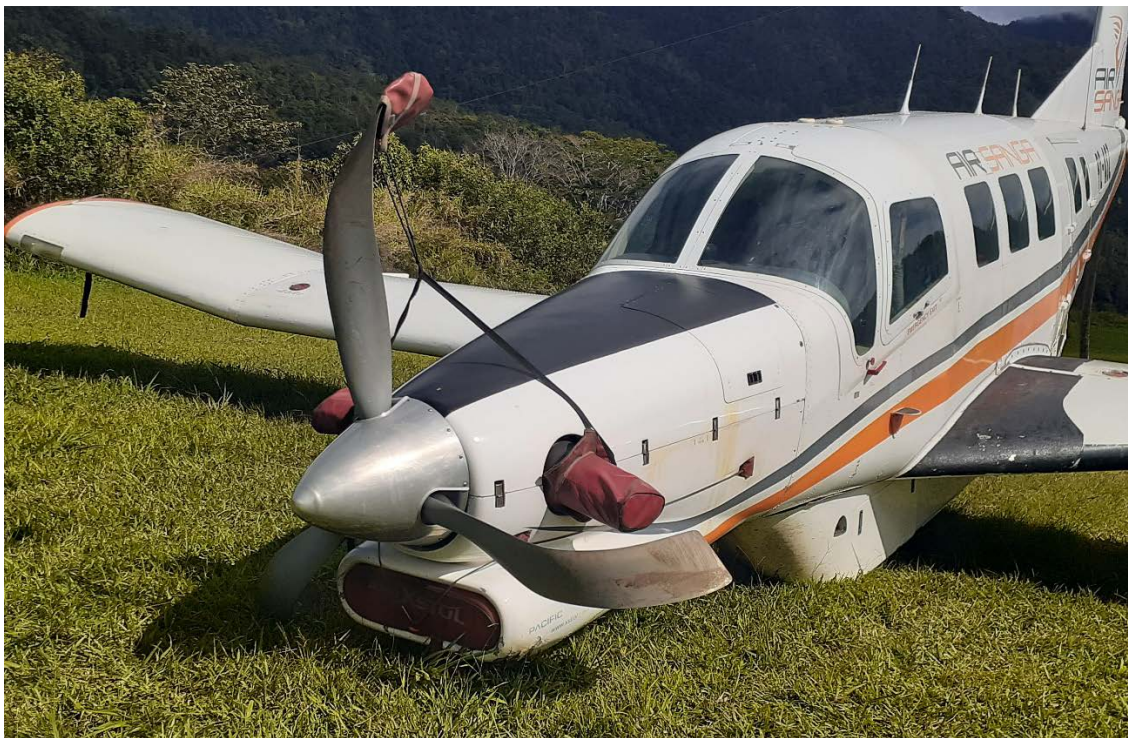
**Figure 3: View of the damaged propeller and nosewheel zone.**

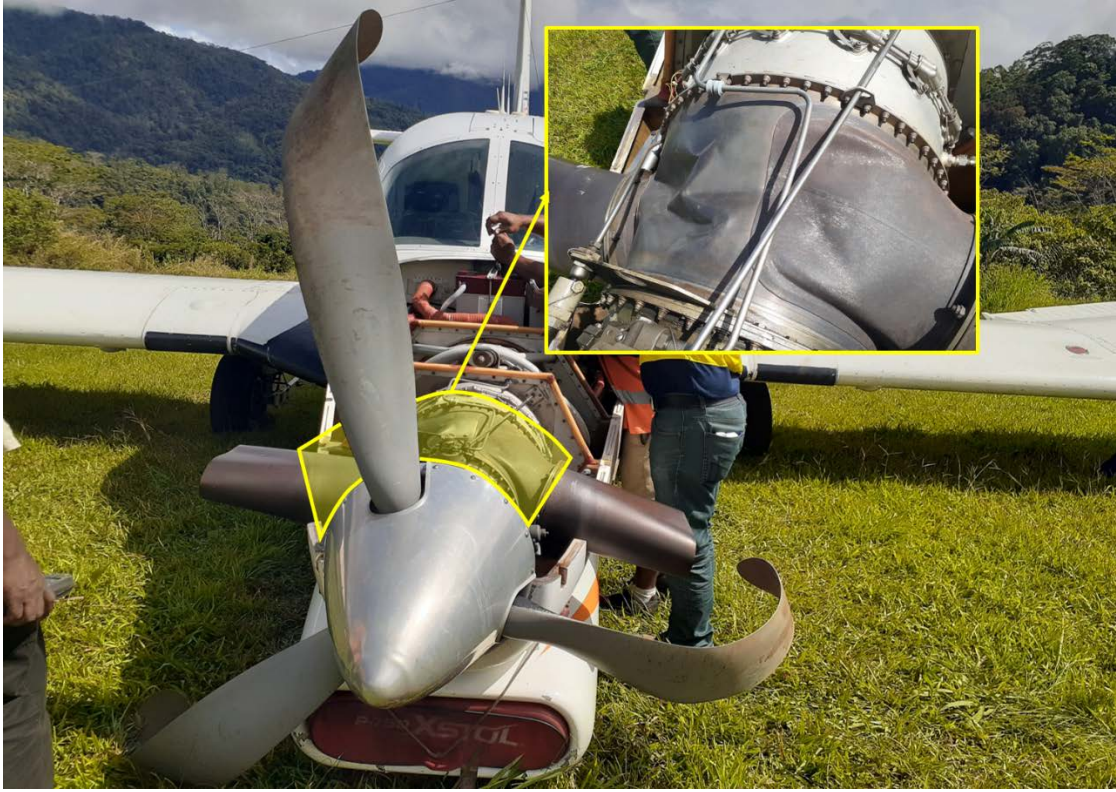
**Image 4: Insert shows engine reduction gearbox and exhaust zone.**

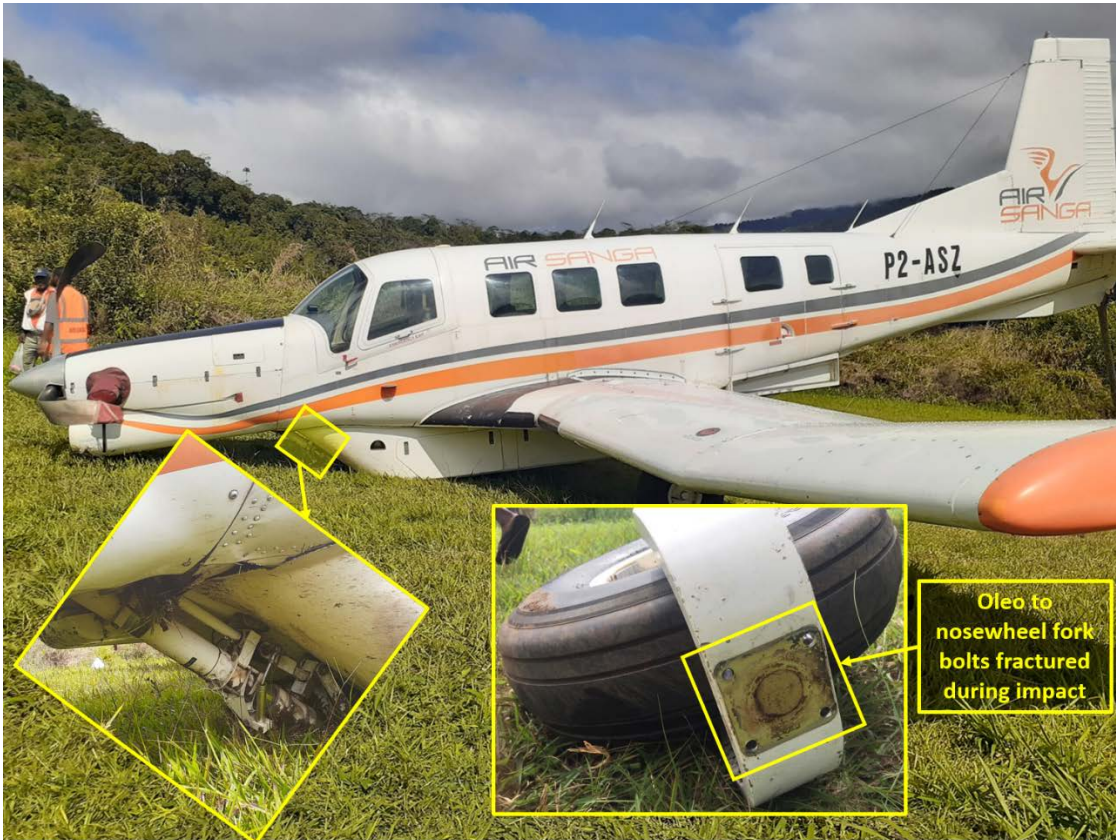
**Image 5: Nose landing gear assembly folded back into the cargo pod**
