PRELIMINARY REPORT

AIC 20 -1005

Cessna 402C

Collision with trees during aborted take-off

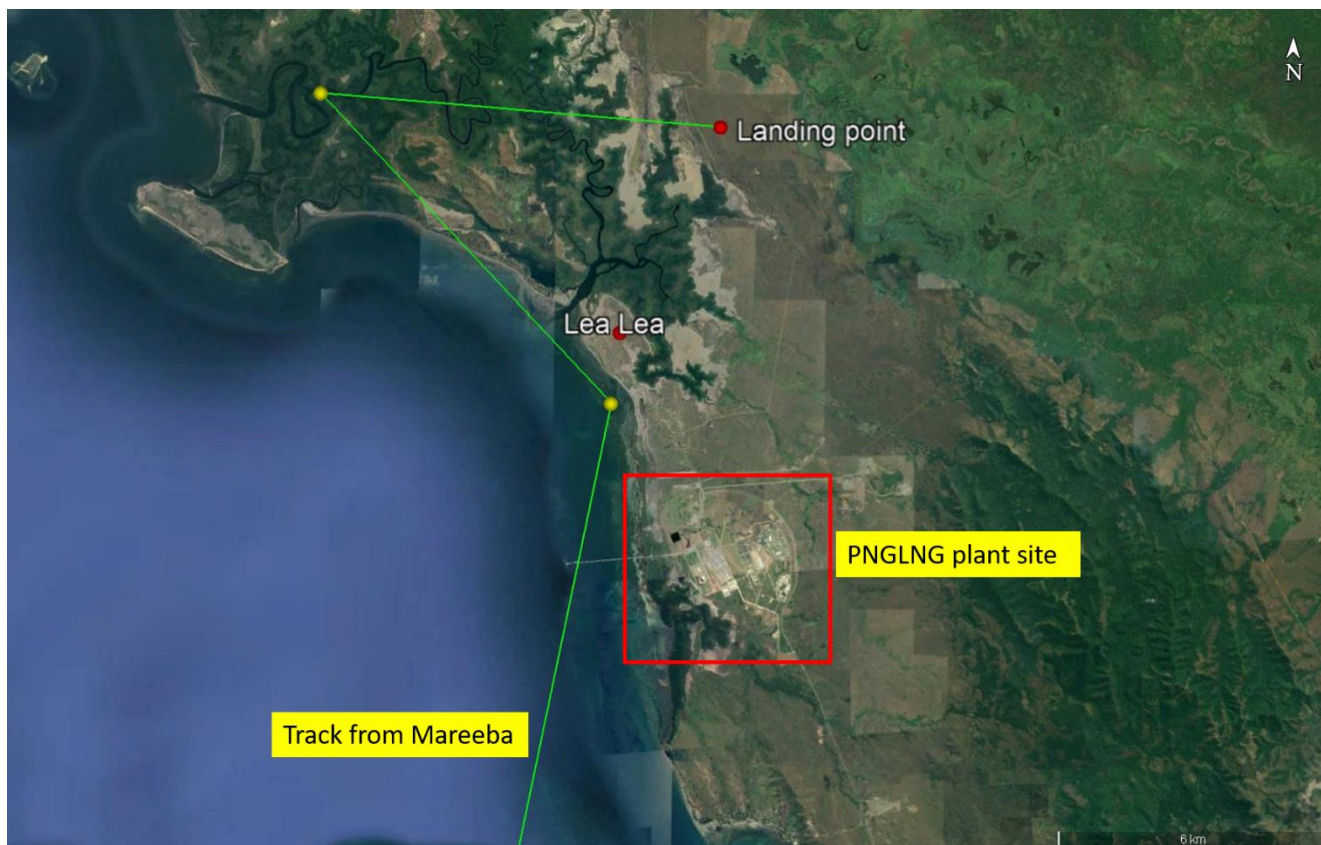
Figure 2: VH-TSI track towards the field using for landing and take-off.

The pilot reported that as soon as the aircraft neared the Southern shoreline (within the Caution Bay area), he diverted left and began tracking towards the North West (see Figure 2) along the coast to avoid flying over villages in the area. The aircraft subsequently crossed over land before turning back to approach the intended landing field.

The pilot stated that as he approached to land from the North, the outboard section of the left wing was clipped by a tree and separated from the aircraft and he managed to continue with the approach and touched down on the field at about 12:20.
