FINAL REPORT

AIC 20 - 1002

P2-MAI

Loss of control during landing at Miyanmin Airstrip

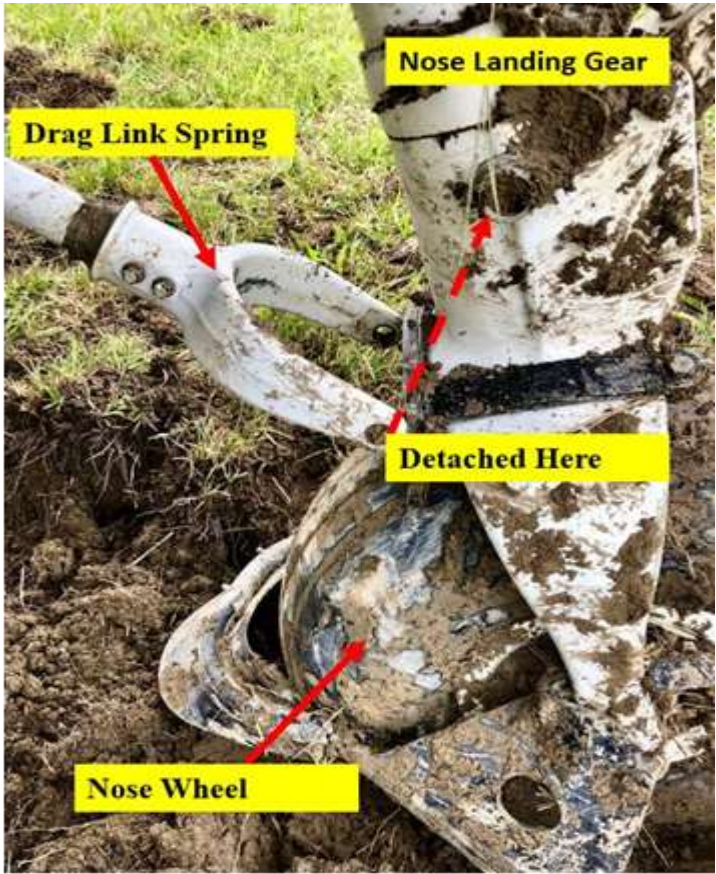
The aircraft sustained substantial damage to the nose landing gear (NLG), propeller blades and the outboard section of the right wing.

Figure 2: Damage to nose landing gear

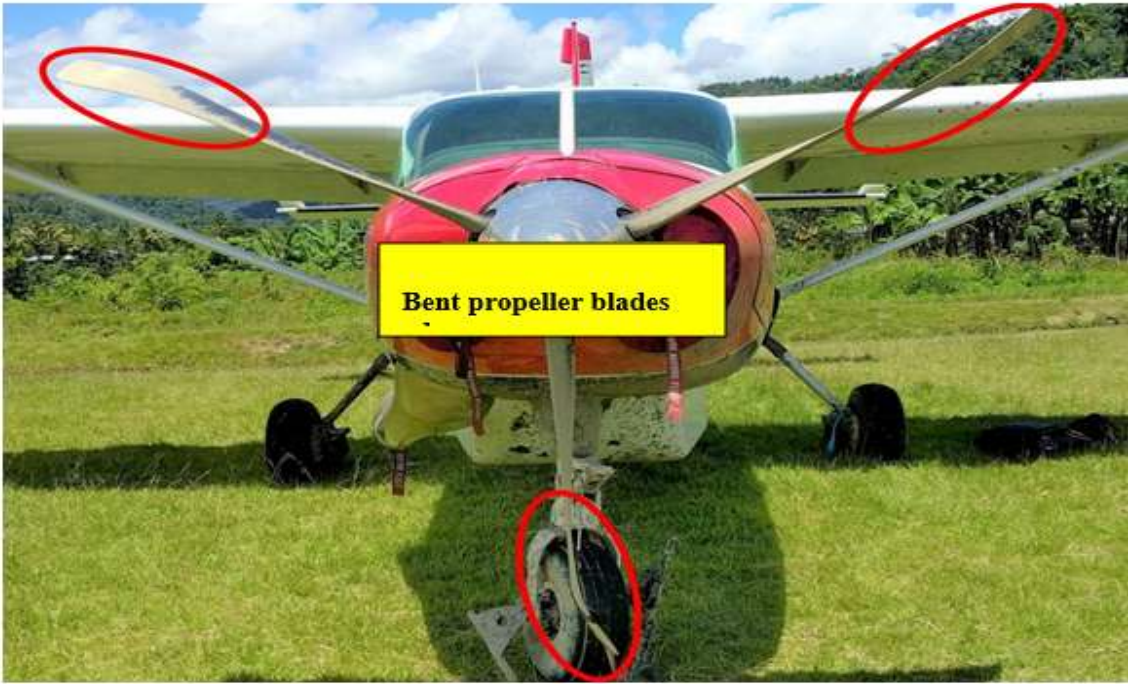
Figure 3: Damage to propeller blades

It was evident from the damage to the propeller blades that the propeller was being powered and that the blades were in the idle to beta range when they struck the surface, followed by the right wing impacting the ground.

All three propeller blades were bent towards the trailing edge of each blade (See Figure 3).

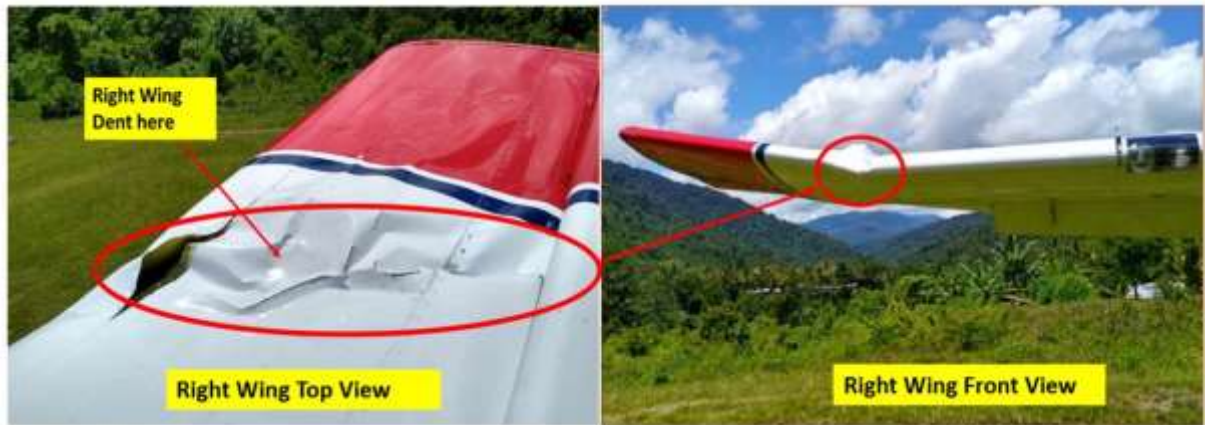
Figure 4: Damage to right wing

The damage on the propeller blades indicated that there was power at the time of impact. The outboard section of the right wing impacted the ground and was bent upwards when the aircraft tipped to its starboard side (See Figure 4).

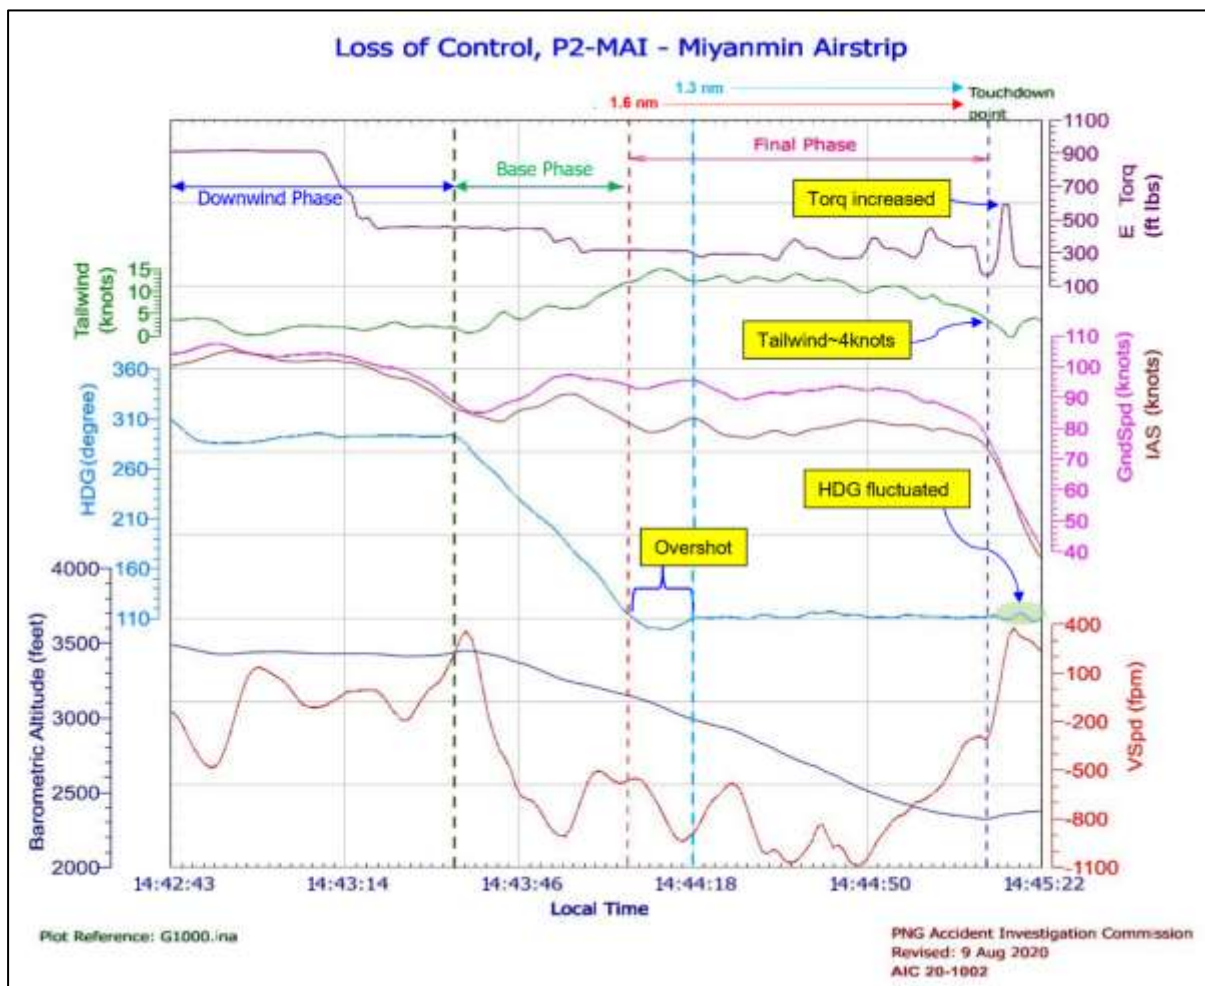
About 2 seconds after touch down, the torque parameter began to increase and subsequently developed a peak value of 591 lb-ft.

An increase in torque was an indication of the application of the reverse thrust. About the same time the torque was increasing, the heading began to fluctuate which was an indication of the aircraft commencing to lose directional control.

Figure 5: G1000 recorded parameters data plot of the accident flight.

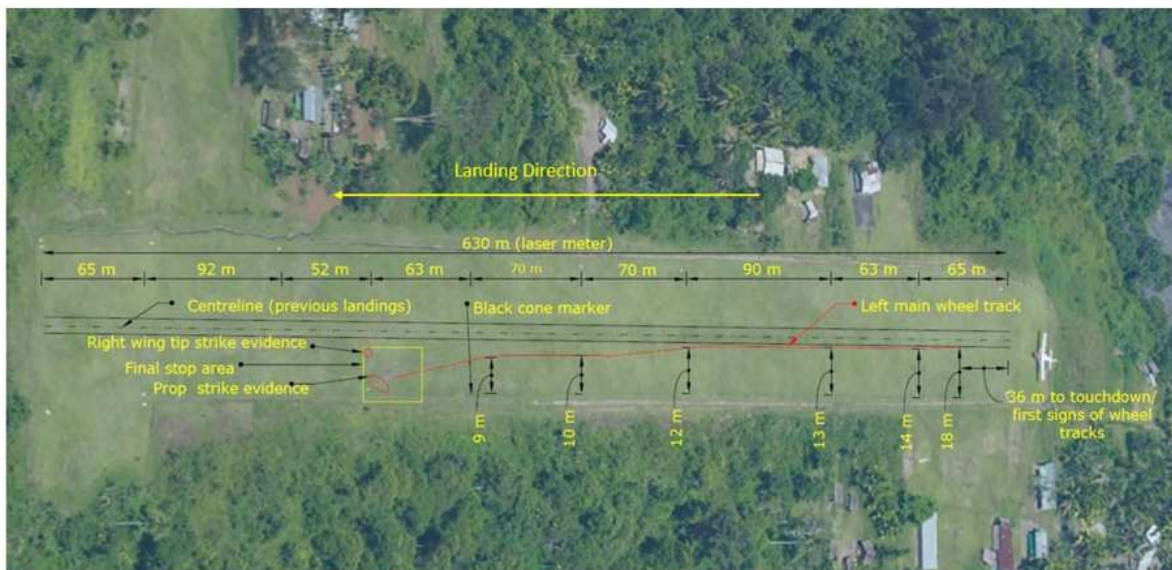
Figure 6: Overview of landing roll track-Full length (Source MAF PNG)

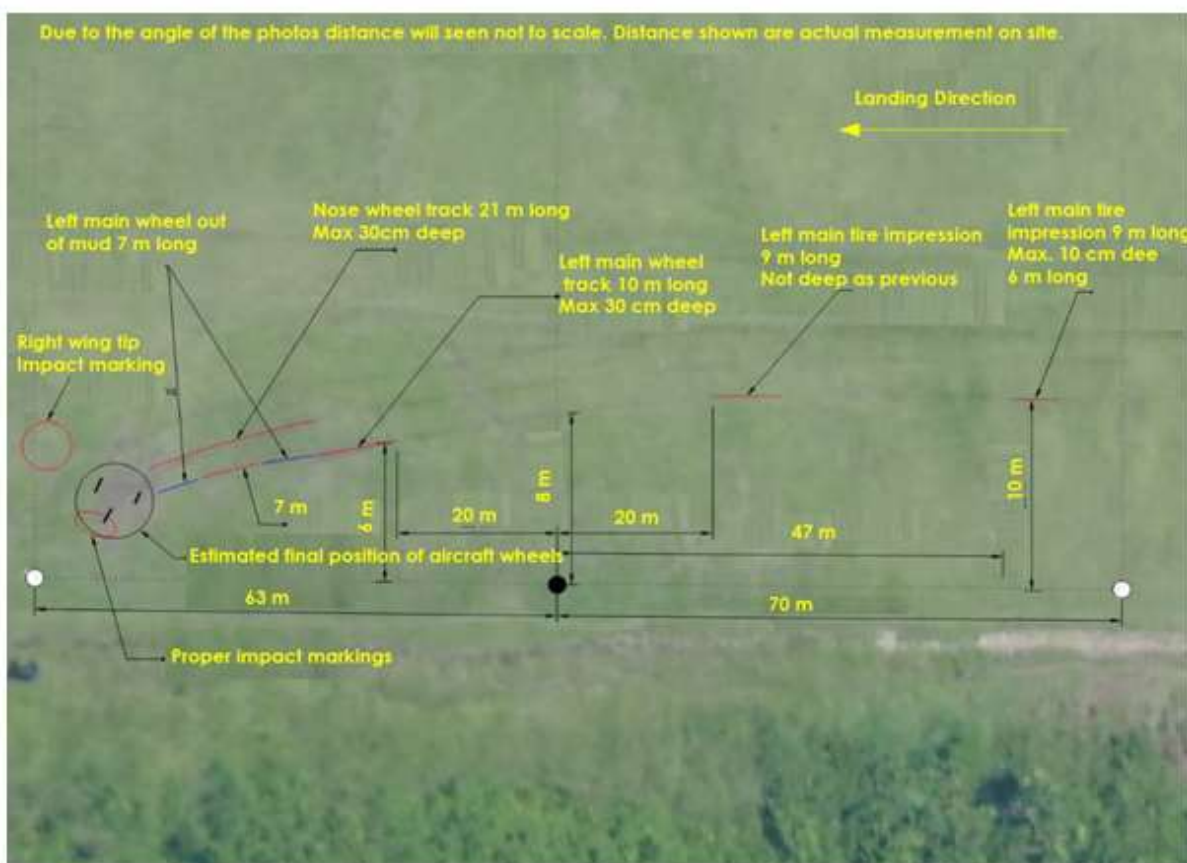
Figure 7: Overview of landing roll track-Mid length (Source MAF PNG)

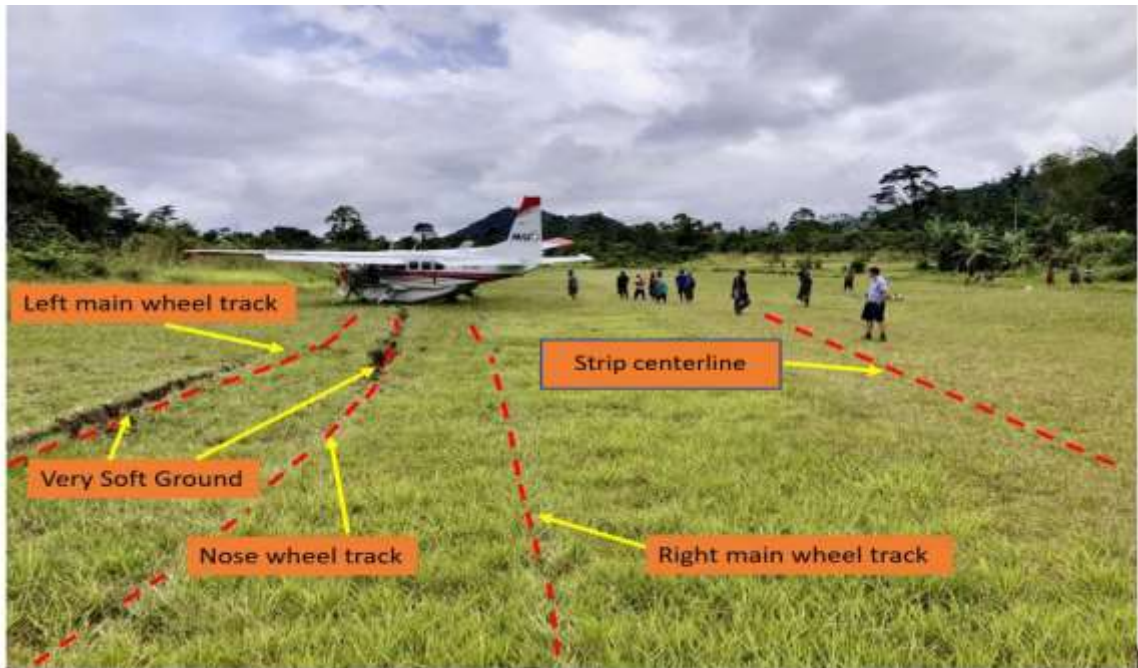
Figure 8: Tyre and impact markings on the runway
