INTERIM STATEMENT

AIC 20 - 2004

P2-MEH

Baggage Compartment Smoke Indication

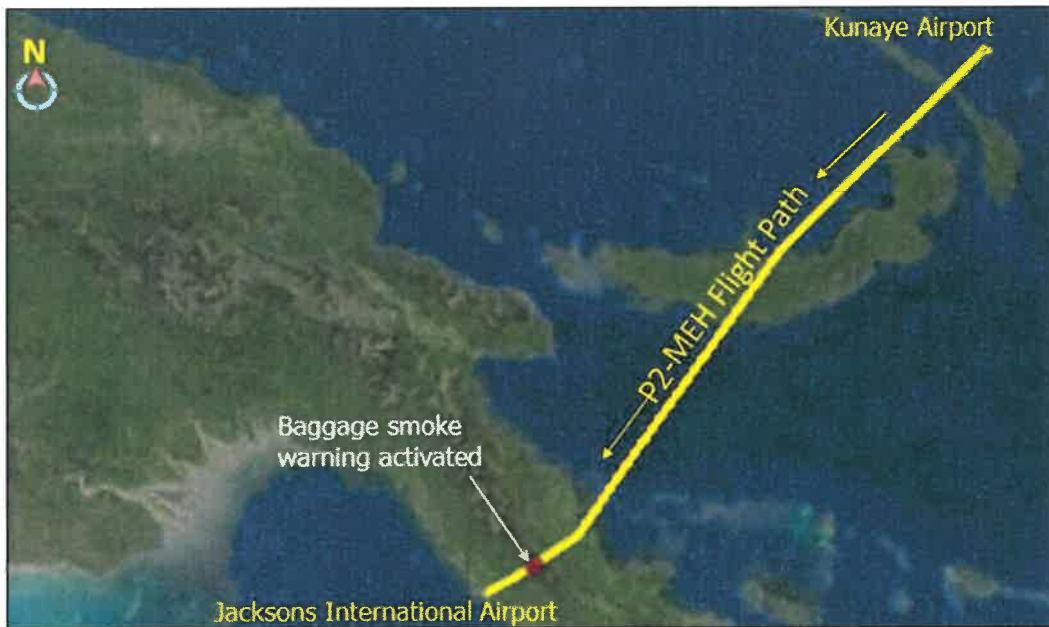
Figure 1: P2-MEH depiction of flight path from Kunaye to Jacksons.

The aircraft departed Kunaye Airport at 09:43 and climbed to an altitude of 40,000 ft with a planned track direct to Port Moresby (see Figure 1) carrying one patient lying on a stretcher and three passengers.

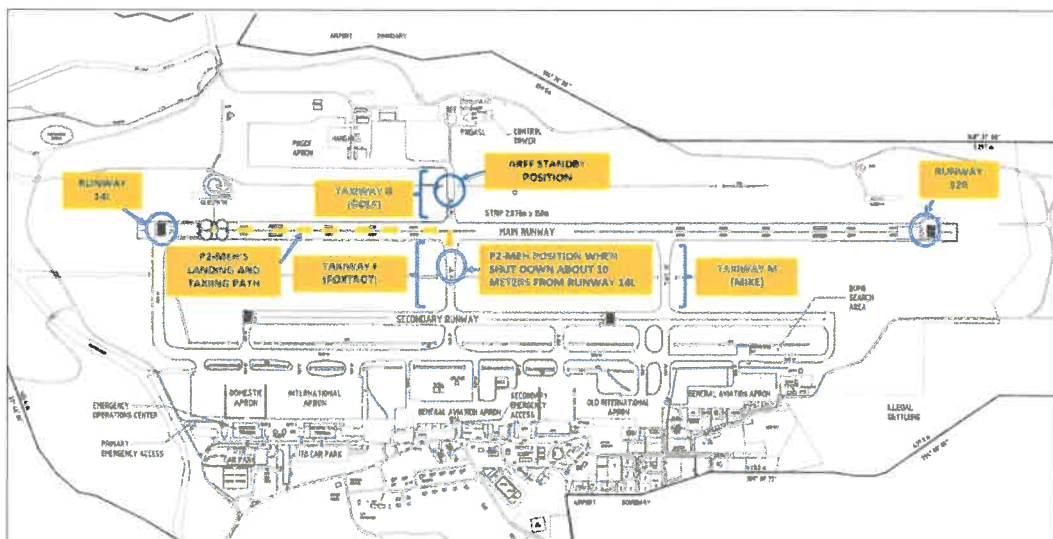
Figure 3: P2-MEH position after landing

The National Airports Corporation (NAC) Incident Report indicated that the ARFF crew were expecting P2-MEH to land on runway 32R at an estimated time of 11:19. Therefore, they were looking towards the runway 32R approach end for the aircraft. However, the aircraft had landed at 11:09 on runway 14L. Their report also stated that they (the ARFF crew) were surprised when they realised that the aircraft had already landed, taxied to taxiway Foxtrot and parked about 10 m away from the runway. They immediately crossed the runway to taxiway Foxtrot following clearance by Jacksons Tower to cross to the aircraft (see Figure 3).

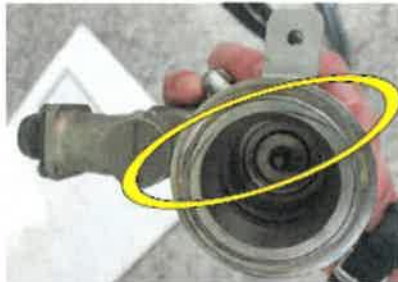
- The Engineer decided to remove the Pressure Regulated Check Valve that was re-installed during the fault-finding process to identify the cause of the Windshield Bleed Air defect and found that one of the Crush Gaskets sealing the Bleed Air Ducting to the Pressure Regulated Check Valve was slightly impregnated.
 - The decision to remove the Pressure Regulated Check Valve was due to it being the only component in the system that has been disturbed previously.
- The slight impregnation on the Crush Gasket may have caused the Smoke Detector activation, although this may have been activated by a totally unrelated source since the Rear Baggage Compartment has a strong smell of medical substances (due to medical equipment being stored in that area) and the compartment is not pressurised. The patient's cargo was also stored in the Rear Baggage Compartment at the time.

- It is assumed that the Crush Gasket got slightly deformed during the re-installation of the Pressure Regulated Check Valve at the time when the blank was removed from the Bleed Air Line which could have caused a small amount of Bleed Air to leak past the mating surface of the Pressure Regulated Check Valve and the Bleed Air Duct.
- By the slight impregnation observed on the Crush Gasket it is evidence that the Pressure Regulated Check Valve and the Bleed Air duct was not perfectly aligned when the Clamp was initially tightened before it moved into position.

- The Engineer has replaced the Crush Gasket with a new item obtained from Stores and re-installed the Pressure Regulated Check Valve.
- On 30 October 2020 another Bleed Air leak check has been performed and no leaks were identified from the Pressure Regulated Check Valve.
