PRELIMINARY REPORT

AIC 23 - 1002

Cessna 208B Grand Caravan

Runway Excursion During Landing

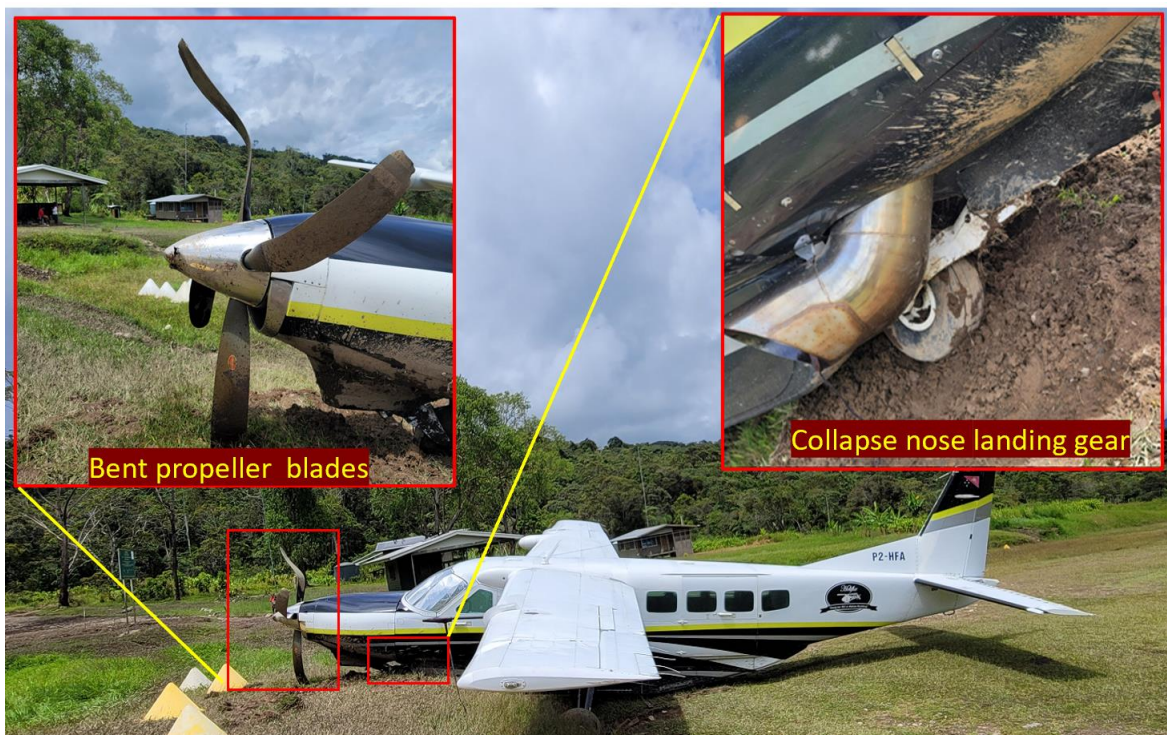
Figure 3. Overview of damage sustained to the aircraft.

The pilot stated that immediately after touchdown, the aircraft became airborne. The aircraft settled back onto the ground again. As the aircraft continued its roll, the aircraft became airborne again. Shortly after settling onto the ground the second time, the aircraft rolled off the end of the airstrip. The aircraft subsequently impacted the embankment of a drain which runs along the edge of the airstrip.

The aircraft was substantially damaged. The aircraft nose landing gear collapsed, and the aircraft propeller blades were substantially bent (see Figure 3).
