PRELIMINARY REPORT

AIC 23 - 1004

VH-MZL

Runway excursion

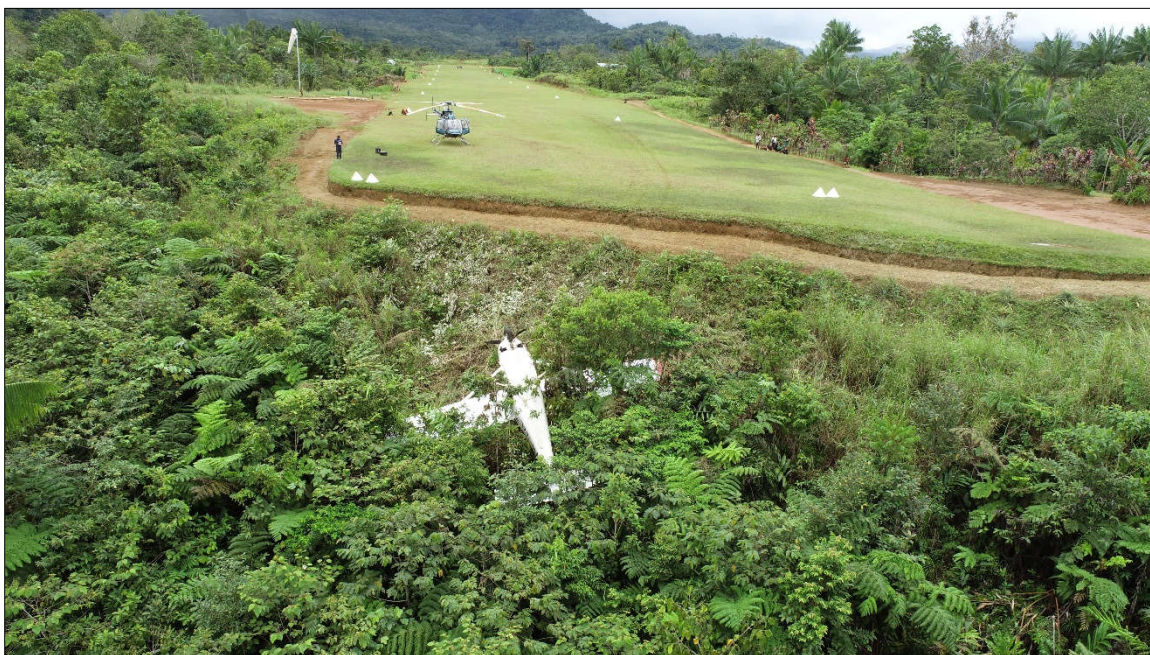
Figure 1: Dodomona Airstrip showing VH-MZL wreckage and landing threshold windsock.

In an attempt to slow down and avoid colliding with the houses, the pilot decided to attempt a ground loop to the right. That manoeuvre was unsuccessful and the aircraft slid off the end of the strip down a steep embankment and overturned coming to rest inverted.

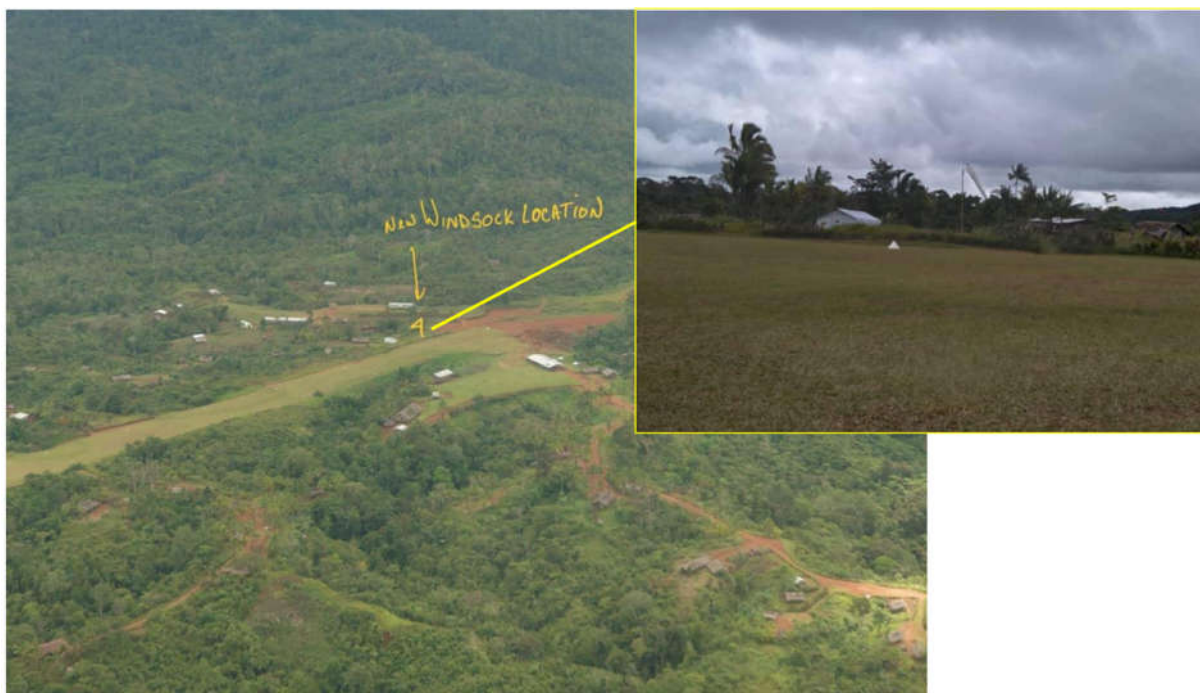
Figure 2: Dodomona Airstrip showing windsock near the take-off departure threshold

On 22 June 2023 the operator informed the AIC by email that the windsock at the landing threshold had been serviced since the accident and a new windsock had been installed opposite the parking bay about 40 meters from the take-off threshold. Both windsocks were tested and found to be serviceable. The location of the windsocks was to enable pilots to see both of them before commencing a take-off roll.
