FINAL REPORT

AIC 22-2002

Close proximity serious incident

Mt Hagen Airport, Western Highlands Province

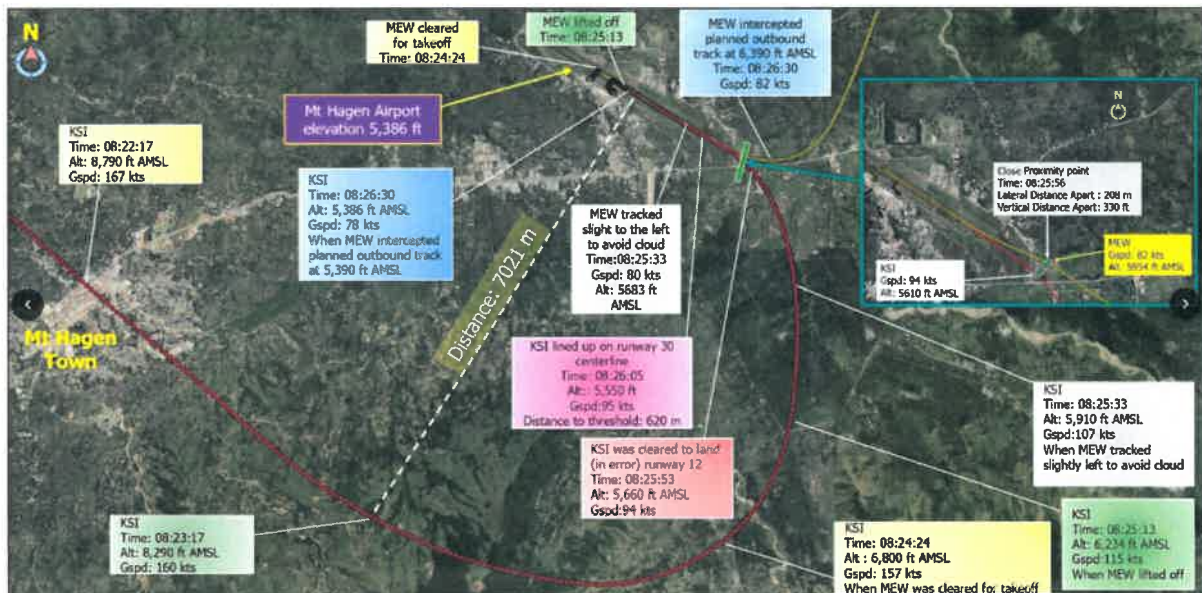
Figure 2. Depiction of the aircraft flight paths.

Figure 2 is reproduced in Appendix 5.4 for clarity. The caption boxes are colour coded for corresponding times of KSI and MEW.

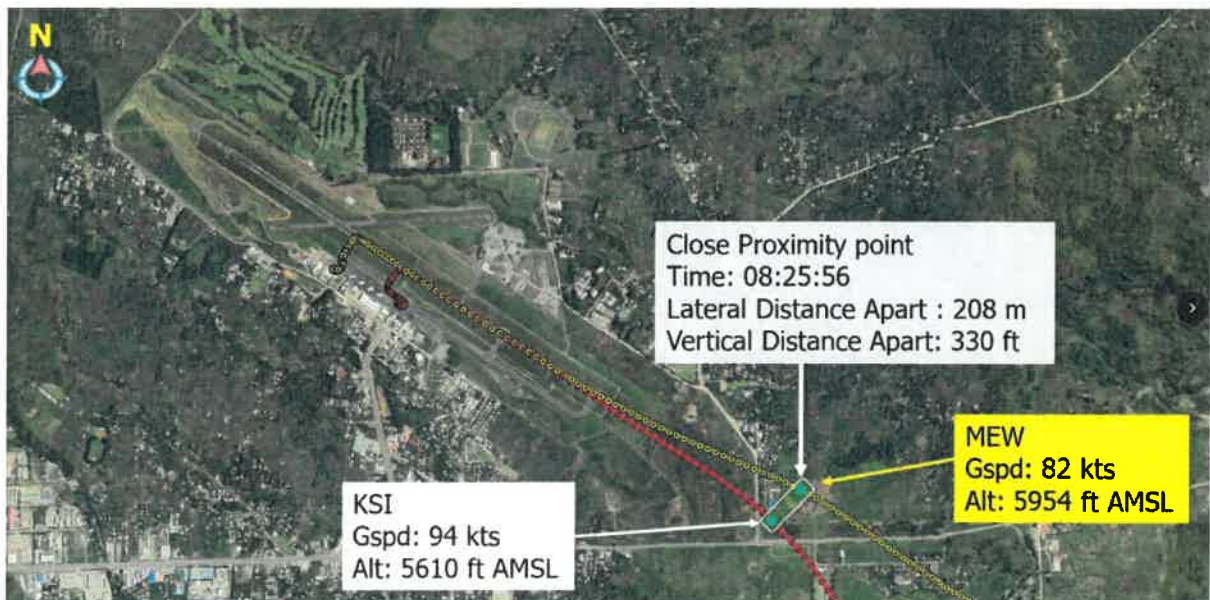
Figure 3: Depiction of close proximity KSI and MEW.

A few seconds later, when KSI was about 926m (0.5NM) from the Runway 30 threshold, KSI and MEW passed each other at a proximity of 330ft vertically and 208m laterally.
