PRELIMINARY REPORT

AIC 17-2002

Casa CN235-100M

Landing on a Closed Runway

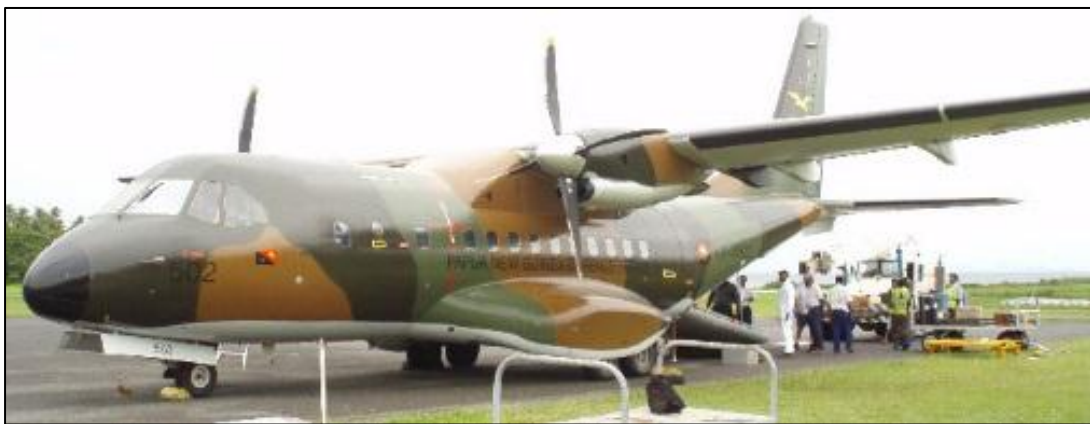
Figure 1: CASA CN235M P2-502

The aircraft sustained an engine failure on 13 July 2016 during a flight from Telefomin to Vanimo, Sundaun Province, necessitating the removal of the right engine Propeller Gearbox (PGB) at the Vanimo Aerodrome. A replacement PGB, Serial Number UDAG0616, was fitted to the right engine to enable the aircraft to be ferried to Port Moresby for further repairs.

The investigation has found that the replacement PGB had been placed in storage 7 years before the incident. Storage preservation requirements confirmed in a written statement from the Original Equipment Manufacturer (OEM) state that a PGB in storage for more than 36 months, must be sent to a PGB Original Equipment Manufacturer's facility for inspection.

This was not carried out, and the PGB fitted in 2016 remains on the aircraft as of the date of this safety recommendation. The aircraft is engaged in flying operations throughout PNG, carrying military personnel and civilians into civilian airports. The PGB fitted to the right engine of P2-502 is classified as unserviceable, bringing the airworthiness of the aircraft into question.

The PNG Accident Investigation Commission recommends that Commander PNG Defence Force (PNGDF) should require the replacement of the unserviceable Propeller Gearbox (PGB) Serial Number UDAG0616, currently fitted to the right engine of Casa CN235-100M aircraft, registered P2-502, before further flight.
