PRELIMINARY REPORT

AIC 17-1001

Bell Helicopter 407

Helicopter impacted aerodrome apron during takeoff

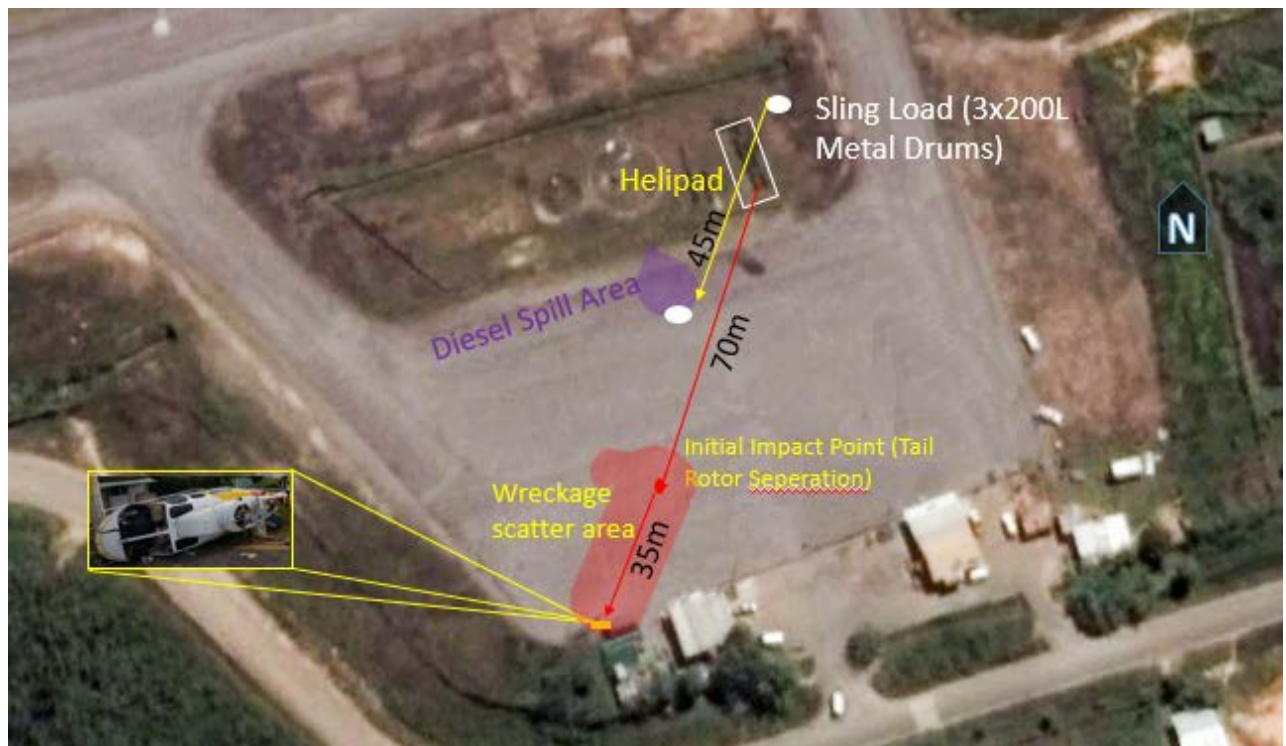
Figure 1: Aerial view of occurrence area

The investigation determined that the tail boom separated at the initial impact area on the tarmac. The fuselage came to rest against the railing around the light pole at the southern end of the tarmac, 35 m from the point where initial impact marks were found, 105 m from the helipad (See Figure 1).

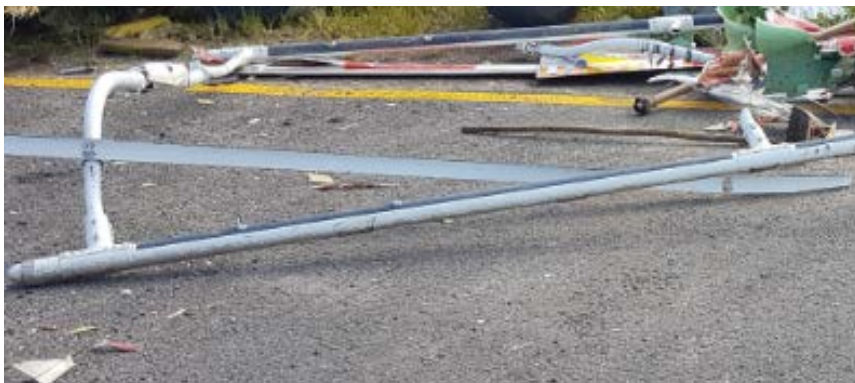
Figure 4: Separated landing gear skid assembly

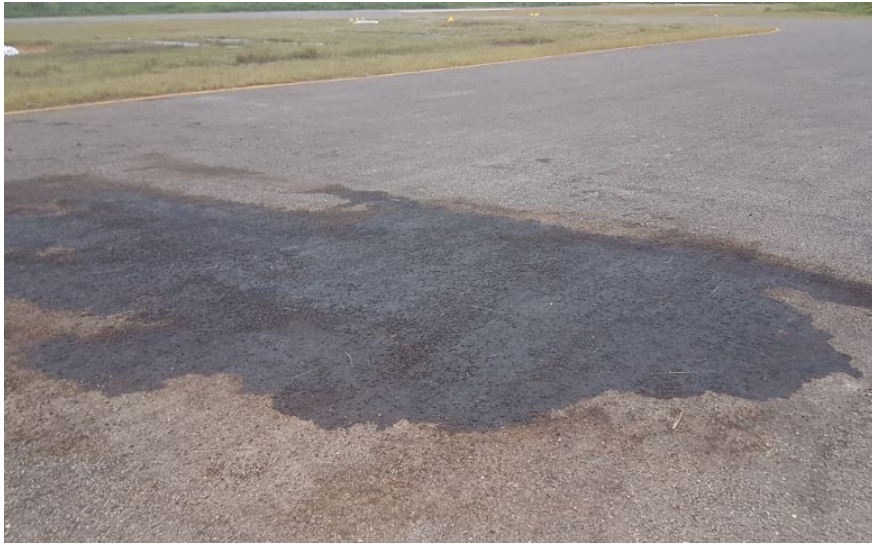
The pilot reported that when the helicopter was about 50 ft AGL and at a speed (IAS)³ between 30-40 kts, it suddenly jerked to the left, spiraled left, and impacted the tarmac, and was destroyed. The pilot and both passenger sustained minor injuries. A significant quantity of fuel spilled from one drum during the impact. There was no significant damage to aerodrome infrastructure.

Figure 4: Fuel spill on the aerodrome apron
