PRELIMINARY REPORT

Tropicair Limited

DHC6-300 Twin Otter

Runway Excursion During Landing

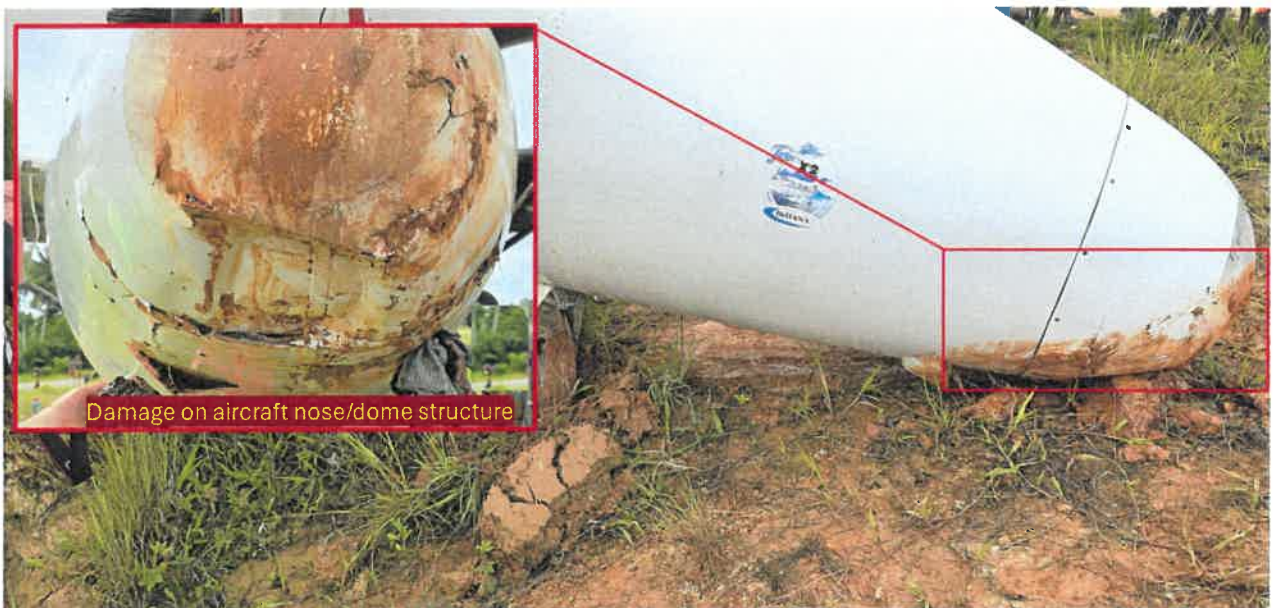
Figure 3. Overview of damage sustained to the aircraft.

The aircraft sustained damage to the nose cone and a punctured nosewheel tyre on impact (*see Figure 3*).
