FINAL REPORT

AIC 23 -1004

On 7 June 2023, at 16:44 local, (06:44 UTC), the AIC was notified by the operator, Strickland Bosavi Foundation, via a phone call, of an accident involving its Cessna 206 aircraft, registered VH-MZL. The accident was reported to have occurred at 15:10 during an aborted take-off, at Dodomona Airstrip, Western Province, Papua New Guinea. The AIC immediately commenced the investigation.

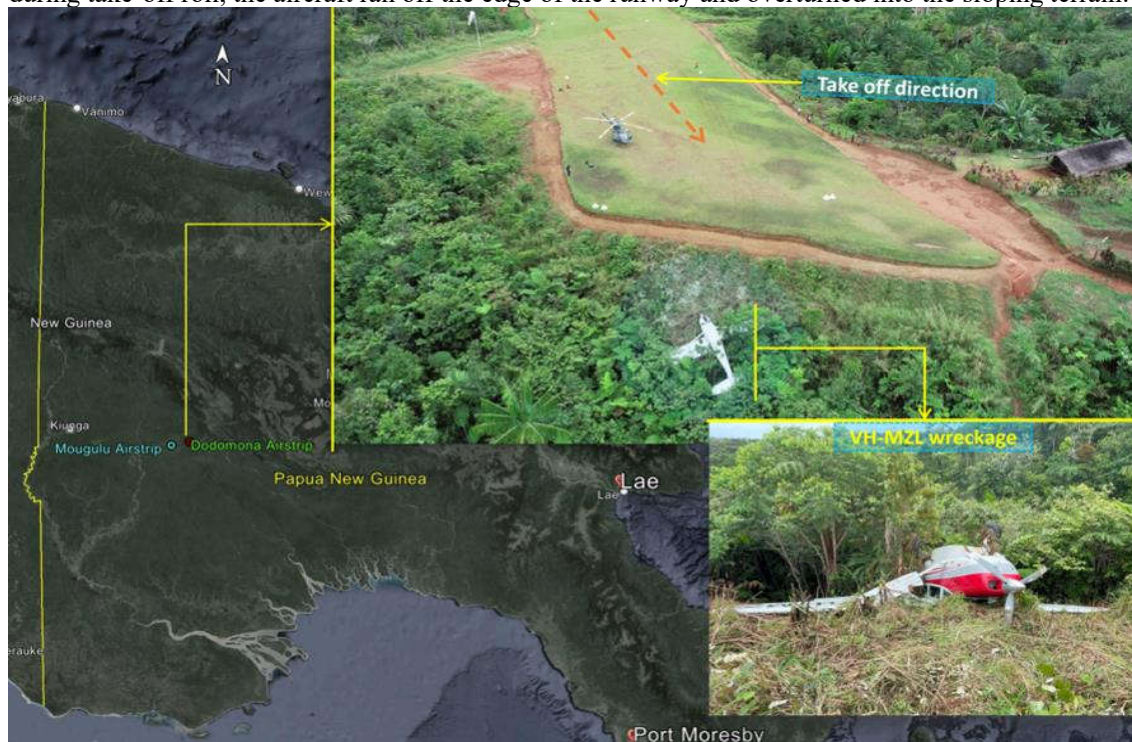
On 7 June 2023, at about 15:10 local (05:10 UTC¹), a Cessna 206 aircraft, registered VH-MZL (MZL), owned and operated by Strickland Bosavi Foundation Limited (SBFL), was conducting a Private VFR² flight from Dodomona Airstrip to Mougulu Airstrip, Western Province, Papua New Guinea, when during take-off roll, the aircraft ran off the edge of the runway and overturned into the sloping terrain.

Figure 1: Accident site at Dodomona showing VH-MZL wreckage. (Source: Google Earth, annotated by AIC)

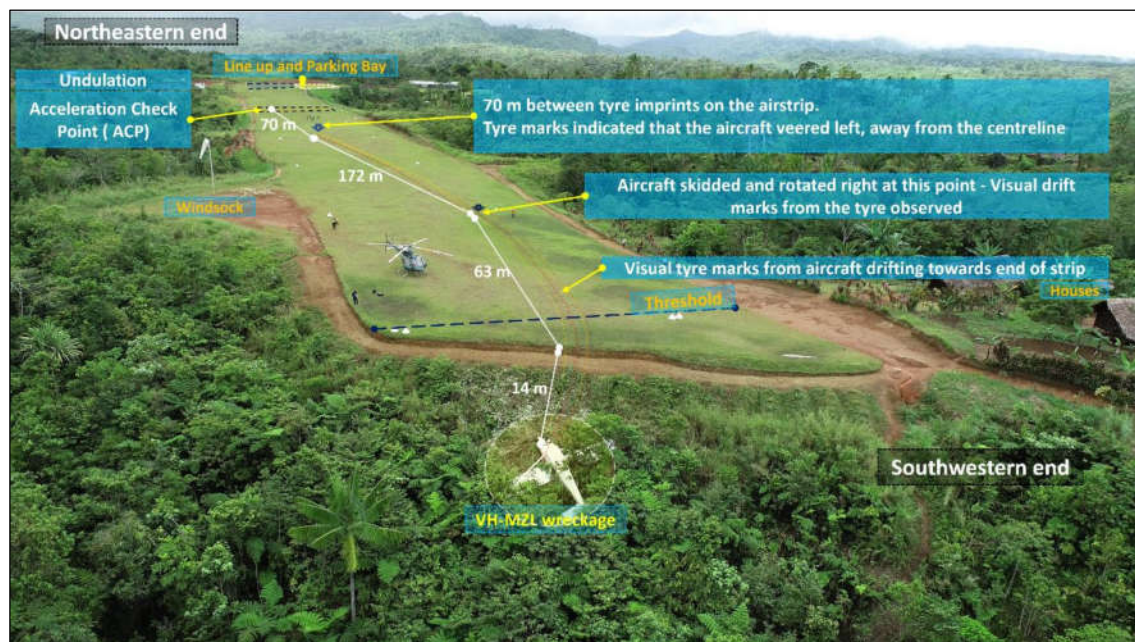
in time. He therefore, resumed full application of brakes to slow the aircraft. The aircraft began skidding and rotating right as momentum carried it past the edge of the airstrip. The aircraft subsequently came to rest inverted 14 m down the adjacent embankment.

Figure 4: Image showing events from undulations to the aircraft's final position.

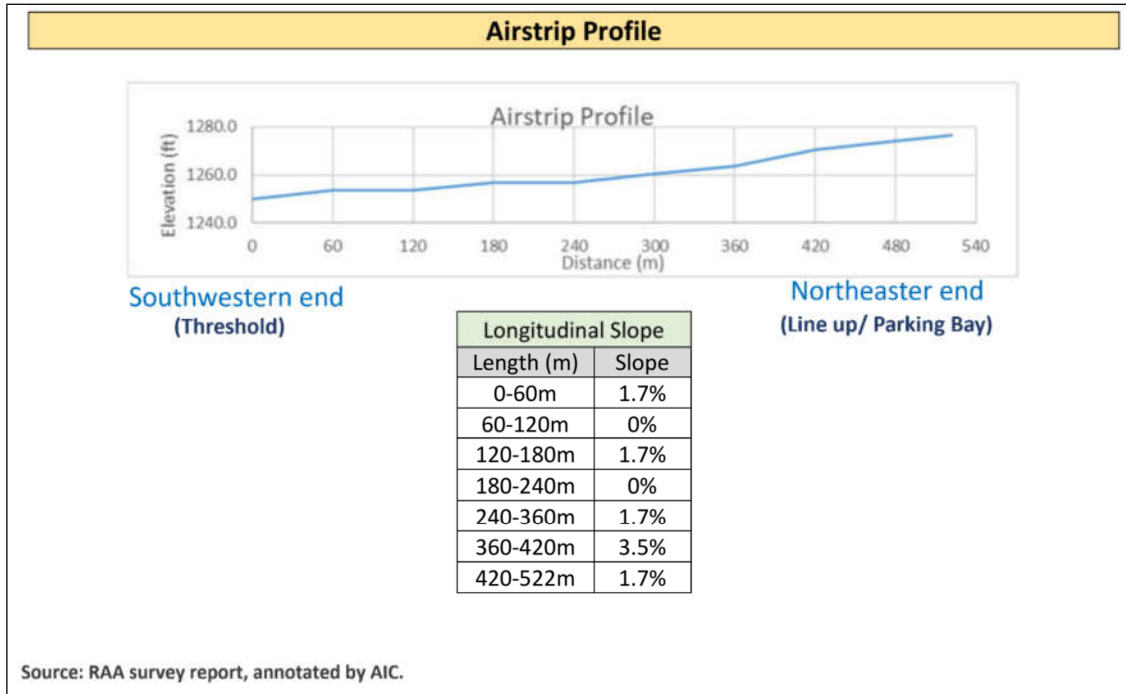
Figure 6. Dodomona Airstrip Profile.

RAA informed the AIC that during the survey, an undulation, approximately 180 m from the line-up end of runway 28 was identified. Its height was measured to be about 50 cm.

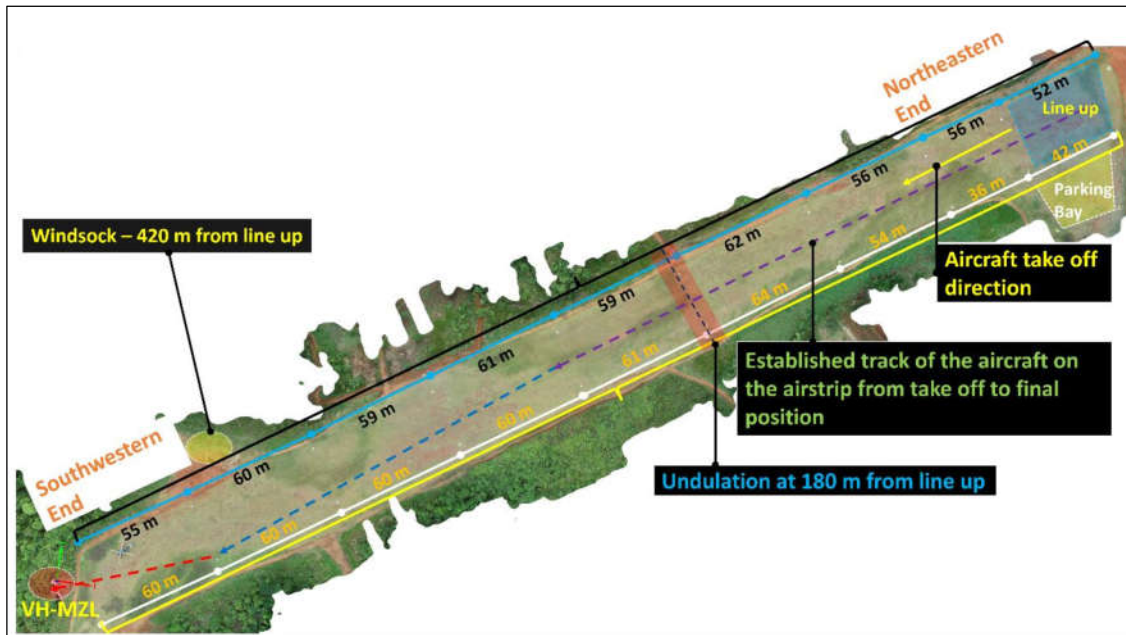
An undulation was observed about 180 m from the aircraft take-off initiation position.

The airstrip has a windsock situated about 420 m from the take-off end of the strip to the right of the airstrip (see *Figure 7*). Cone markers are placed along each side of the airstrip.

Figure 7. Modelling of Dodomona Airstrip including points and measurements of interest.

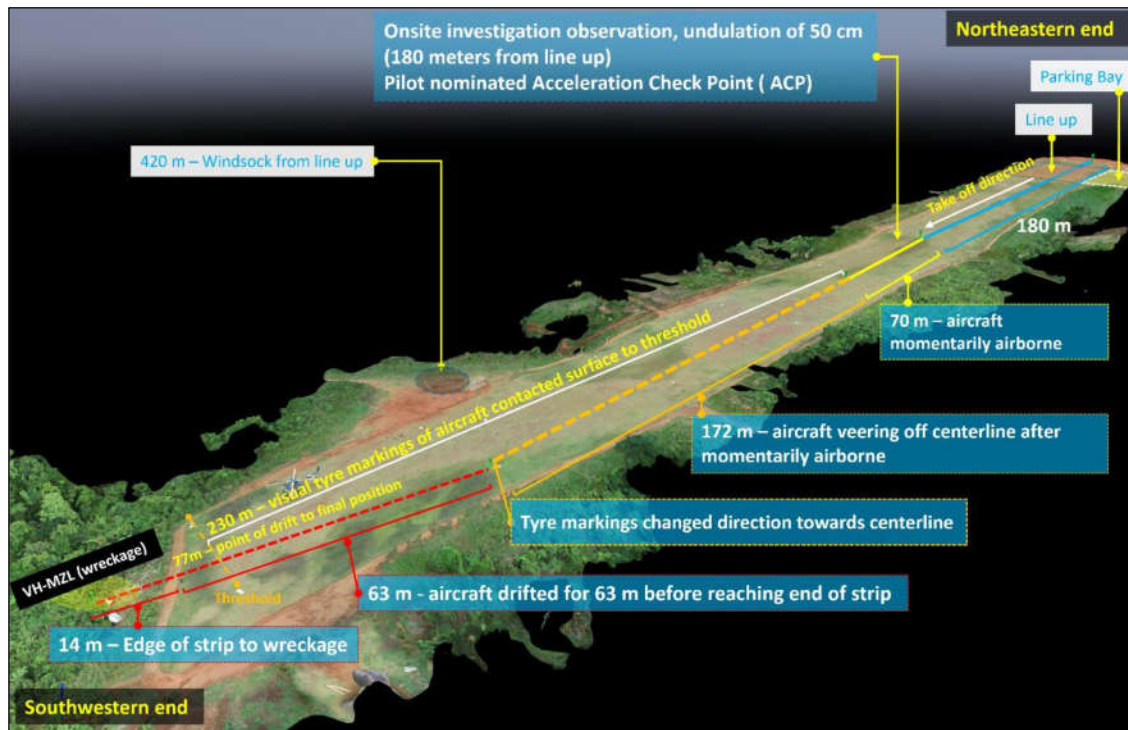
Tyre markings show that when the aircraft veered back to the right, the nosewheel tyre and the right main tyre tracks intersect, indicating that the aircraft was rotating laterally toward the right and that the aircraft was skidding across the surface with momentum. This caused the nosewheel track to transition to the outer right track, while the track of the right main tyre became the middle track. The aircraft's tyre tracks showed that the tyres maintained this configuration until it reached the edge of the strip. The

The layout of these tyre tracks also clearly indicated that while the aircraft continued down the airstrip, it was evident that the aircraft experienced a change of heading to the right, while it maintained tracking or continued drifting for the final 63 meters of the airstrip, towards the end.

Ultimately, it veered off at the southwestern end of the runway and flipped over, with the left-wing tip and the nose contacting the ground and subsequently came to rest inverted.

Figure 8: Accident site assessment using photogrammetry technique.

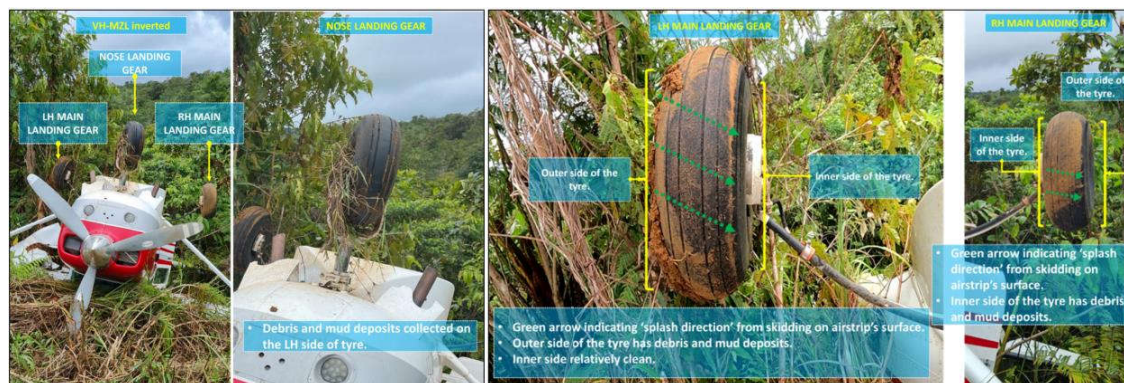
The debris and mud deposits that were found on the aircraft's tyres (refer Figure 9) indicated how the aircraft had drifted after the pilot initiated the ground loop to the right by applying the right landing gear brake.

Figure 9: Debris and mud deposits on the tyre indicating how the aircraft drifted during ground loop.

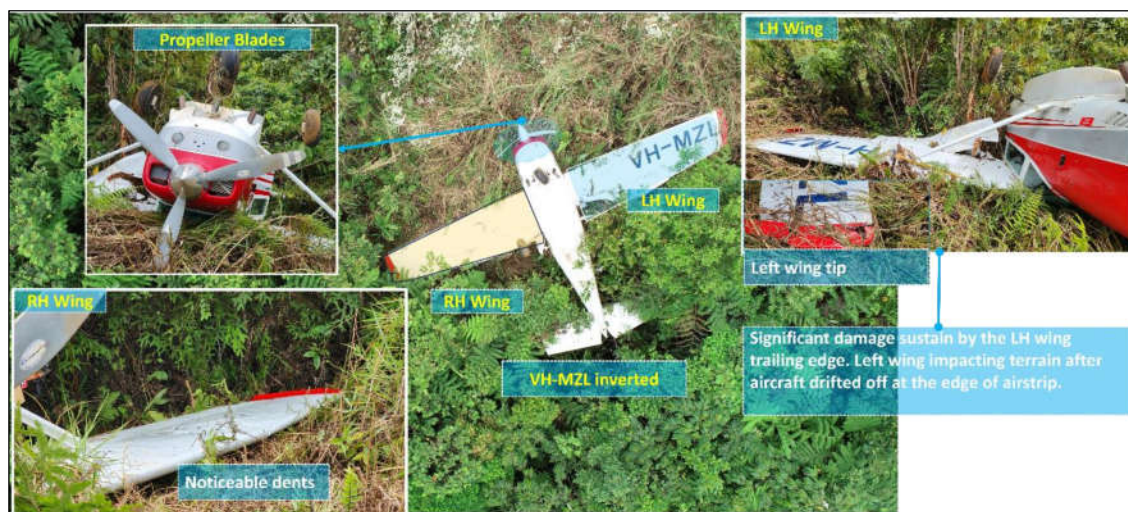
The impact forces of the accident resulted in significant damage observed on the right-hand (RH) flap, RH wing tip, left-hand (LH) leading edge, as well as damage to the propeller blade tips.

Figure 10: Damage to the aircraft.

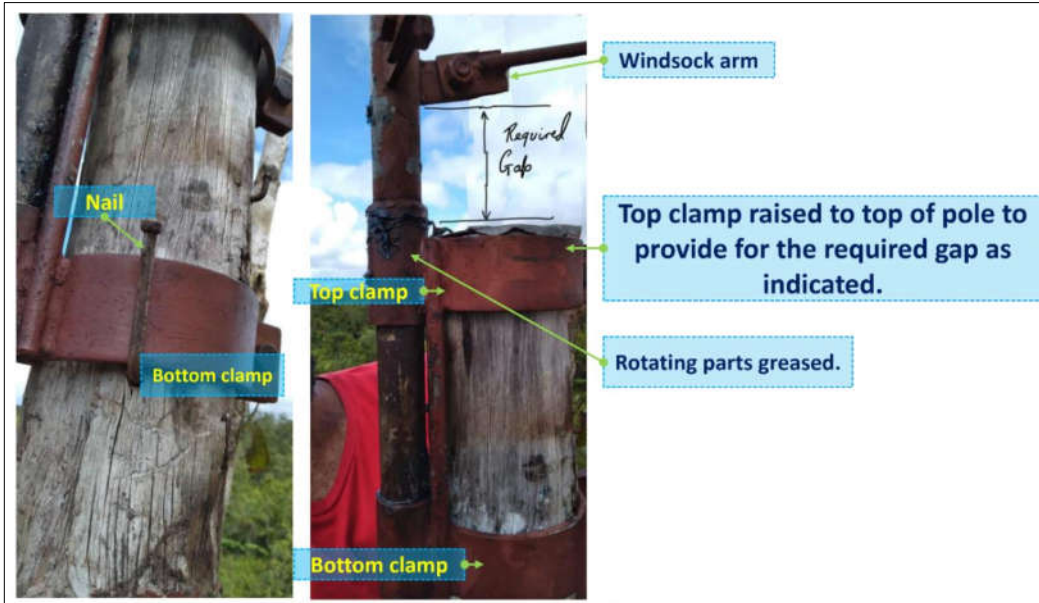
The operator stated in the report that they identified the primary fault with the windsock to be the aging timber that upholds the windsock post. As the timber deteriorated over time, the clamps of the windsock post that secure the windsock post onto the timber could no longer appropriately grip the timber. Subsequently, the windsock post became displaced by sliding down the timber resulting in the two lower arm of the windsock post coming into contact with the top of the timber. This caused the windsock pole to jam in various positions producing inaccurate indication of wind activity.

Figure 12. Rectification of faulty windsock.

The jammed windsock arm was raised to the top of the windsock post (pole). This was achieved by moving the two clamps (bottom and top) up the post and correcting the position on the pole. A nail was

then nailed below the bottom clamp to ensure the clamp does not slip down. Additional fix was the greasing of the rotating parts of the windsock.

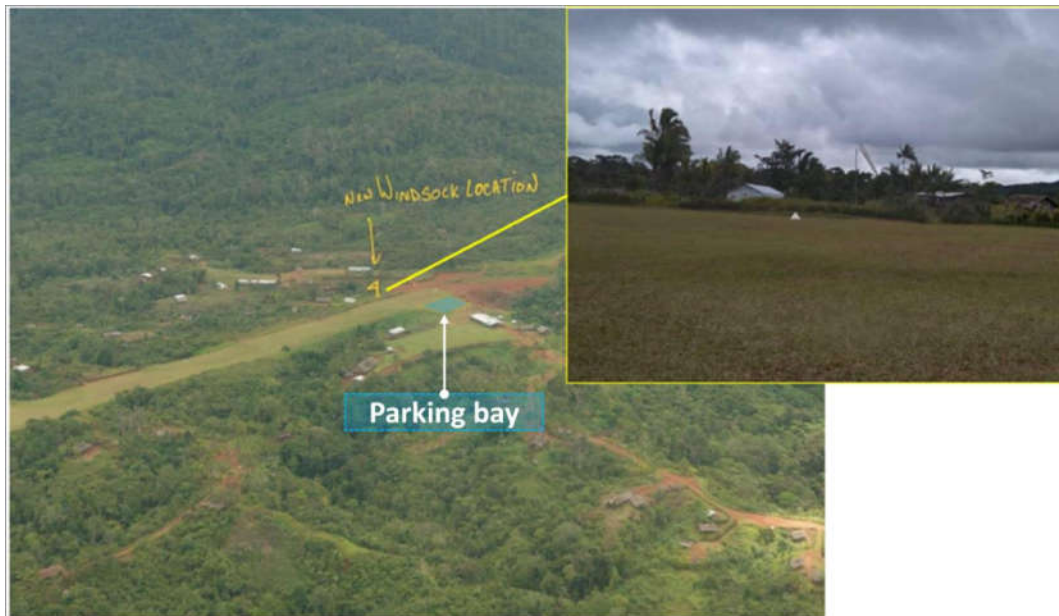
Figure 13. Dodomona Airstrip showing the newly installed windsock near the parking bay.

A new windsock had been installed opposite the parking bay, at the Northeastern end of the airstrip about 40 meters from the line up.

Both windsocks were tested and found to be serviceable.
