FINAL REPORT

AIC 23-1006

On 22 September 2023 at 16:50 local time (06:50 UTC), the AIC was notified by Niusky Pacific via a phone call of an accident involving a Bell 407 helicopter, registered P2-HSN, owned and operated by Heli Solutions, when during hover to land, the rotor blades struck a tree at Gebrau Village, Madang Province. The AIC immediately commenced an investigation and a team was deployed to the accident site on 23 September 2023.

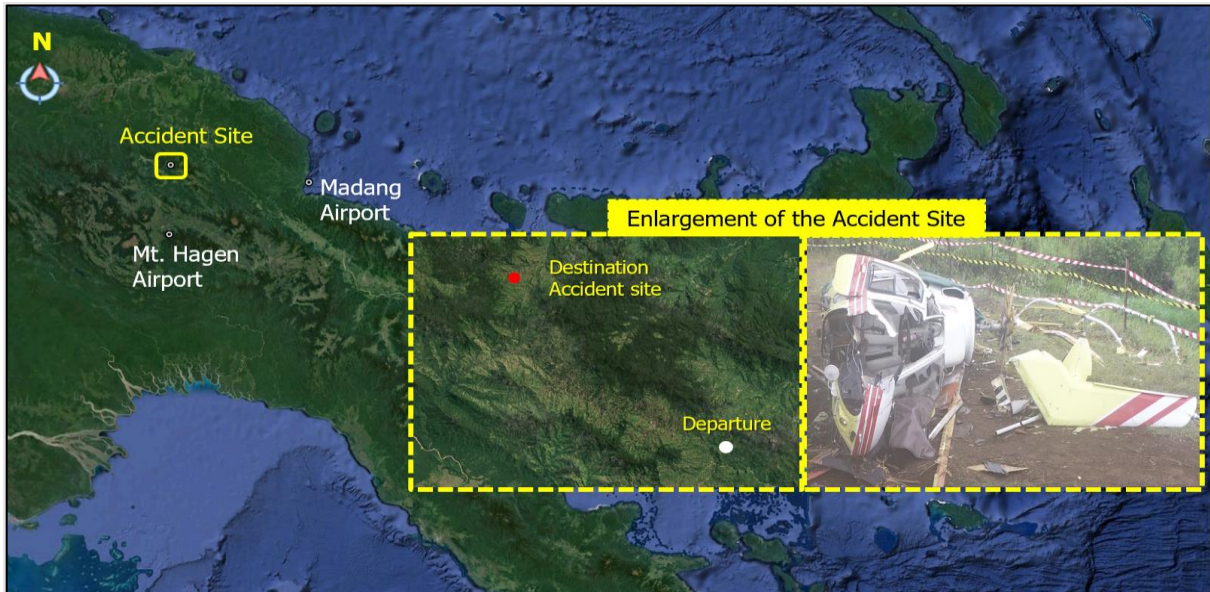
Figure 1: Overview of the P2-HSN accident site

On 22 September 2023, at 15:15 local time (05:15 UTC¹), a Bell 407 helicopter, registered P2-HSN (HSN), owned and operated by Heli Solutions Limited was conducting a VFR² passenger charter flight from Simbai to Kovon, Madang Province, when during its hover to land on a field at Gebrau village in the Kovon LLG³, the helicopter's rotor blades struck a tree.

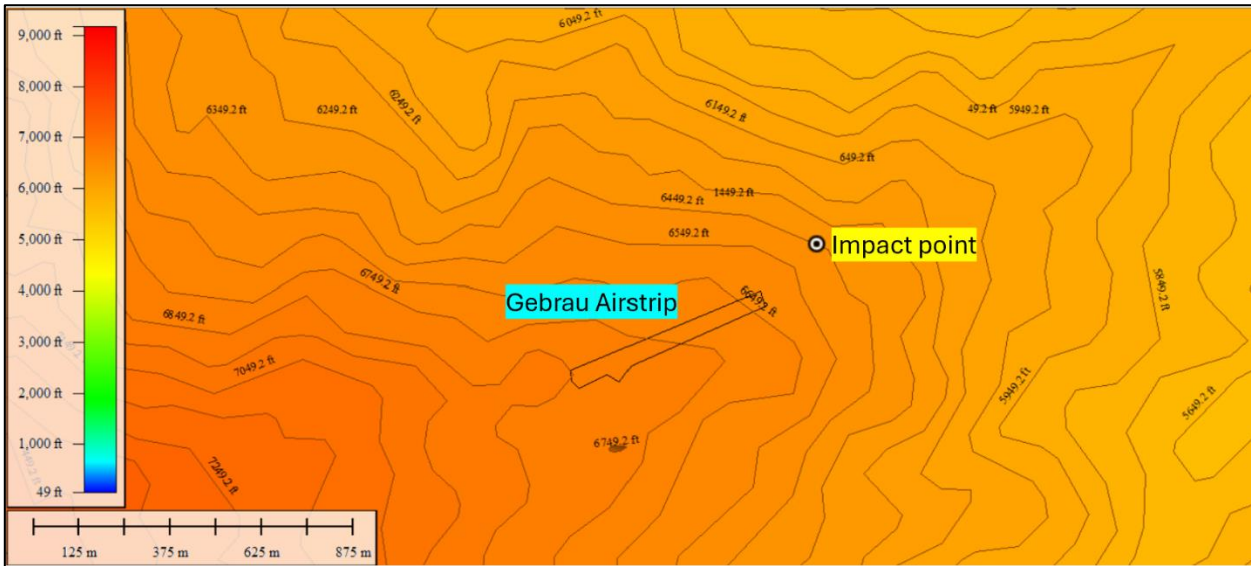
Figure 6:Topography Data

The investigation plotted the location of the accident area on the topographic map and identified that the landing area is about 6,500 ft AMSL and situated on the side of a mountain. The accident area was at a location that was considered as high elevation.

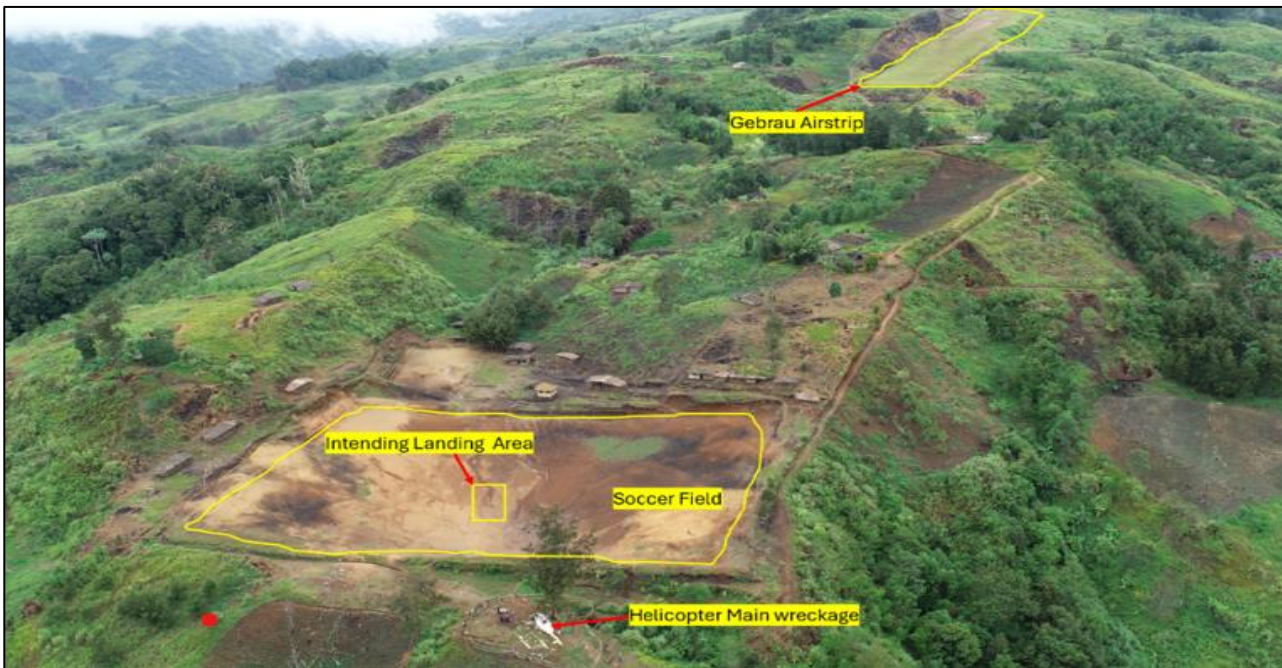
Figure 7: Overview of Helicopter Landing Area and Final Resting Position of P2-HSN

The accident site was located about 800 m Northeast of Gebrau Airstrip, Madang Province. The intended landing area (field) is sloped and located in between mountains ranges.

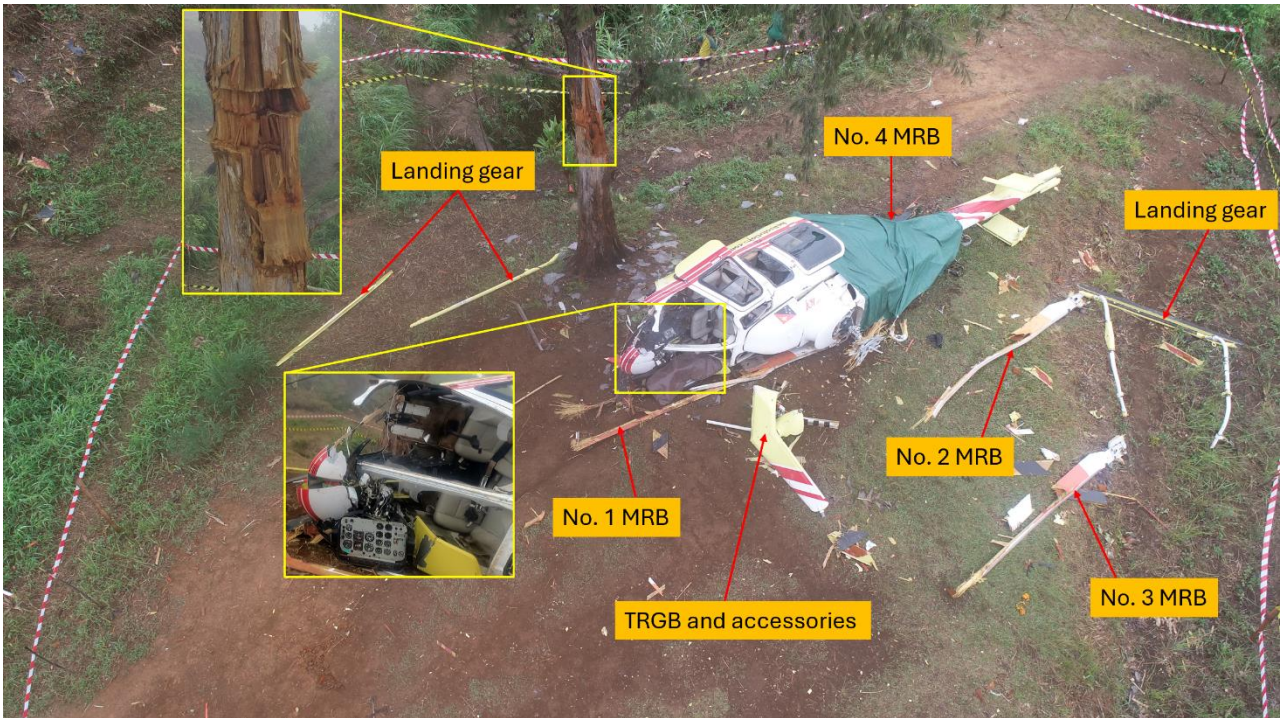
Figure 8:P2-HSN Wreckage Distribution and tree showing evidence of impact

Evidence gathered by the investigation team onsite showed that the helicopter had drifted backwards for 50 m towards the northern end of the field, where it struck a tree and impacted the ground, coming to rest on its left side at the base of the tree. The blade markings on the tree indicated that all four Main Rotor Blades (MRB) struck the tree at once and one of the MRB struck it twice.

As a result, all four of the MRBs sheared off from the main attachment. Consequently, the helicopter lost its lift and spun out of control and the Tail Rotor Blades (TRB) struck the ground. Subsequently, the Tail Rotor Gearbox (TRGB) assembly snapped off from the 4th drive shaft segment. Following this, the helicopter impacted the ground.

1. The cockpit and cabin sustained significant damage
2. The landing skids were snapped off from the main landing gear attachment.
3. TRGB snapped off from 4th drive segment and separated from the tail boom.
4. The instrument panel was separated from its mounting upon impact on the ground.
5. All four main rotor blades (MRB) were sheared off from its mounting mast and were destroyed
6. The exhaust cover of the engine sustained substantial damage.

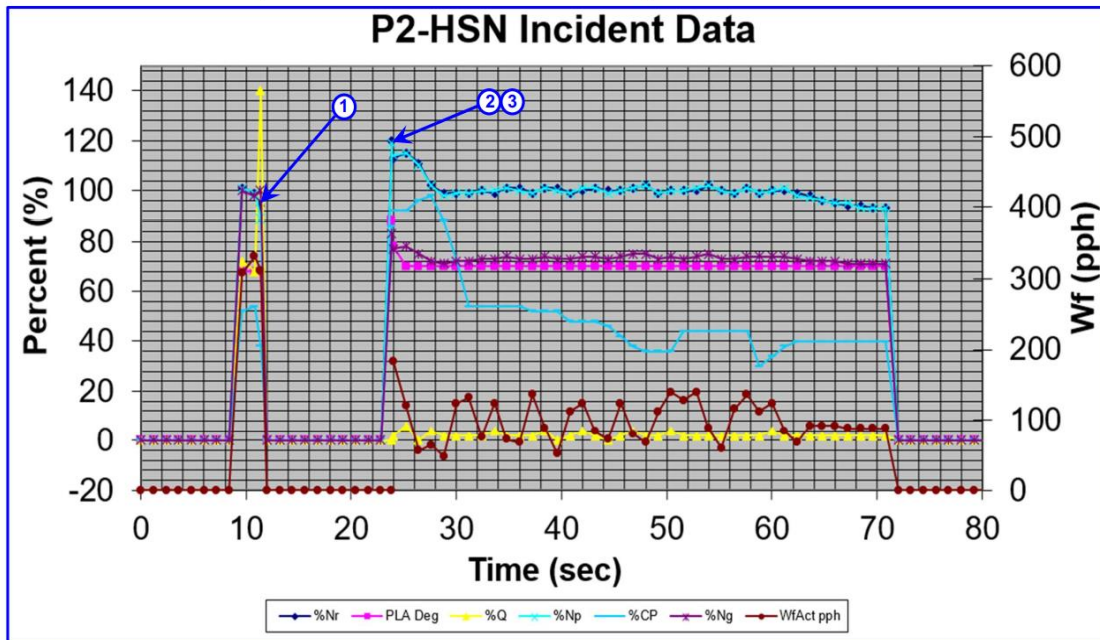
Event Synopsis

1. Trigger #1 was an Nr droop at the time the main rotor blades contacted the tree (rotor slowing down). Note the corresponding torque spike (%Q) yellow line consistent with the tree strike.
2. The lack of data from time 0 to 9.6 seconds & 12 to 22.8 seconds was due to lack of power to the ECU caused during the accident. These time gaps indicate the periods at which the incident recorder was attempting to capture the previous 10 records in its memory buffer following the triggers but was unable to do so due to the lack of power to the ECU. These time gaps are not reflective of “real time” during the accident sequence, rather they are essentially unfilled records holds in the buffer but was unable to fill.
