FINAL REPORT

AIC 16-1002

AIRCRAFT ACCIDENT INVESTIGATION REPORT

P2-SBC

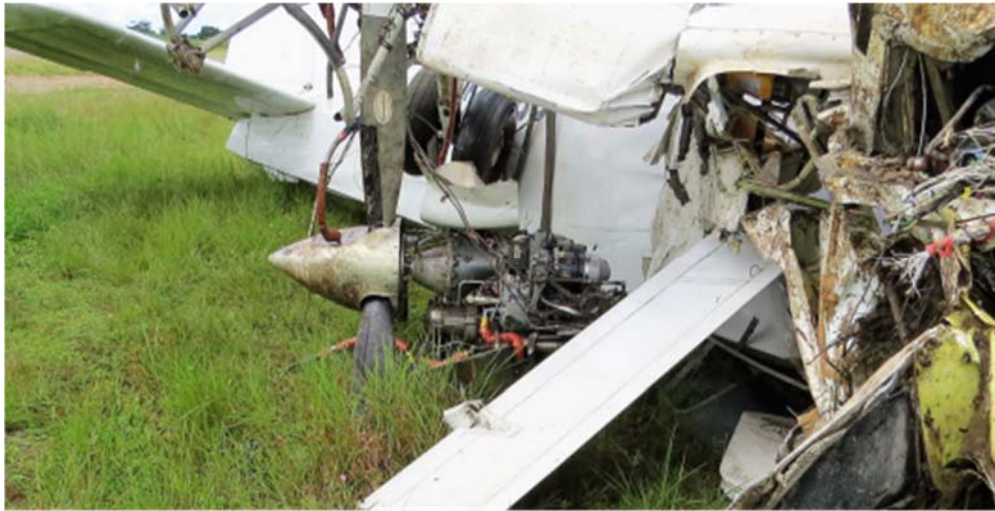
Figure 27: The wreckage at Kiunga Aerodrome

Unlike the left engine, the right engine had been forced into the soft, grassy soil during the impact sequence. The engine's compressor was packed tightly with grass and mud, which was extruding from the compressor bleed valve. This mud prevented manual rotation of the compressor and N1 drive train. Long blades of grass were found to be tightly wrapped around the compressor rotor, as well as progressively finer chopped grass deeper within the compressor.

Grass was found tightly wrapped around the leading edges of all compressor blades. This evidence is consistent with engine rotation at low power during the impact sequence.

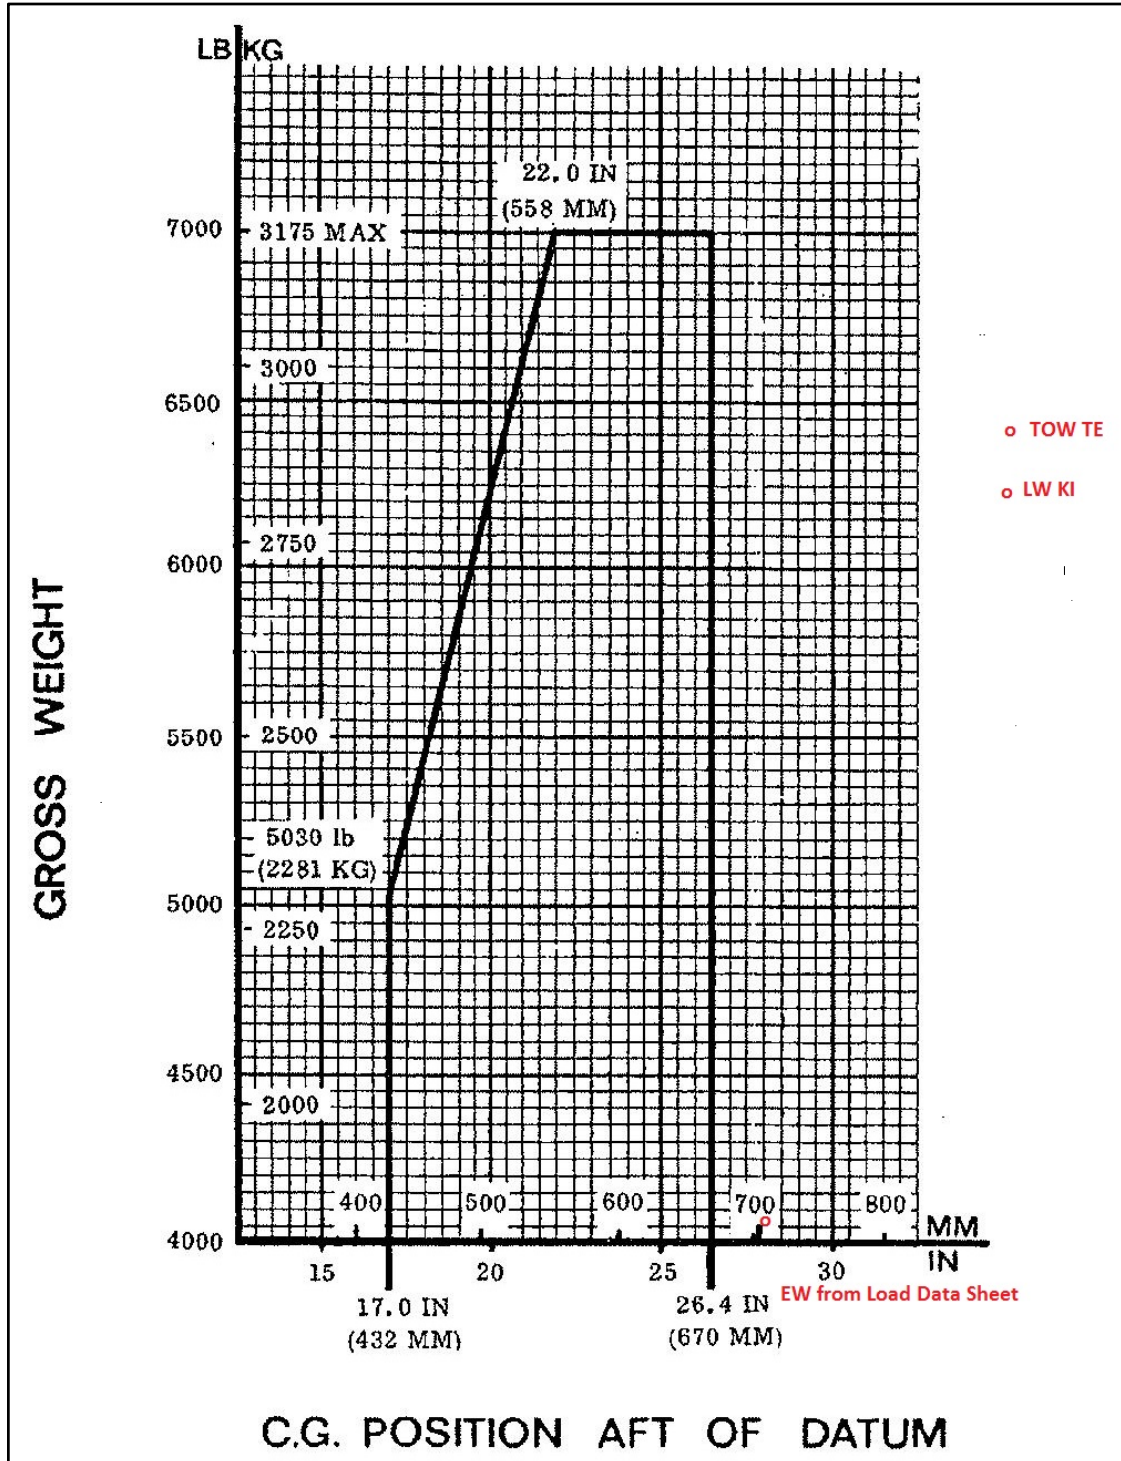
5.1.5 Centre of Gravity envelope for SBC

Max Allowable weight (3175kg, 7000lb). Stall speed at 6239.2lbs is **43kts**. Aft Limit is **26.4in**. The aircraft was well within its weight limits, but distribution was the main factor. The CG after reweigh was 28in, already out of the envelope. The previous CG was **23.22in**. The basic empty weight (BEW) was found to be the same, **1848kg (4065.6lbs)**.
