AIC 12-1007

**PAPUA NEW GUINEA
ACCIDENT INVESTIGATION COMMISSION
AIRCRAFT ACCIDENT REPORT**

P2-HCY

Bell 206L-1/C30P

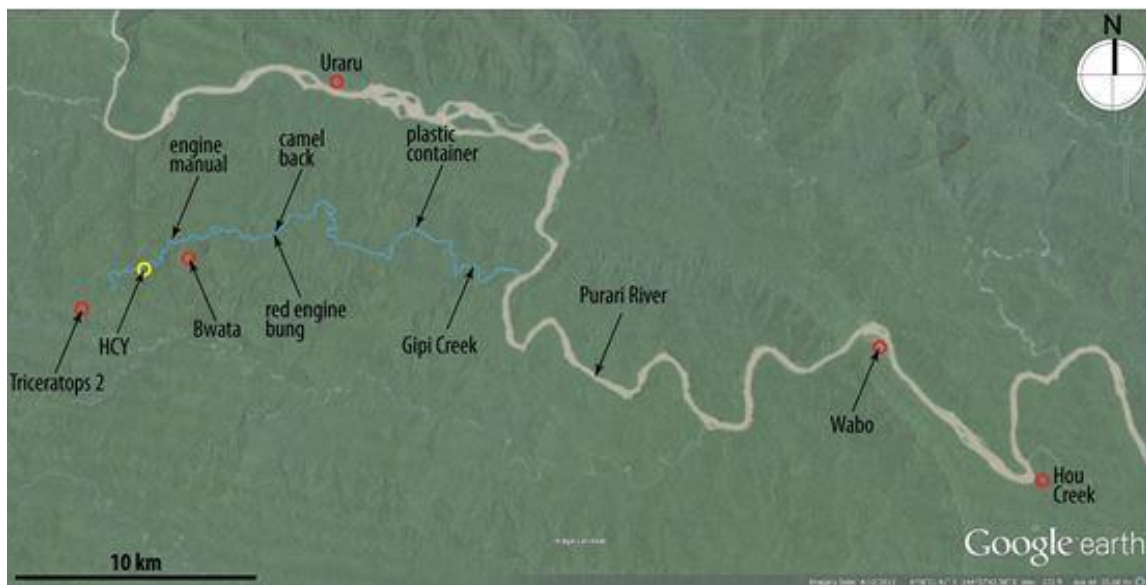
Figure 4: Area of the intended flight from Triceratops 2 to Hou Creek, with the location of items found downstream from the accident site

Even without knowledge of the actual track flown, the location of the accident site near Bwata (Figure 4) indicates that the pilot of HCY was taking the route past Bwata to Hou Creek i.e. the route that had been flown 10 minutes previously by the other company pilot. In addition, the pilot of HCY is reported to have included the word ‘Bwata’ in his MAYDAY broadcast.

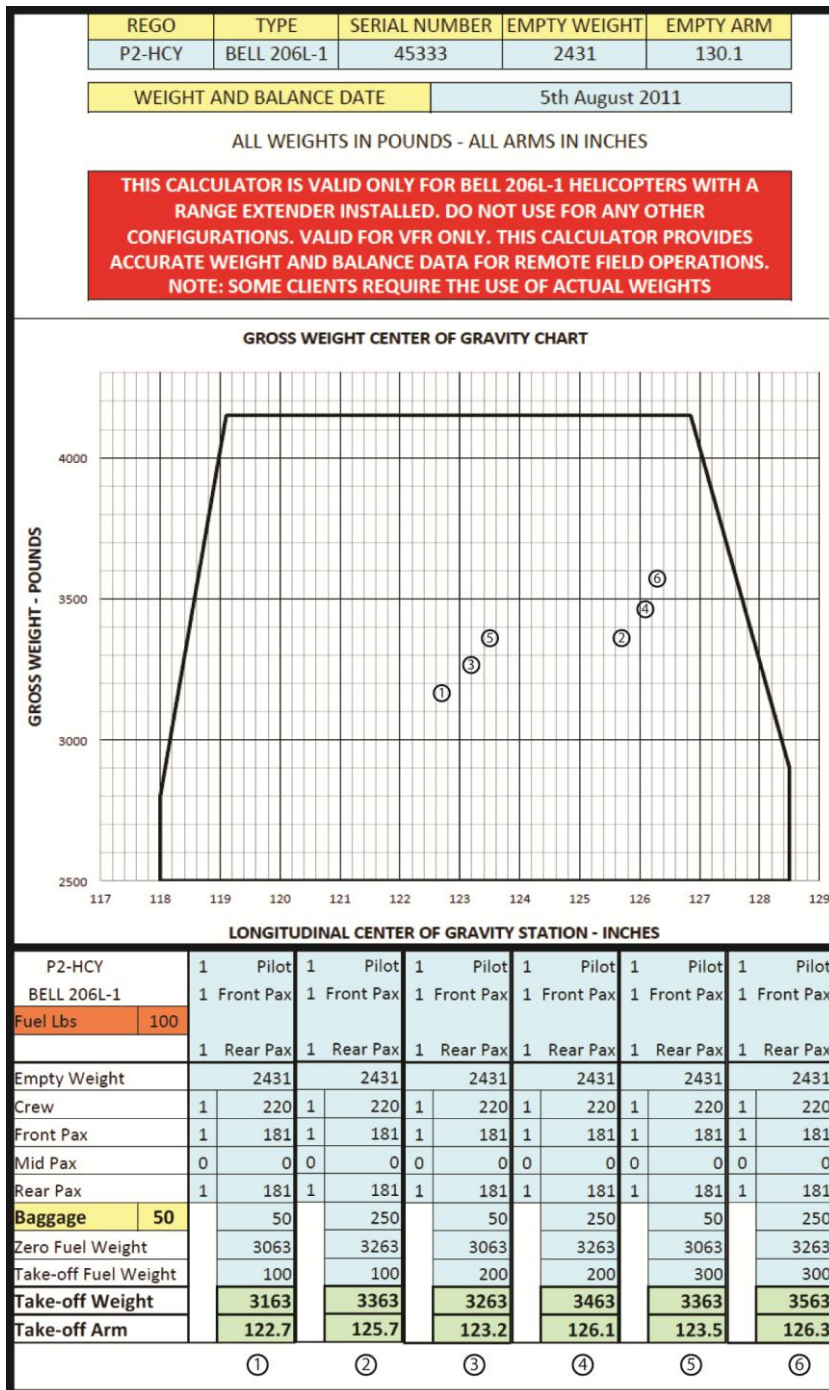
Figure 6: Estimate of weight and balance on the accident flight. Hevilift Ltd weight & balance chart for Bell 206L-1 helicopters.

It is not known exactly how much baggage/cargo was on board HCY, nor exactly how much fuel was on board. However, using ranges for the baggage/cargo and fuel figures, the B206L-1 Standard Load and Trim Calculator showed the helicopter would have been within its permitted flight envelope (Figure 6) during the accident flight on the basis of the weights in Table 2.

Although the fuel quantity on board HCY when it departed on the accident flight is not known, the calculations in Section 1.6.5. *Fuel information* below suggest that it may have been approximately 200 lbs. On this basis, the range 100 lbs to 300 lbs of fuel has been considered for the purpose of these weight-and-balance calculations.

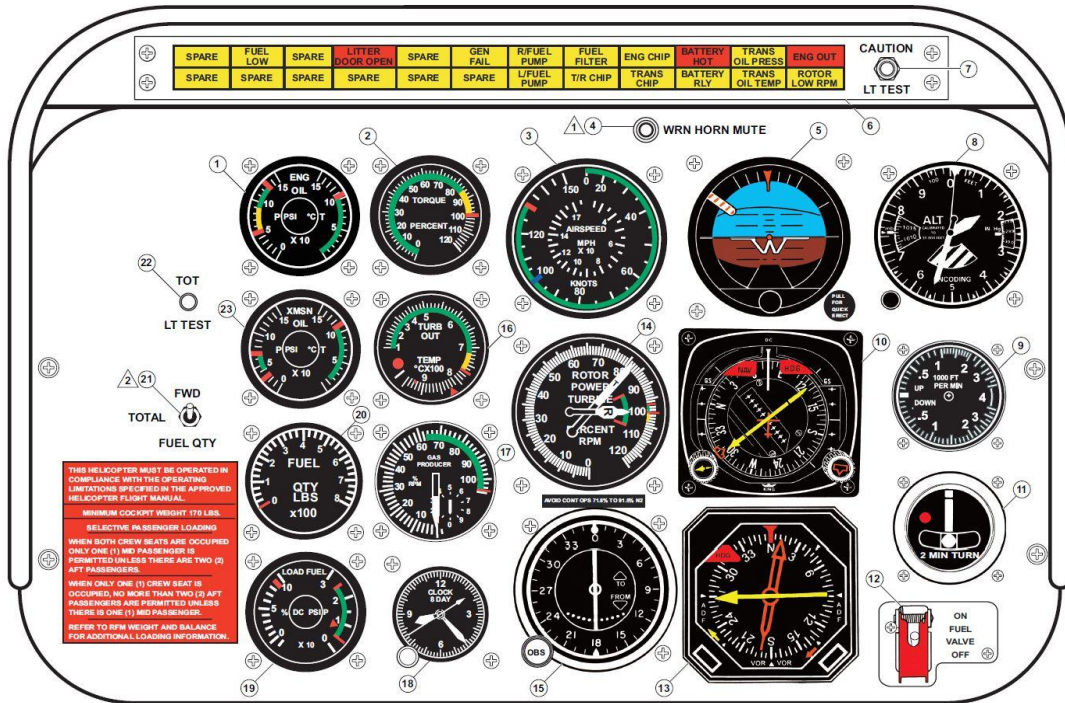
Figure 7: Caution warning panel mounted above the instrument panel

The AIC was unable to establish what happened to the caution and warning panel despite extensive questioning of parties who were present at the accident site at the time.

The loss of the caution warning panel deprived the AIC of important evidence. In particular, filament stretch, or lack of it, in the FUEL LOW caution light bulb would have indicated whether there had been 50 lbs to 70 lbs (28.5 L to 39.8 L) or less fuel remaining in the rear tank (see Figure 7) at the time of impact. The status of the filament in the FUEL LOW caution light bulb would therefore be strong evidence for or against the hypothesis that the engine stopped because of fuel exhaustion. Without knowing the status of the filament in this bulb, the AIC was unable to determine if the FUEL LOW caution light was on, and therefore if the rear tank contained 50 lbs to 70 lbs (or less) of fuel at the time of impact.
