AIC 16-1001

**PAPUA NEW GUINEA
ACCIDENT INVESTIGATION COMMISSION
SHORT SUMMARY REPORT**

P2-NCA

Nose wheel into soft ground during take-off roll involving P2-NCA PAC-750XL

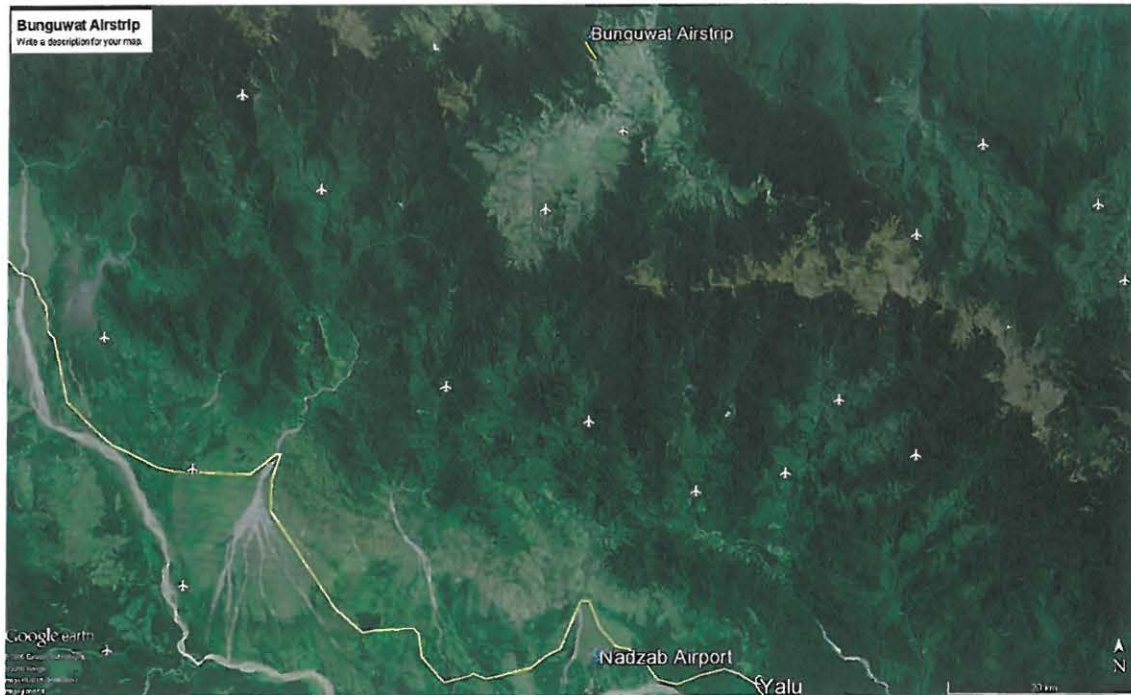
Figure 2: Bunguwat located north of Nadzab

Bunguwat is located about 30 nm (60 km) north of Nadzab (Figure 2), at an elevation of about 5,400ft (See Figure 2). The Morobe Provincial Government often charters North Coast Aviation for flights to deliver school materials to the Bunguwat Village. The villagers also charter flights to Nadzab for the transport of passengers, and vegetables to sell in Lae. This is typical for isolated villages with no physical connection to the outside world other than by aircraft. Air transport is crucial and having and maintaining an airstrip is vitally important. The villagers had recently extended the airstrip by approximately 50 metres, which was the area the pilot used to commence his take-off roll at time of the occurrence.
