**FINAL REPORT
AIC 15-1001**

**PAPUA NEW GUINEA
ACCIDENT INVESTIGATION COMMISSION
AIRCRAFT ACCIDENT REPORT**

**Helifix Ltd
P2-HFZ
Bell 206
Bobcat Rig Site
Gulf Province
PAPUA NEW GUINEA
15 February 2015**

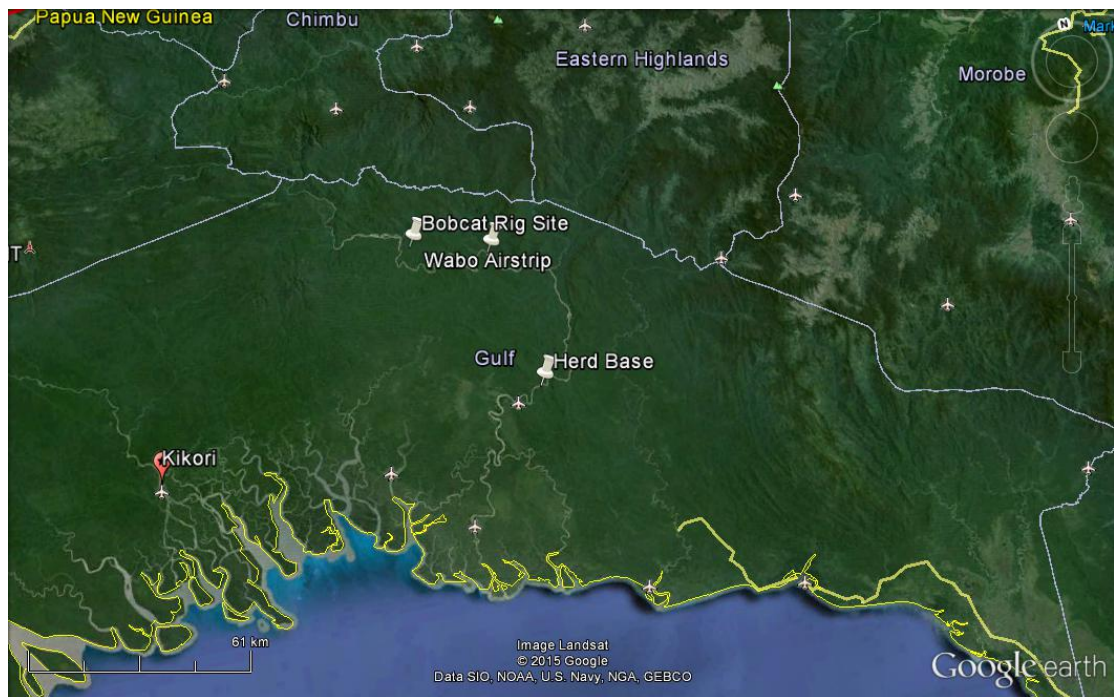
Figure 1: Area of the accident

The pickup was normal, with the helicopter's engine performing normally. The generator repositioning flight to the drop-off point was uneventful. As the load approached a position over the drop-off point, the load master on the ground signalled for it to be lowered to the ground. After the load was on the ground, the load master signalled for the pilot to lower the helicopter to release the tension on the line to allow the load master to unhook the sling.

As the pilot lowered the helicopter there was a sudden loss of power and the helicopter yawed left. He initiated an autorotation and the helicopter landed heavily, striking the generator and sustaining substantial damage to both of its landing-gear skids, the main rotor blades, and the tail boom.
