PRELIMINARY REPORT

AIC 23 - 1002

Cessna 208B Grand Caravan

Runway Excursion During Landing

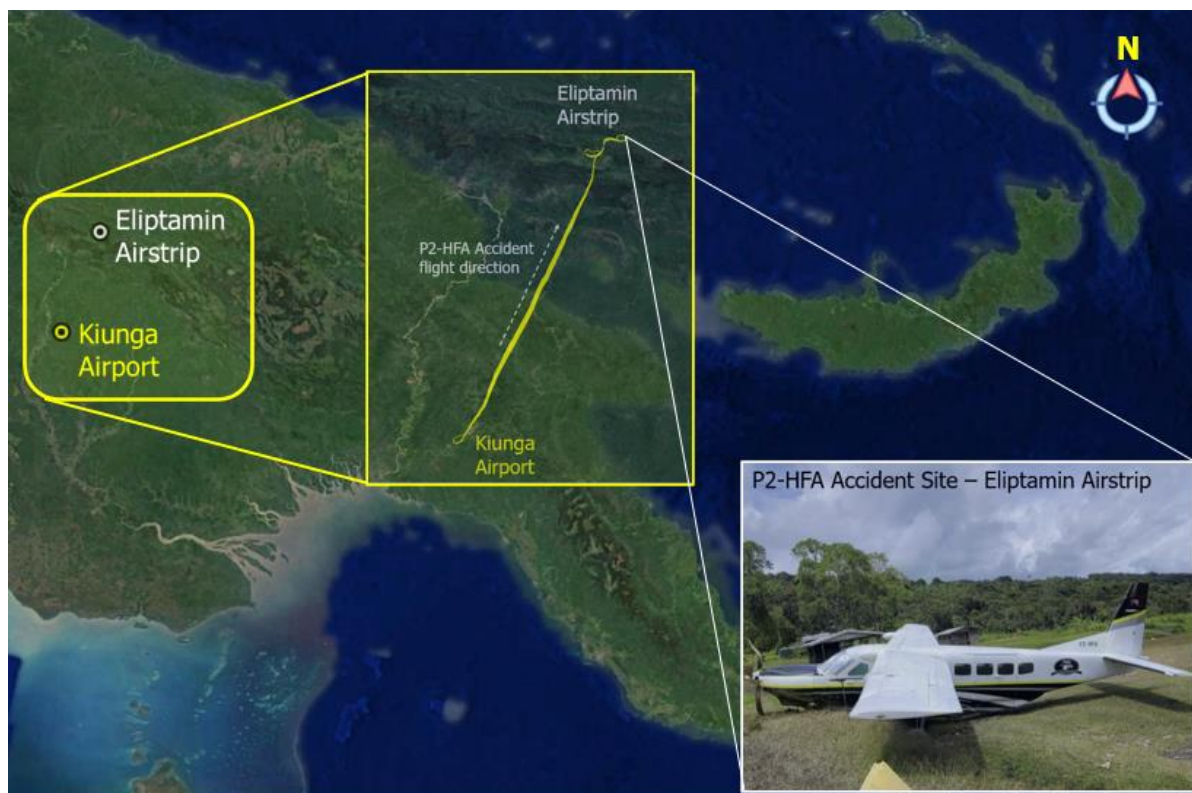
Figure 1. Depiction of P2-HFA flight path.

According to the Appareo recorded data, at 13:07 the aircraft departed from Kiunga Airport, climbed to an altitude of 1,847 ft AGL³ and began tracking Northeast for Eliptamin. The pilot reported the estimated time of arrival at Eliptamin to be in 34 minutes.

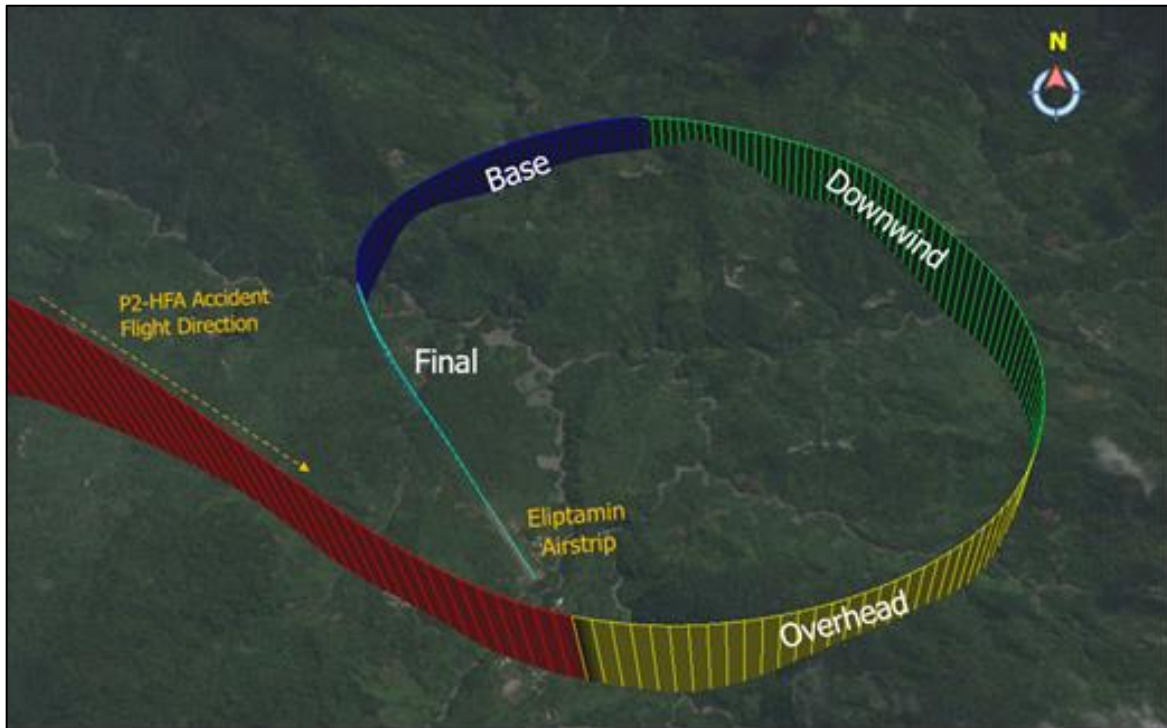
Figure 2. Circuit area at Eiptamin

During an interview with the AIC, the pilot stated that there was no significant weather along the route and in the Eliptamin area when he arrived. The recorded data shows that at 13:41 local time while descending through about 2,500 ft AGL, the aircraft turned left and began tracking towards the Northwest, downwind. The aircraft then tracked Northwest and made a base turn for final (*see Figure 2*).

The pilot stated that before entering the final approach, he extended full flap and maintained a speed of about 90 knots. The wind within the circuit area was calm.
