FINAL REPORT

AIC 23 -1004

On 7 June 2023, at 16:44 local, (06:44 UTC), the AIC was notified by the operator, Strickland Bosavi Foundation, via a phone call, of an accident involving its Cessna 206 aircraft, registered VH-MZL. The accident was reported to have occurred at 15:10 during an aborted take-off, at Dodomona Airstrip, Western Province, Papua New Guinea. The AIC immediately commenced the investigation.

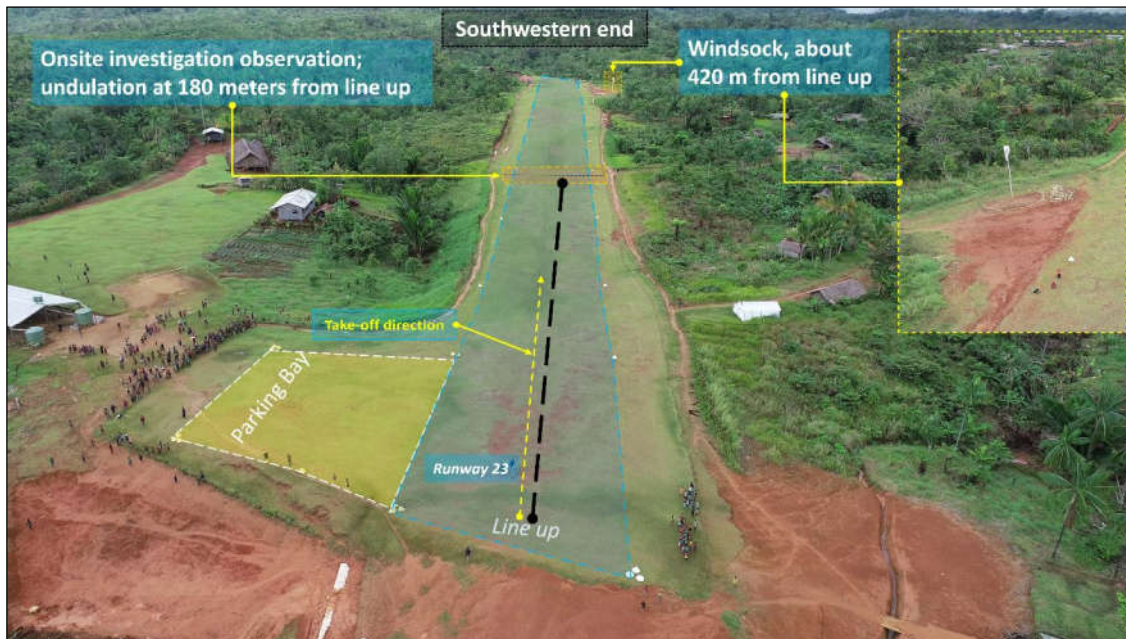
With full power applied, the pilot released the brake, and the aircraft began rolling forward and accelerated down the runway. The pilot reported to the AIC that he nominated an acceleration check point (ACP)⁶ at a position along the runway immediately prior to a undulation about 180 m down the airstrip. The speed that he expected to reach for the take-off to continue from that point was 40 kts. However, when he reached ACP, during the take-off roll and checked the airspeed indicator, he observed a lower airspeed.

Because of that observation, he immediately executed the *Engine Failure/Abort During Takeoff Procedure* (see 5.1, Appendix 5.1.2). The aircraft continued with momentum and bounced off the bump in the undulation and became airborne. The aircraft travelled forward in the air for about 70 m before contacting the ground again and continued to roll forward.

Figure 2: View of the airstrip from the Northeastern end of the strip.

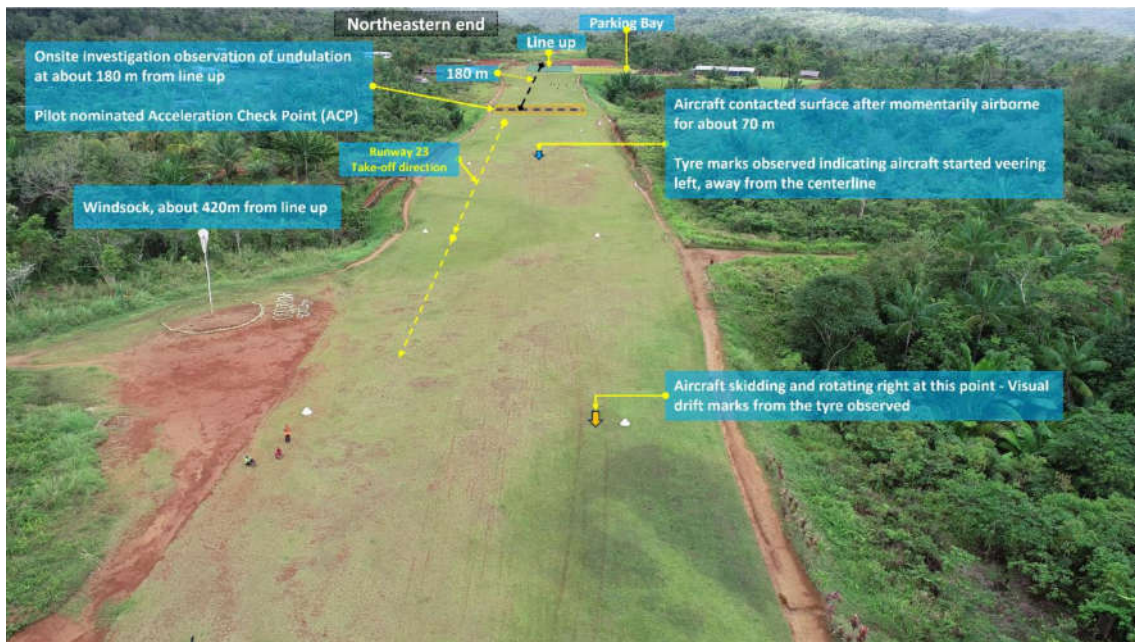
in time. He therefore, resumed full application of brakes to slow the aircraft. The aircraft began skidding and rotating right as momentum carried it past the edge of the airstrip. The aircraft subsequently came to rest inverted 14 m down the adjacent embankment.

Figure 3: View of the airstrip from the Southwestern end of the strip.

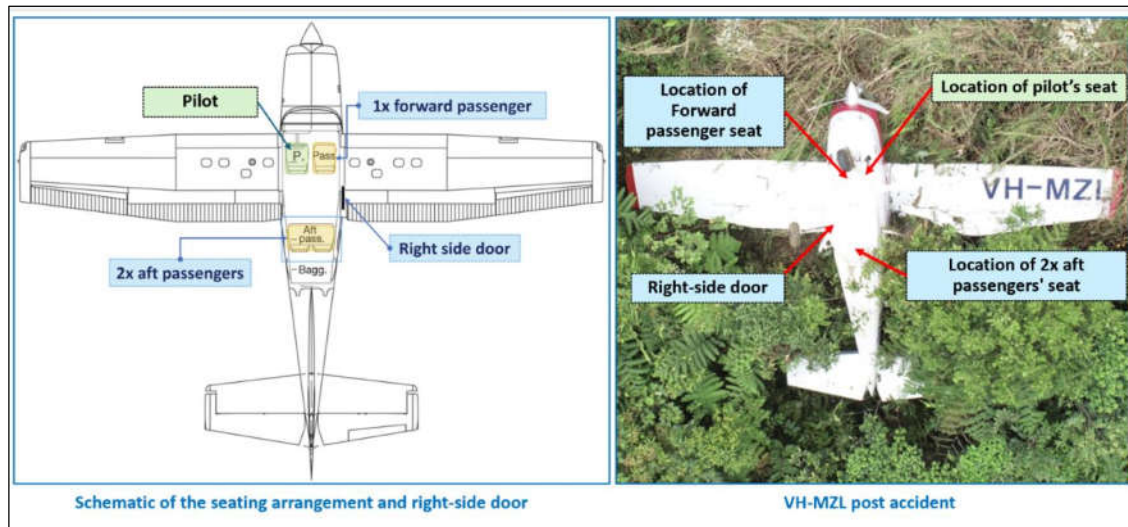
According to the pilot and the passengers, they exited the aircraft through the right-side door. The pilot stated that he was the last to exit the aircraft and walked up to the airstrip edge, where he assessed the three passengers for injuries.

Figure 11. Schematic of the seating arrangement and the right-hand side door.
