FINAL REPORT

AIC 23-1006

On 22 September 2023 at 16:50 local time (06:50 UTC), the AIC was notified by Niusky Pacific via a phone call of an accident involving a Bell 407 helicopter, registered P2-HSN, owned and operated by Heli Solutions, when during hover to land, the rotor blades struck a tree at Gebrau Village, Madang Province. The AIC immediately commenced an investigation and a team was deployed to the accident site on 23 September 2023.

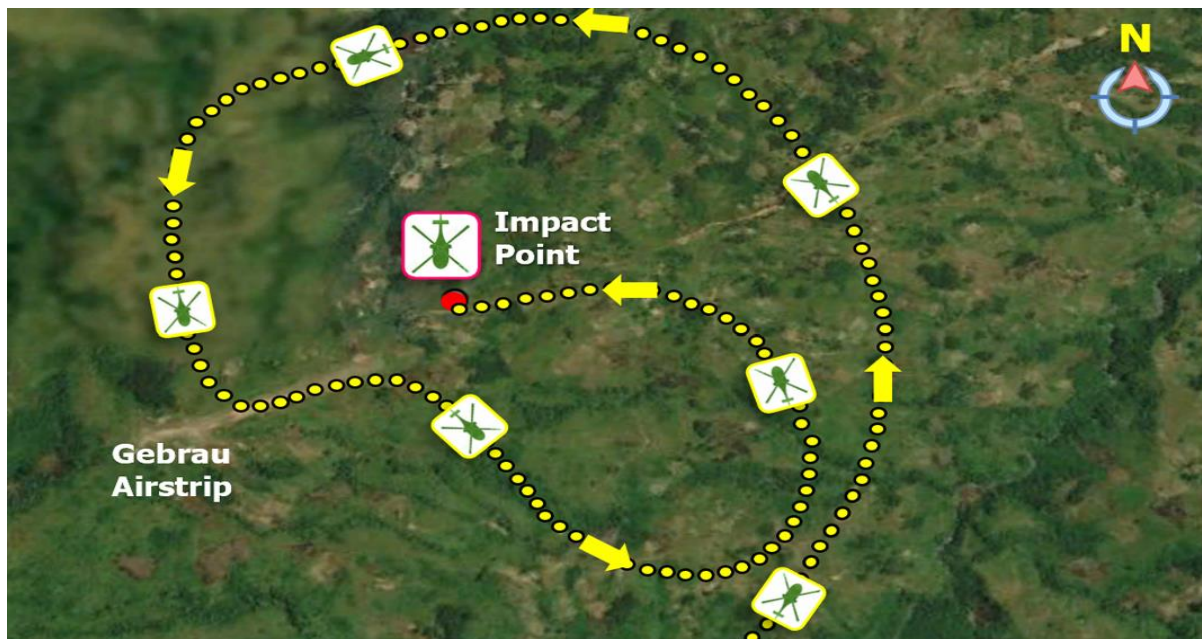
Figure 4:P2-HSN Flight Path at Gebrau Airstrip Circuit Area

The Spidertracks recorded⁶ data showed that from overhead the Gebrau Airstrip, the helicopter tracked towards the landing area. The helicopter then made a right turn onto a southeasterly heading before turning left and continued with the turn towards the landing area with a low shallow approach.

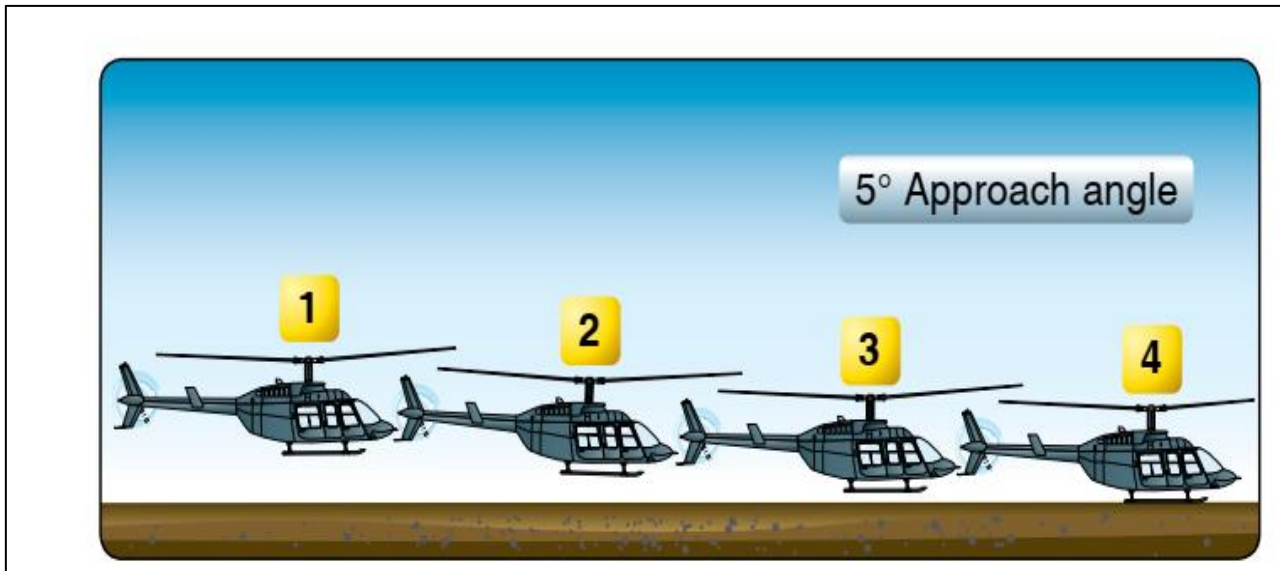
Figure 9:Shallow Approach and Running Landing

The investigation determined that the shallow approach was conducted due to the high gross weight conditions so a normal or steep approach could not be made because of insufficient power to hover. The landing area was not smooth so when the helicopter was sliding to a stop, during this manoeuvre, dust flowed upwards and engulfed the helicopter.
